PROJECT NO. I-0914BA

BRIDGE NO. 64

SUBSTRUCTURE REPAIR

BENT 1

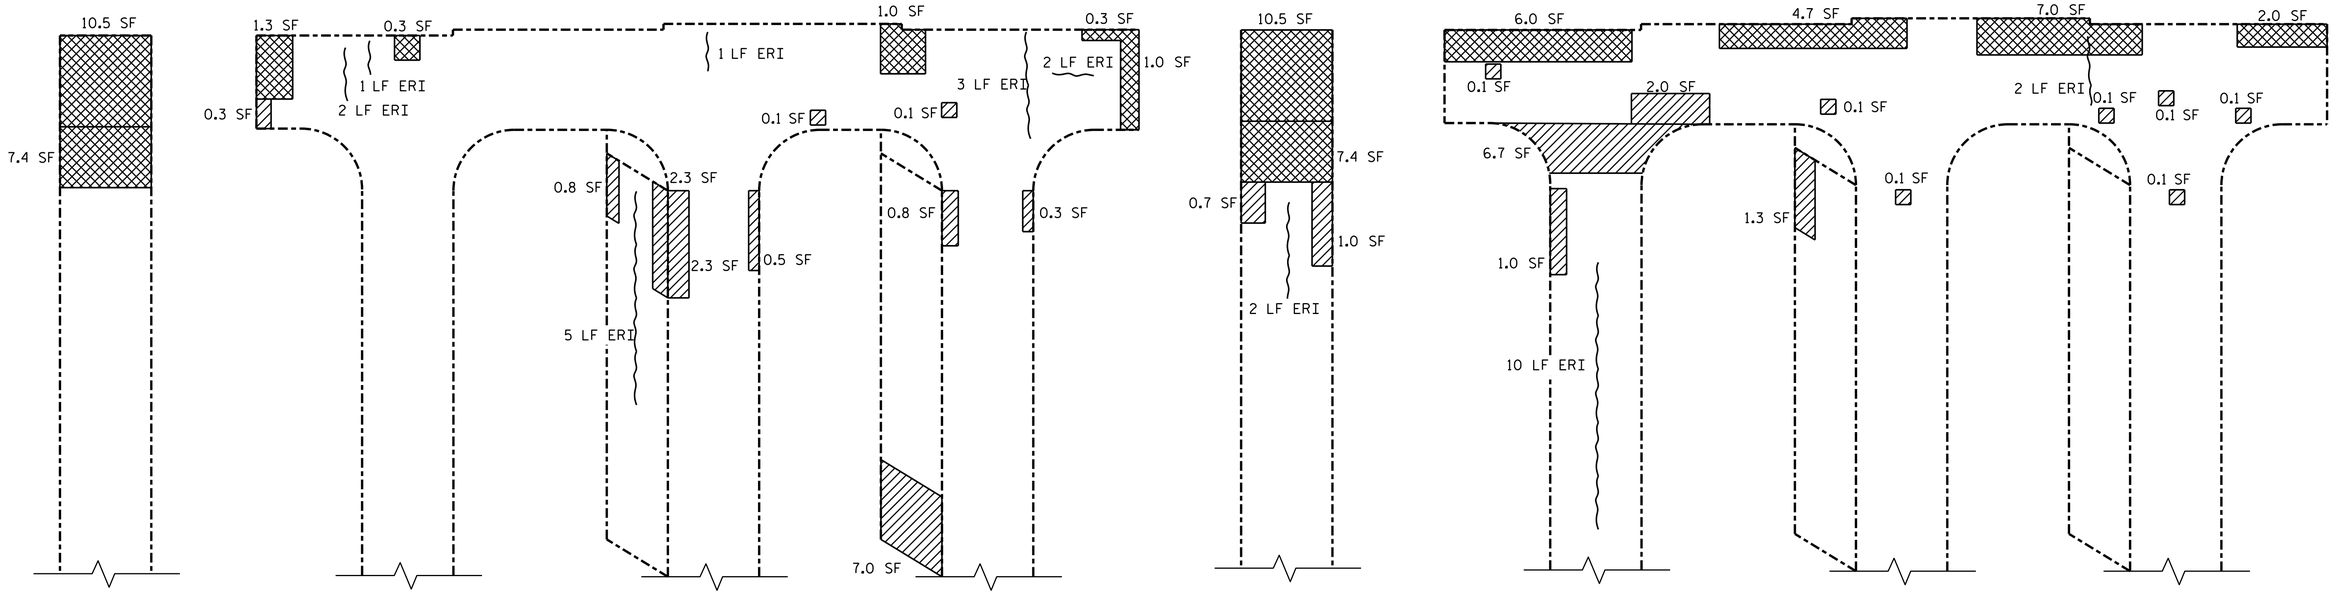
PLAN - TOP

REPAIRS BENT 1	QUANTITIES			
	ESTIMATE		ACTUAL	
SHOTCRETE REPAIRS	AREA SF.	VOLUME CF.	AREA SF.	VOLUME CF.
CAP (VERTICAL FACE)	3.0	1.0		
CAP (HORIZONTAL FACE)	0	0		
COLUMN (VERTICAL FACE)	24.9	8.3		
CONCRETE REPAIRS	75.7	25.2		
EPOXY RESIN INJECTION		LN. FT.		LN. FT.
CAP		11.0		
COLUMN		17.0		
EPOXY COATING		SQ. FT.		SQ. FT.
TOP OF CAP		114

EPOXY COATING SHALL BE APPLIED TO THE TOP FACE OF THE BENT CAPS AND ENDS OF GIRDERS.

FOR STRUCTURE REPAIRS, SEE "TYPICAL REPAIR DETAILS" SHEET.
