PROJECT NO. I-0914BA
VANCE COUNTY
BRIDGE NO. 55

SHEET 2 OF 3

SUBSTRUCTURE REPAIRS

BENT 2

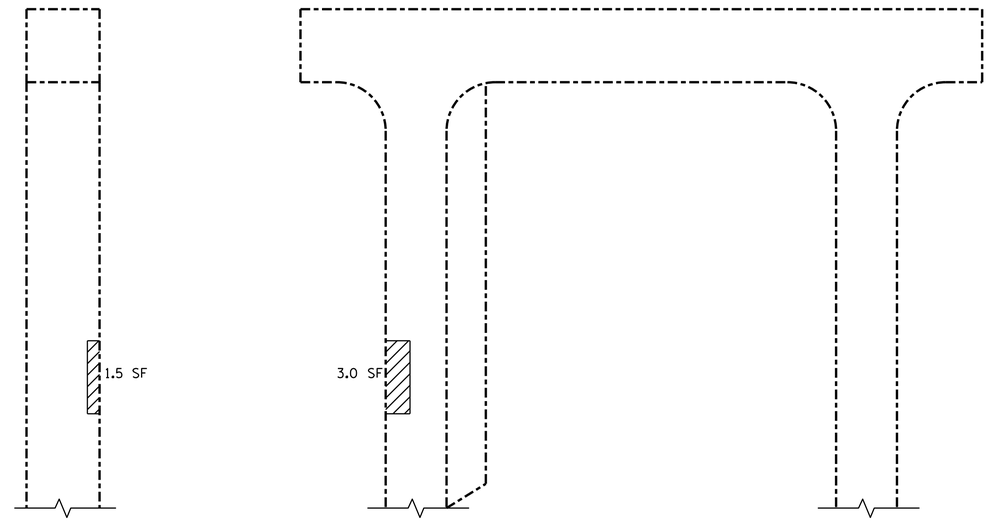
REPAIR QUANTITY TABLE				
REPAIRS BENT 2	QUANTITIES			
	ESTIMATE		ACTUAL	
SHOTCRETE REPAIRS	AREA SF.	VOLUME CF.	AREA SF.	VOLUME CF.
CAP (VERTICAL FACE)	0	0		
CAP (HORIZONTAL FACE)	0	0		
COLUMN (VERTICAL FACE)	4.5	1.5		
CONCRETE REPAIRS	0	0		
EPOXY RESIN INJECTION		LN. FT.		LN. FT.
CAP		3.0		
COLUMN		0		
EPOXY COATING		SQ. FT.		SQ. FT.
TOP OF CAP		84
