PROJECT NO. I-0914BA
VANCE COUNTY
BRIDGE NO. 54

SHEET 2 OF 3

SUBSTRUCTURE REPAIR

BENT 2

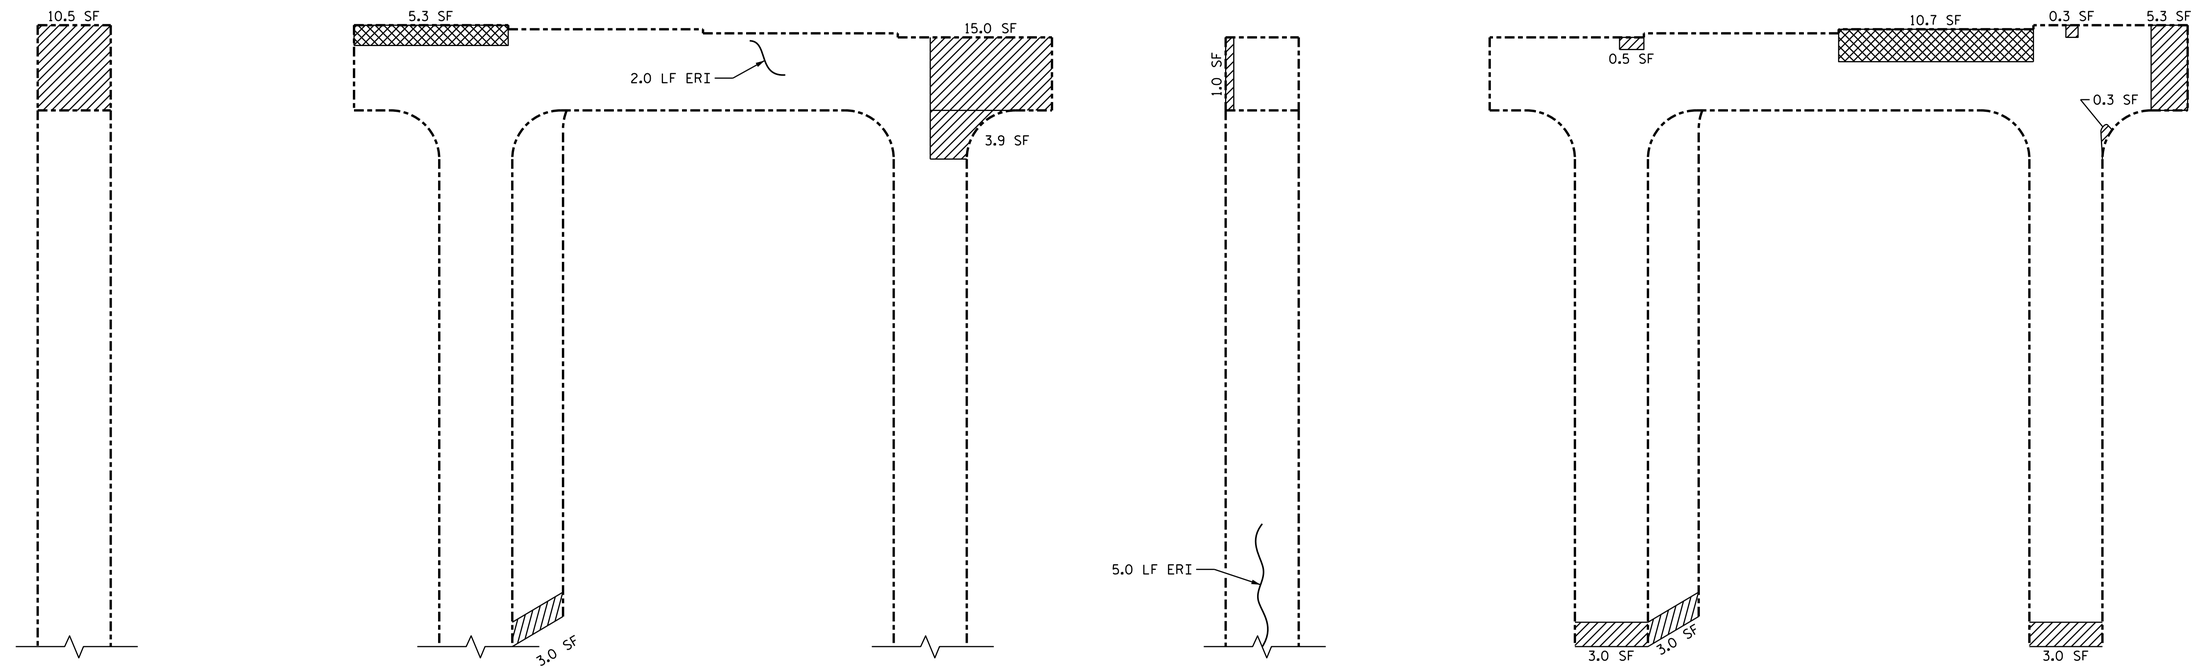
REPAIR QUANTITY TABLE				
REPAIRS BENT 2	QUANTITIES			
	ESTIMATE		ACTUAL	
SHOTCRETE REPAIRS	AREA SF.	VOLUME CF.	AREA SF.	VOLUME CF.
CAP (VERTICAL FACE)	32.6	10.9		
CAP (HORIZONTAL FACE)	1.0	0.3		
COLUMN (VERTICAL FACE)	16.2	5.4		
CONCRETE REPAIRS	22.2	7.4		
EPOXY RESIN INJECTION		LN. FT.		LN. FT.
CAP		2.0		
COLUMN		5.0		
EPOXY COATING		SQ. FT.		SQ. FT.
TOP OF CAP		86

EPOXY COATING SHALL BE APPLIED TO THE TOP FACE OF THE BENT CAPS AND ENDS OF GIRDERS.

FOR STRUCTURE REPAIRS, SEE "TYPICAL REPAIR DETAILS" SHEET.
