PROJECT NO. I-0914BA
VANCE COUNTY
BRIDGE NO. 64

SHEET 3 OF 3

SUBSTRUCTURE REPAIR
BENT 3

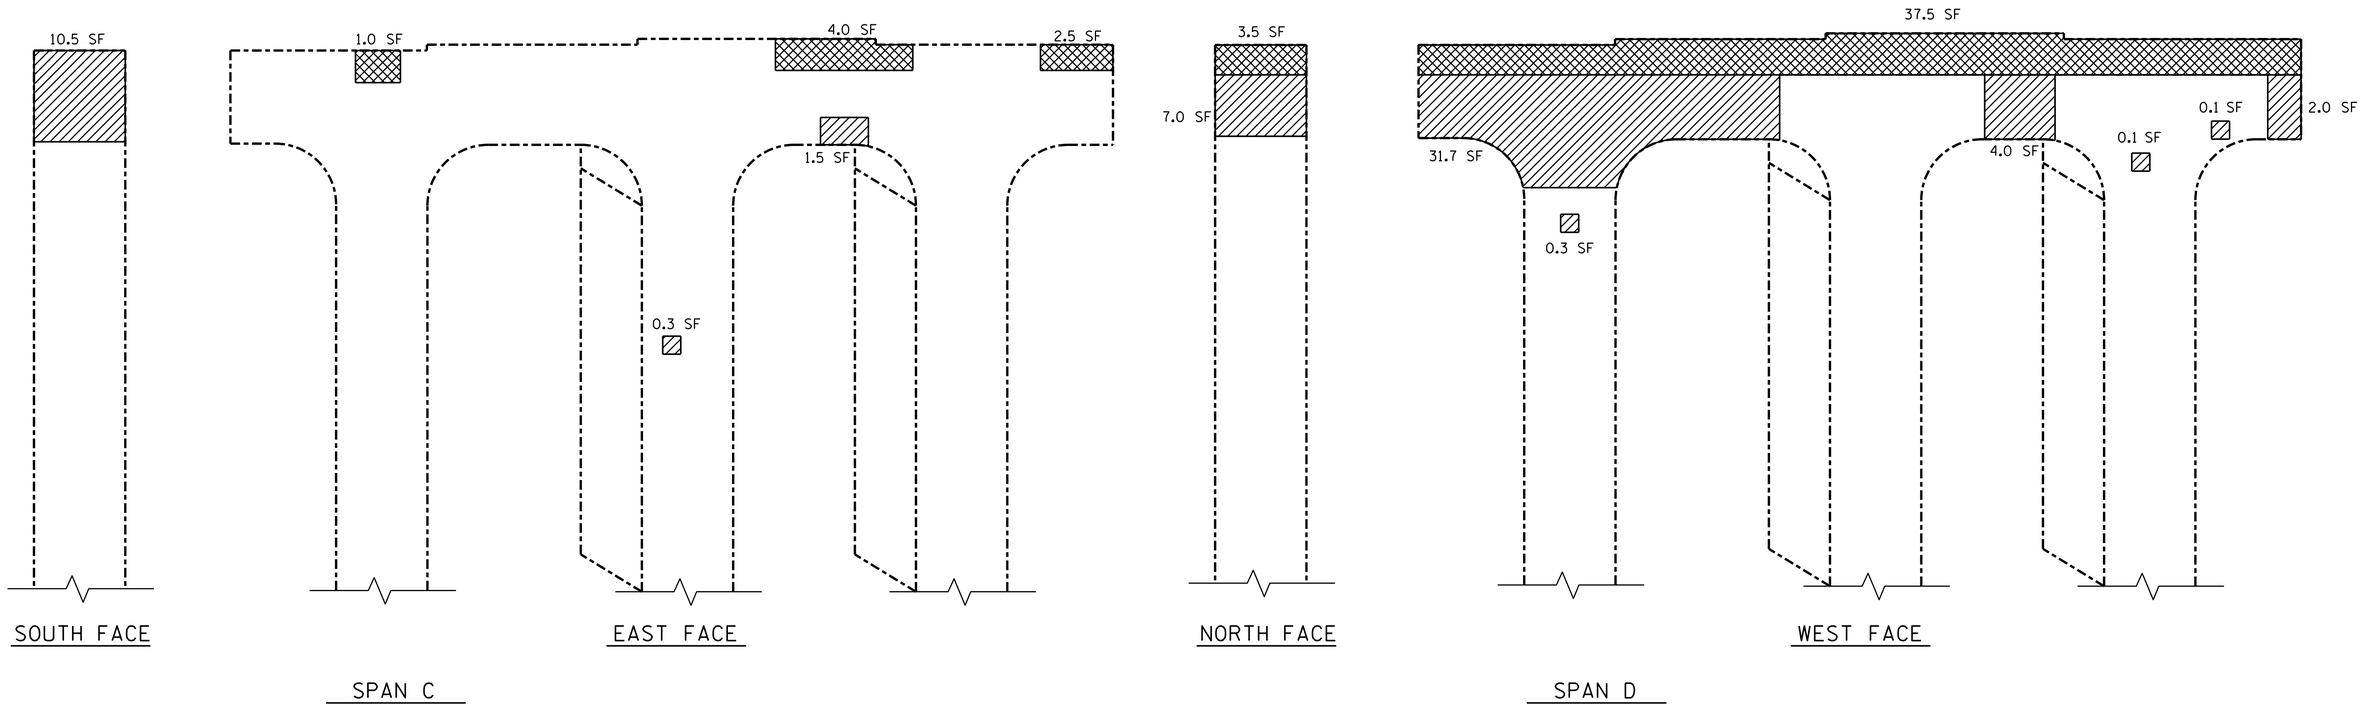
PLAN - TOP

REPAIR QUANTITY TABLE				
REPAIRS BENT 3	QUANTITIES			
	ESTIMATE		ACTUAL	
SHOTCRETE REPAIRS	AREA SF.	VOLUME CF.	AREA SF.	VOLUME CF.
CAP (VERTICAL FACE)	56.9	19.0		
CAP (HORIZONTAL FACE)	0	0		
COLUMN (VERTICAL FACE)	0.6	0.2		
CONCRETE REPAIRS	57.7	19.2		
EPOXY RESIN INJECTION		LN. FT.		LN. FT.
CAP		0		
COLUMN		0		
EPOXY COATING		SQ. FT.		SQ. FT.
TOP OF CAP		114

EPOXY COATING SHALL BE APPLIED TO THE TOP FACE OF THE BENT CAPS AND ENDS OF GIRDERS.
