PROJECT NO. I-0914BA
VANCE COUNTY
BRIDGE NO. 55

SHEET 2 OF 2

SUBSTRUCTURE REPAIR

END BENT 2

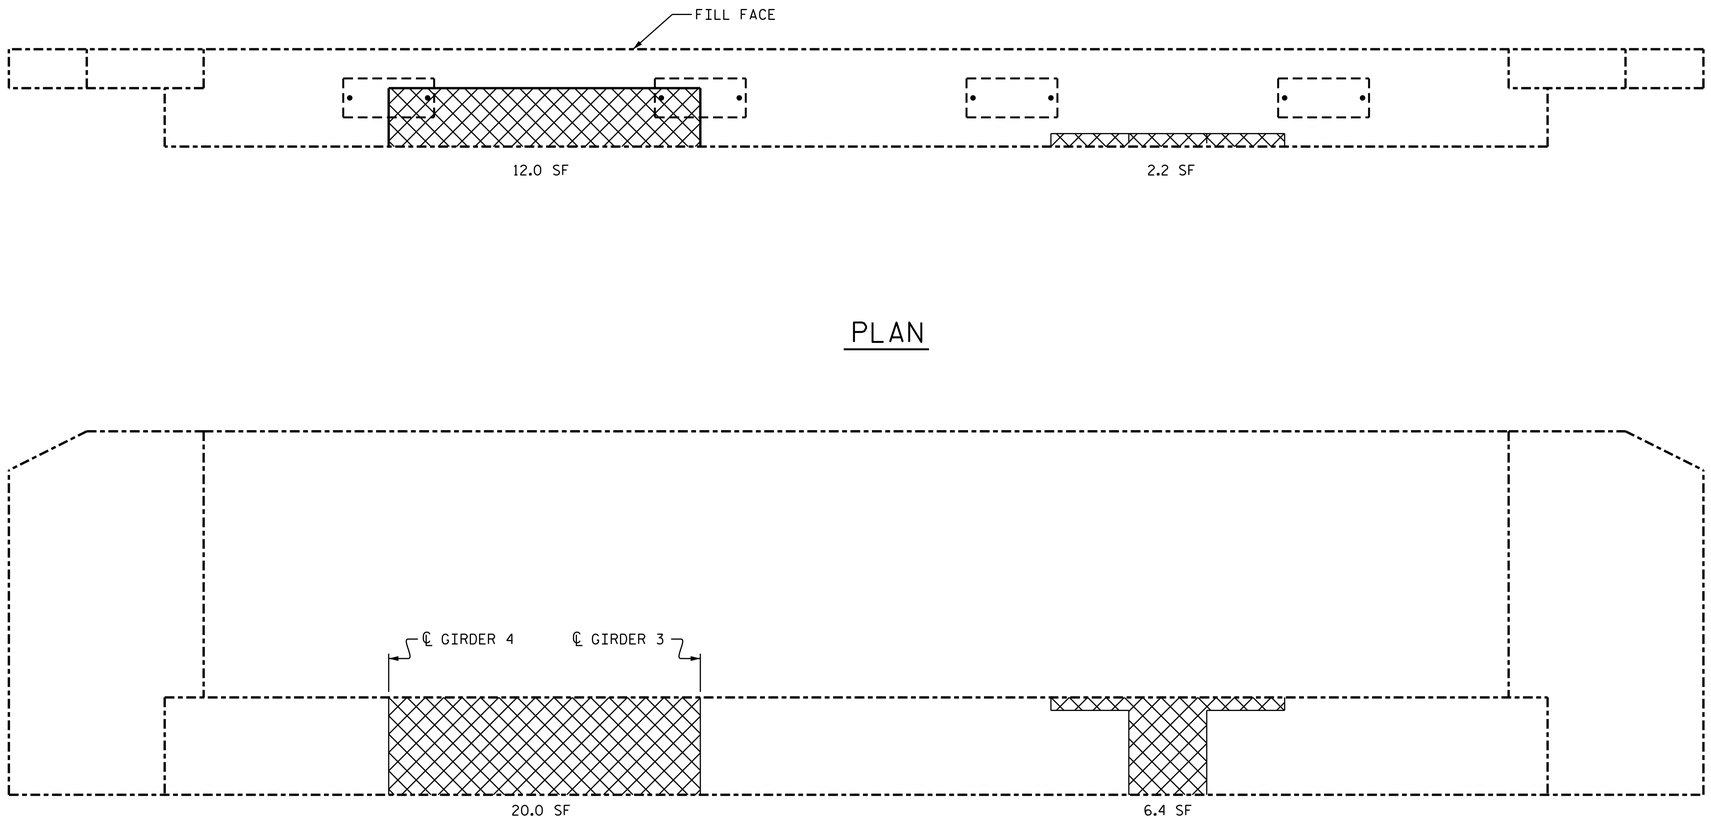
REPAIR QUANTITY TABLE				
REPAIRS END BENT 2	QUANTITIES			
	ESTIMATE		ACTUAL	
SHOTCRETE REPAIRS	AREA SF.	VOLUME CF.	AREA SF.	VOLUME CF.
CAP (VERTICAL FACE)	0	0		
CAP (HORIZONTAL FACE)	0	0		
CURTAIN WALL (VERTICAL FACE)	0	0		
CONCRETE REPAIRS	40.6	13.5		
EPOXY RESIN INJECTION		LN. FT.		LN. FT.
CAP		0		
CURTAIN WALL		0		
EPOXY COATING		SQ. FT.		SQ. FT.
TOP OF CAP		53

VALUES IN CHART REPRESENT ESTIMATED REPAIR TOTALS AFTER REMOVAL OF UNSOUND CONCRETE, MIN. OF 1" BEHIND REBAR AND MIN. 1" CL TO SAWCUT. SEE REPAIR DETAILS.

EPOXY COATING SHALL BE APPLIED TO THE TOP FACE OF THE END BENT CAP.

FOR STRUCTURE REPAIRS, SEE "TYPICAL REPAIR DETAILS" SHEET.
