PROJECT NO. I-0914BA

BRIDGE NO. 10

SUBSTRUCTURE REPAIR

BENT 1

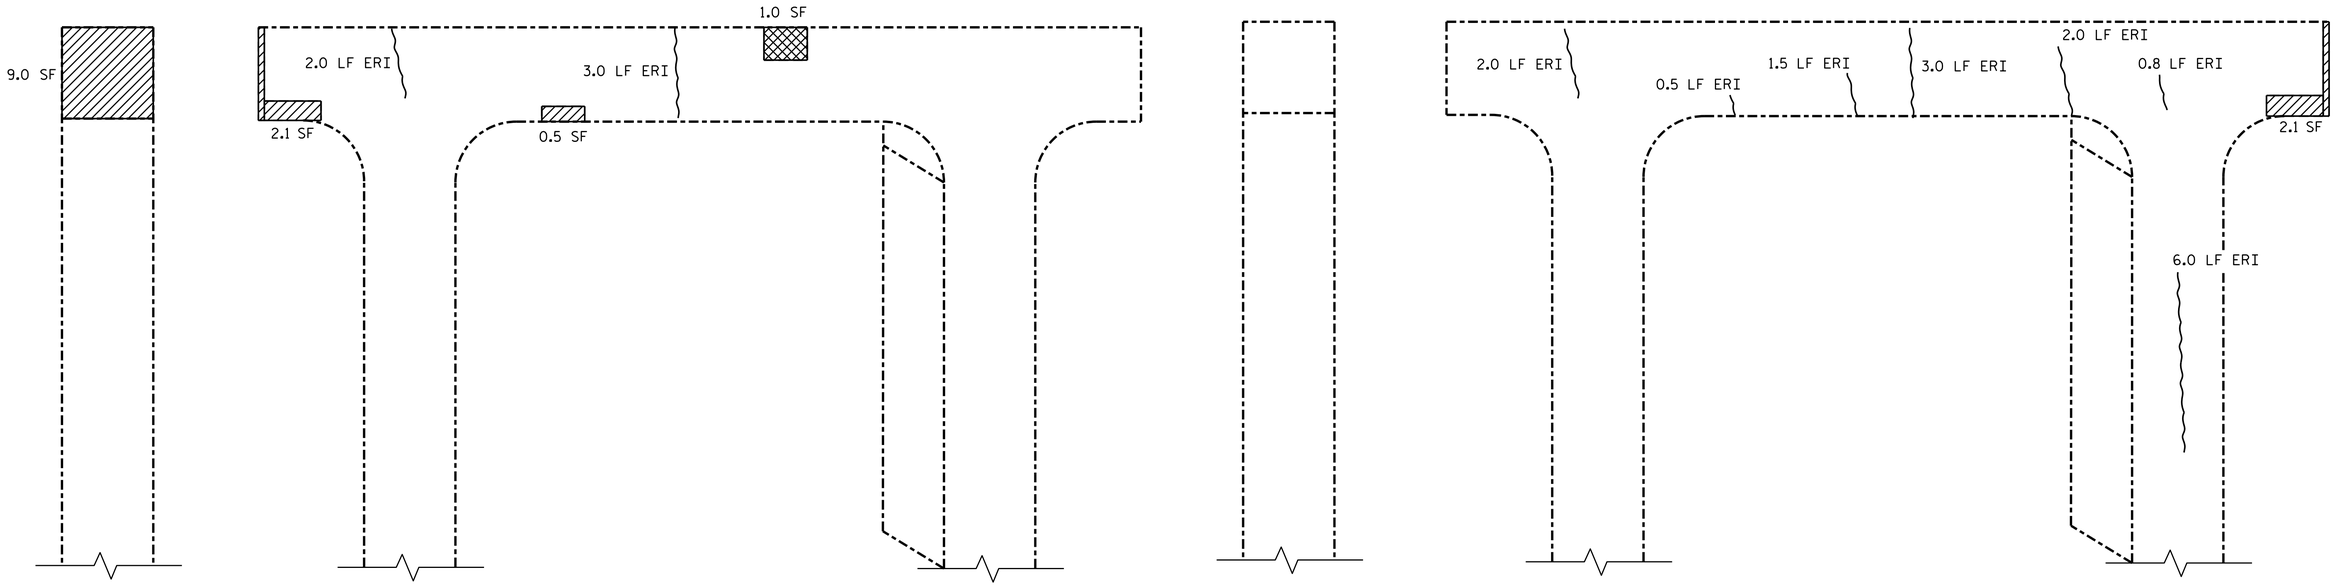
REPAIR QUANTITY TABLE				
REPAIRS BENT 1	QUANTITIES			
	ESTIMATE		ACTUAL	
SHOTCRETE REPAIRS	AREA SF.	VOLUME CF.	AREA SF.	VOLUME CF.
CAP (VERTICAL FACE)	13.7	4.6		
CAP (HORIZONTAL FACE)	0	0		
COLUMN (VERTICAL FACE)	0	0		
CONCRETE REPAIRS	1.0	0.3		
EPOXY RESIN INJECTION		LN. FT.		LN. FT.
CAP		16.3		
COLUMN		6.0		
EPOXY COATING		SQ. FT.		SQ. FT.
TOP OF CAP		87

EPOXY COATING SHALL BE APPLIED TO THE TOP FACE OF THE BENT CAPS AND ENDS OF GIRDERS.
