PROJECT NO. I-0914BA

BRIDGE NO. 57

SUBSTRUCTURE REPAIRS

BENT 2

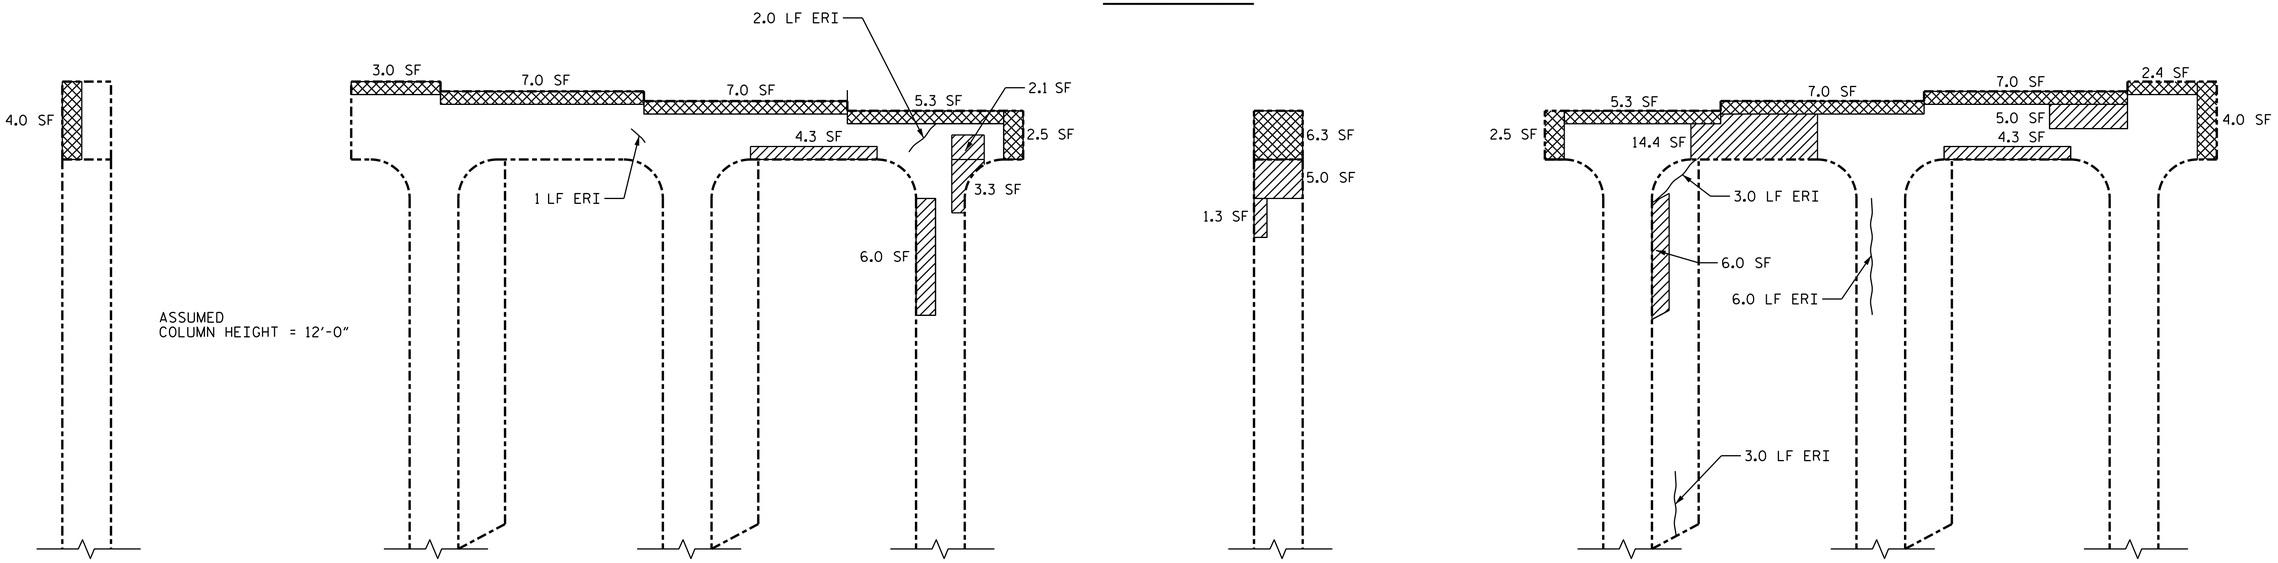
PLAN - TOP

REPAIR QUANTITY TABLE				
REPAIRS BENT 2	QUANTITIES			
	ESTIMATE		ACTUAL	
SHOTCRETE REPAIRS	AREA SF.	VOLUME CF.	AREA SF.	VOLUME CF.
CAP (VERTICAL FACE)	30.1	10.0		
CAP (HORIZONTAL FACE)	32.6	10.9		
COLUMN (VERTICAL FACE)	21.6	7.2		
CONCRETE REPAIRS	157.1	52.3		
EPOXY RESIN INJECTION		LN. FT.		LN. FT.
CAP		3.0		
COLUMN		12.0		
EPOXY COATING		SQ. FT.		SQ. FT.
TOP OF CAP		86

FOR STRUCTURE REPAIRS, SEE "TYPICAL REPAIR DETAILS" SHEET.

EPOXY COATING SHALL BE APPLIED TO THE TOP FACE OF THE BENT CAPS AND ENDS OF GIRDERS.
