PROJECT NO. I-0914BA
VANCE COUNTY
BRIDGE NO. 55

STATE OF NORTH CAROLINA
DEPARTMENT OF TRANSPORTATION
RALEIGH

SUBSTRUCTURE REPAIR

END BENT 1

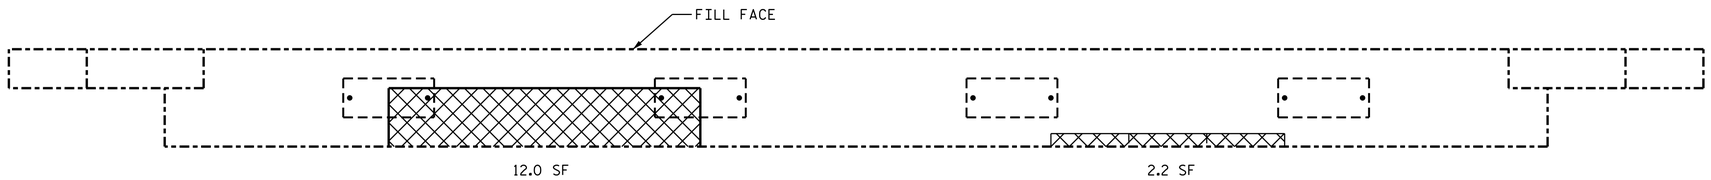
PLAN

EPOXY COATING SHALL BE APPLIED TO THE TOP FACE OF THE END BENT CAP.

FOR STRUCTURE REPAIRS, SEE "TYPICAL REPAIR DETAILS" SHEET.
