PROJECT NO. I-0914BA

BRIDGE NO. 64

SUBSTRUCTURE REPAIR

END BENT 2

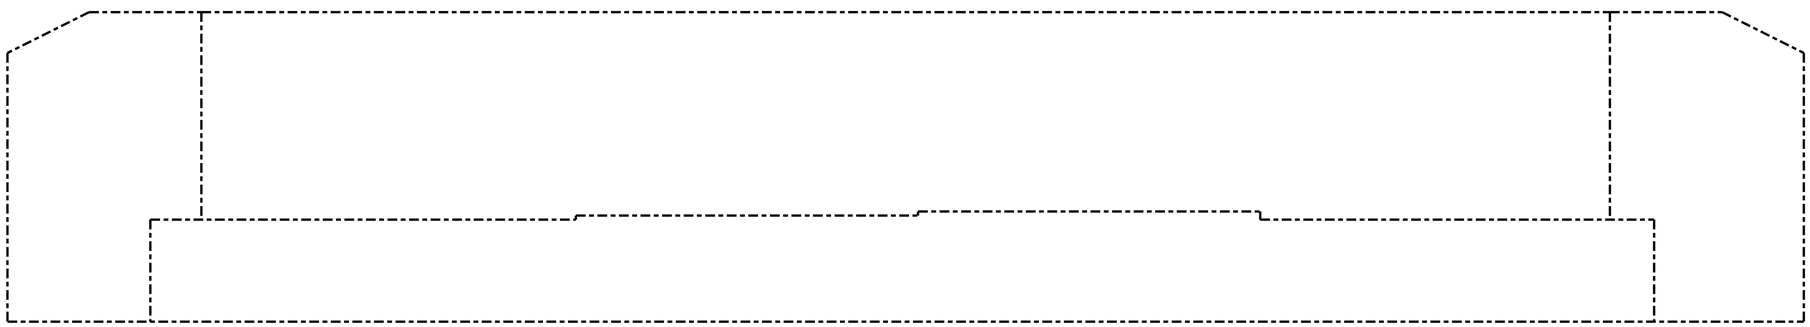
PLAN

EPOXY COATING SHALL BE APPLIED TO THE TOP FACE OF THE BENT CAPS AND ENDS OF GIRDERS.

FOR STRUCTURE REPAIRS, SEE "TYPICAL REPAIR DETAILS" SHEET.
