PROJECT NO. I-0914BA
VANCE COUNTY
BRIDGE NO. 57

STATE OF NORTH CAROLINA
DEPARTMENT OF TRANSPORTATION
RALEIGH

SUBSTRUCTURE REPAIR
END BENT 1

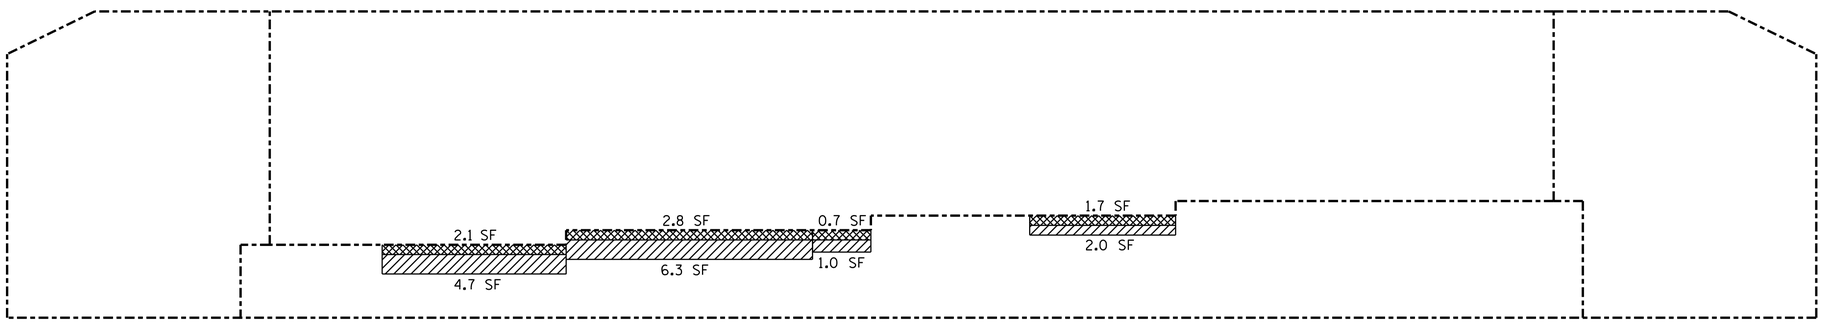
PLAN

REPAIR QUANTITY TABLE				
REPAIRS END BENT 1	QUANTITIES			
	ESTIMATE		ACTUAL	
SHOTCRETE REPAIRS	AREA SF.	VOLUME CF.	AREA SF.	VOLUME CF.
CAP (VERTICAL FACE)	14.0	4.7		
CAP (HORIZONTAL FACE)	0	0		
CURTAIN WALL (VERTICAL FACE)	0	0		
CONCRETE REPAIRS	26.8	8.9		
EPOXY RESIN INJECTION		LN. FT.		LN. FT.
CAP		0		
CURTAIN WALL		0		
EPOXY COATING		SQ. FT.		SQ. FT.
TOP OF CAP		92

EPOXY COATING SHALL BE APPLIED TO THE TOP FACE OF THE END BENT CAP.
