PROJECT NO. I-0914BA
VANCE COUNTY
BRIDGE NO. 60

STATE OF NORTH CAROLINA
DEPARTMENT OF TRANSPORTATION
RALEIGH

SUBSTRUCTURE REPAIR
BENT 1

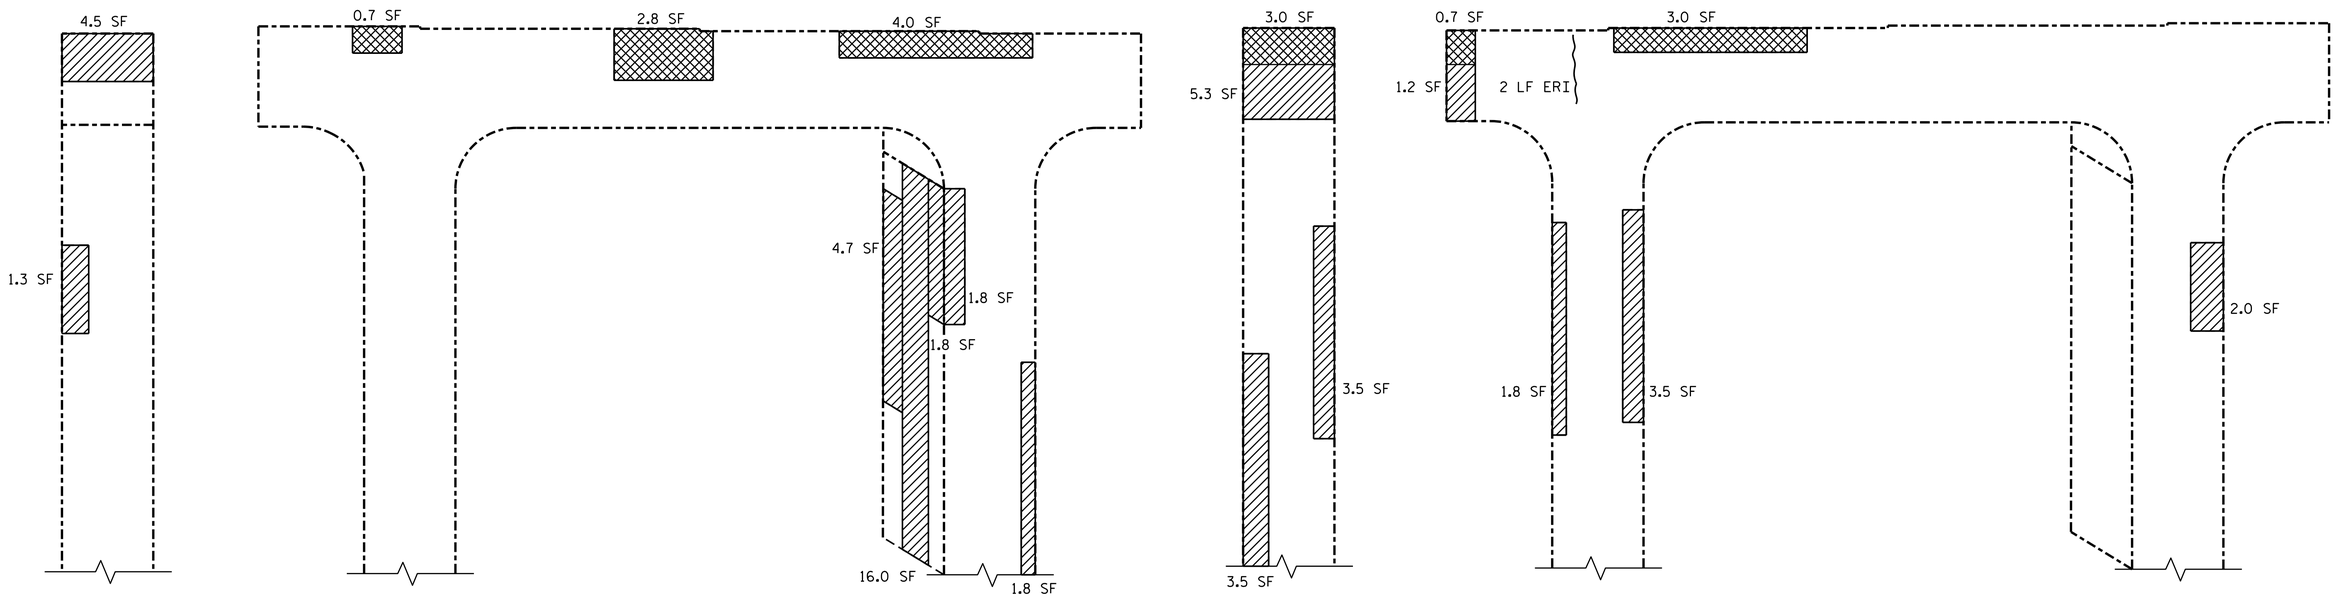
REPAIRS BENT 1	QUANTITIES			
	ESTIMATE		ACTUAL	
SHOTCRETE REPAIRS	AREA SF.	VOLUME CF.	AREA SF.	VOLUME CF.
CAP (VERTICAL FACE)	11.0	3.7		
CAP (HORIZONTAL FACE)	0	0		
COLUMN (VERTICAL FACE)	41.7	13.9		
CONCRETE REPAIRS	33.0	11.0		
EPOXY RESIN INJECTION		LN. FT.		LN. FT.
CAP		2.0		
COLUMN		0		
EPOXY COATING		SQ. FT.		SQ. FT.
TOP OF CAP		82.0

VALUES IN CHART REPRESENT ESTIMATED REPAIR TOTALS AFTER REMOVAL OF UNSOUND CONCRETE, MIN. OF 1" BEHIND REBAR AND MIN. 1" CL TO SAWCUT. SEE REPAIR DETAILS.

EPOXY COATING SHALL BE APPLIED TO THE TOP FACE OF THE BENT CAPS AND ENDS OF GIRDERS.
