PROJECT NO. I-0914BA

BRIDGE NO. 60

SUBSTRUCTURE REPAIR

BENT 3

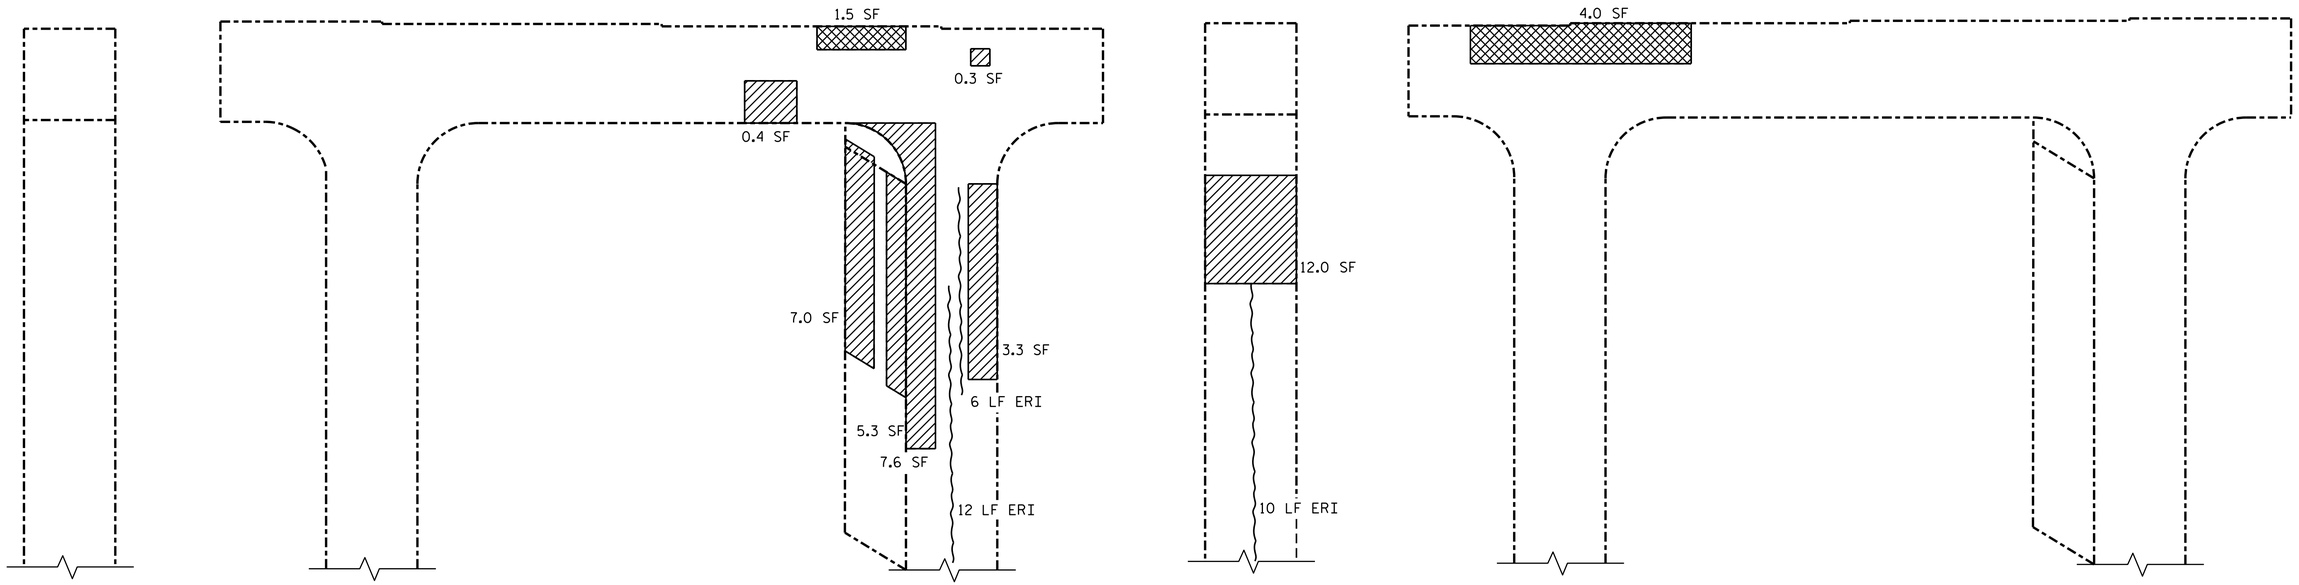
REPAIRS BENT 3	QUANTITIES			
	ESTIMATE		ACTUAL	
SHOTCRETE REPAIRS	AREA SF.	VOLUME CF.	AREA SF.	VOLUME CF.
CAP (VERTICAL FACE)	0.7	0.2		
CAP (HORIZONTAL FACE)	0	0		
COLUMN (VERTICAL FACE)	35.2	11.7		
CONCRETE REPAIRS	5.5	1.8		
EPOXY RESIN INJECTION		LN. FT.		LN. FT.
CAP		0		
COLUMN		28		
EPOXY COATING		SQ. FT.		SQ. FT.
TOP OF CAP		82.0

EPOXY COATING SHALL BE APPLIED TO THE TOP FACE OF THE BENT CAPS AND ENDS OF GIRDERS.
