PROJECT NO. I-0914BA
VANCE COUNTY
BRIDGE NO. 54

SHEET 3 OF 3

SUBSTRUCTURE REPAIR

BENT 3

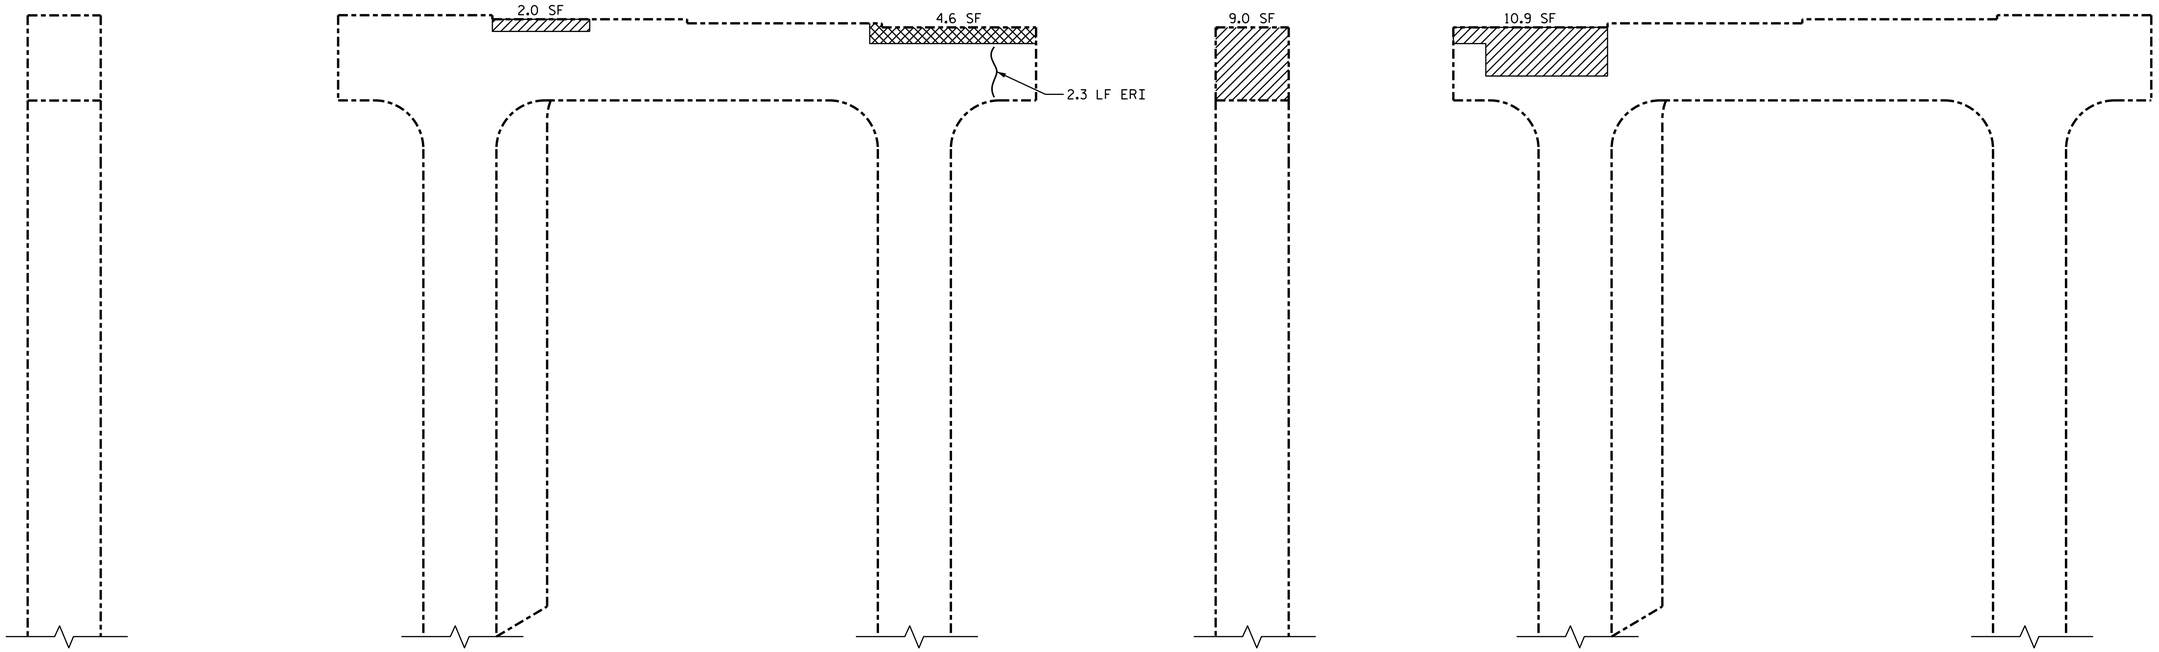
REPAIR QUANTITY TABLE				
REPAIRS BENT 3	QUANTITIES			
	ESTIMATE		ACTUAL	
SHOTCRETE REPAIRS	AREA SF.	VOLUME CF.	AREA SF.	VOLUME CF.
CAP (VERTICAL FACE)	21.9	7.3		
CAP (HORIZONTAL FACE)	0	0		
COLUMN (VERTICAL FACE)	0	0		
CONCRETE REPAIRS	13.7	4.6		
EPOXY RESIN INJECTION		LN. FT.		LN. FT.
CAP		2.3		
COLUMN		0		
EPOXY COATING		SQ. FT.		SQ. FT.
TOP OF CAP		86

VALUES IN CHART REPRESENT ESTIMATED REPAIR TOTALS AFTER REMOVAL OF UNSOUND CONCRETE, MIN. OF 1" BEHIND REBAR AND MIN. 1" CL TO SAWCUT. SEE REPAIR DETAILS.

EPOXY COATING SHALL BE APPLIED TO THE TOP FACE OF THE BENT CAPS AND ENDS OF GIRDERS.
