PROJECT NO. I-0914BA
VANCE COUNTY
BRIDGE NO. 55

STATE OF NORTH CAROLINA
DEPARTMENT OF TRANSPORTATION
RALEIGH

SUBSTRUCTURE REPAIRS

BENT 1

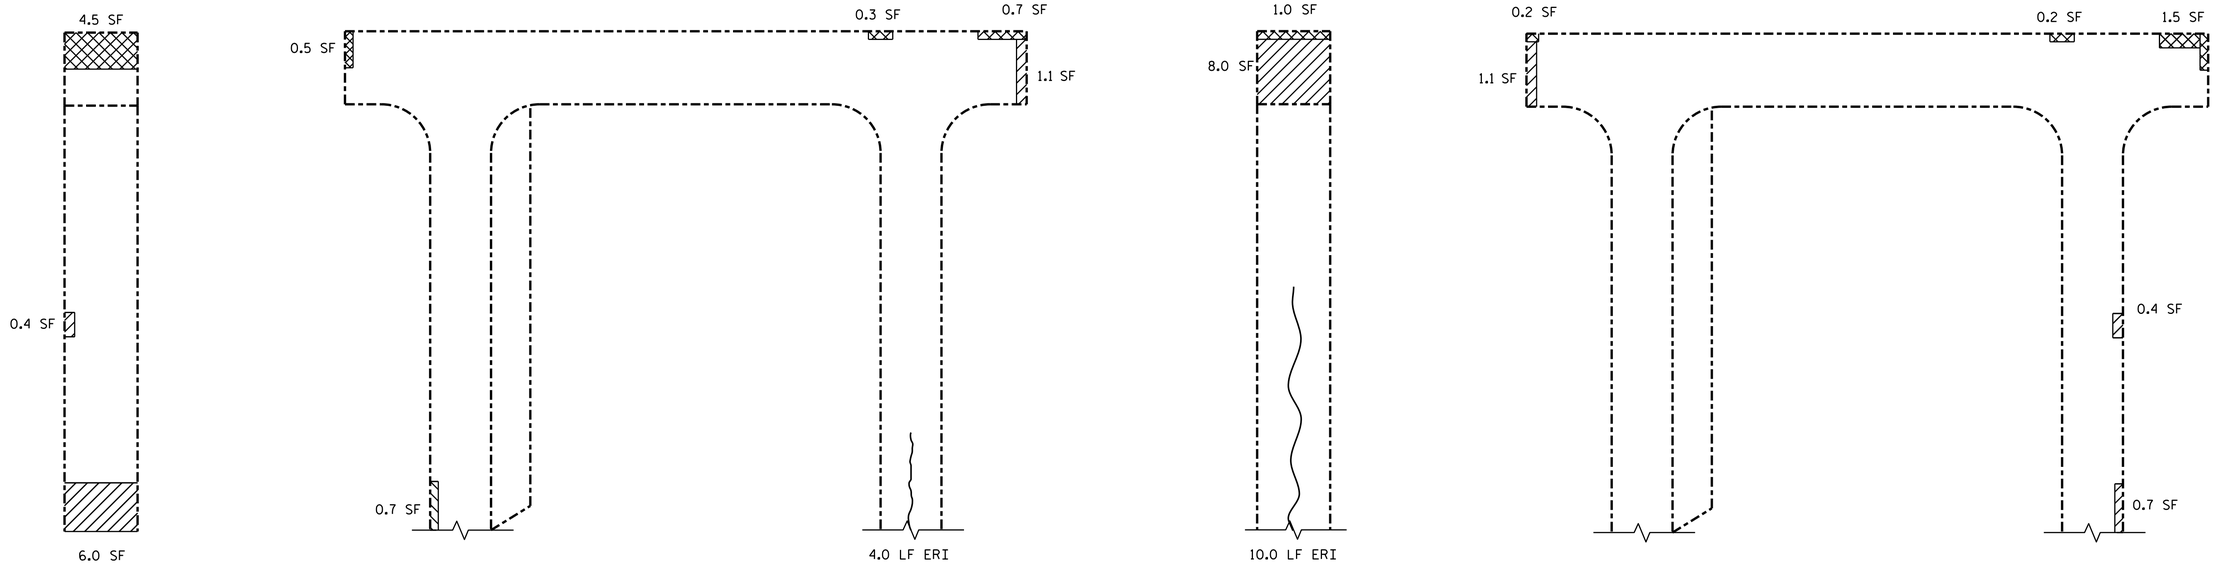
REPAIR QUANTITY TABLE				
REPAIRS BENT 1	QUANTITIES			
	ESTIMATE		ACTUAL	
SHOTCRETE REPAIRS	AREA SF.	VOLUME CF.	AREA SF.	VOLUME CF.
CAP (VERTICAL FACE)	10.2	3.4		
CAP (HORIZONTAL FACE)	0	0		
COLUMN (VERTICAL FACE)	8.2	2.7		
CONCRETE REPAIRS	14.2	4.7		
EPOXY RESIN INJECTION		LN. FT.		LN. FT.
CAP		4.0		
COLUMN		14.0		
EPOXY COATING		SQ. FT.		SQ. FT.
TOP OF CAP		84

VALUES IN CHART REPRESENT ESTIMATED REPAIR TOTALS AFTER REMOVAL OF UNSOUND CONCRETE. MIN. OF 1" BEHIND REBAR AND MIN. 1" CL TO SAWCUT. SEE REPAIR DETAILS.

EPOXY COATING SHALL BE APPLIED TO THE TOP FACE OF THE BENT CAPS AND ENDS OF GIRDERS.
