PROJECT NO. I-0914BA
VANCE COUNTY
BRIDGE NO. 60

SHEET 1 OF 2

STATE OF NORTH CAROLINA
DEPARTMENT OF TRANSPORTATION
RALEIGH

SUBSTRUCTURE REPAIR
END BENT 1

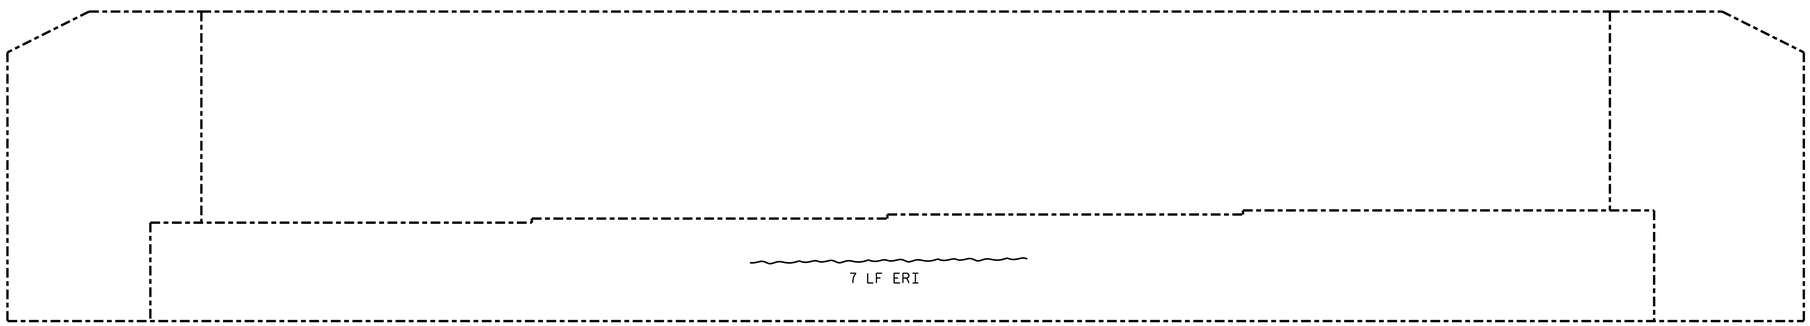
PLAN

REPAIR QUANTITY TABLE				
REPAIRS END BENT 1	QUANTITIES			
	ESTIMATE		ACTUAL	
SHOTCRETE REPAIRS	AREA SF.	VOLUME CF.	AREA SF.	VOLUME CF.
CAP (VERTICAL FACE)	0	0		
CAP (HORIZONTAL FACE)	0	0		
CURTAIN WALL (VERTICAL FACE)	0	0		
CONCRETE REPAIRS	0	0		
EPOXY RESIN INJECTION		LN. FT.		LN. FT.
CAP		7.0		
CURTAIN WALL		0		
EPOXY COATING		SQ. FT.		SQ. FT.
TOP OF CAP		80

VALUES IN CHART REPRESENT ESTIMATED REPAIR TOTALS AFTER REMOVAL OF UNSOUND CONCRETE, MIN. OF 1" BEHIND REBAR AND MIN. 1" CL TO SAWCUT. SEE REPAIR DETAILS.

EPOXY COATING SHALL BE APPLIED TO THE TOP FACE OF THE BENT CAPS AND ENDS OF GIRDERS.
