PROJECT NO. I-0914BA
WARREN COUNTY
BRIDGE NO. 10

SHEET 2 OF 3

SUBSTRUCTURE REPAIR
BENT 2

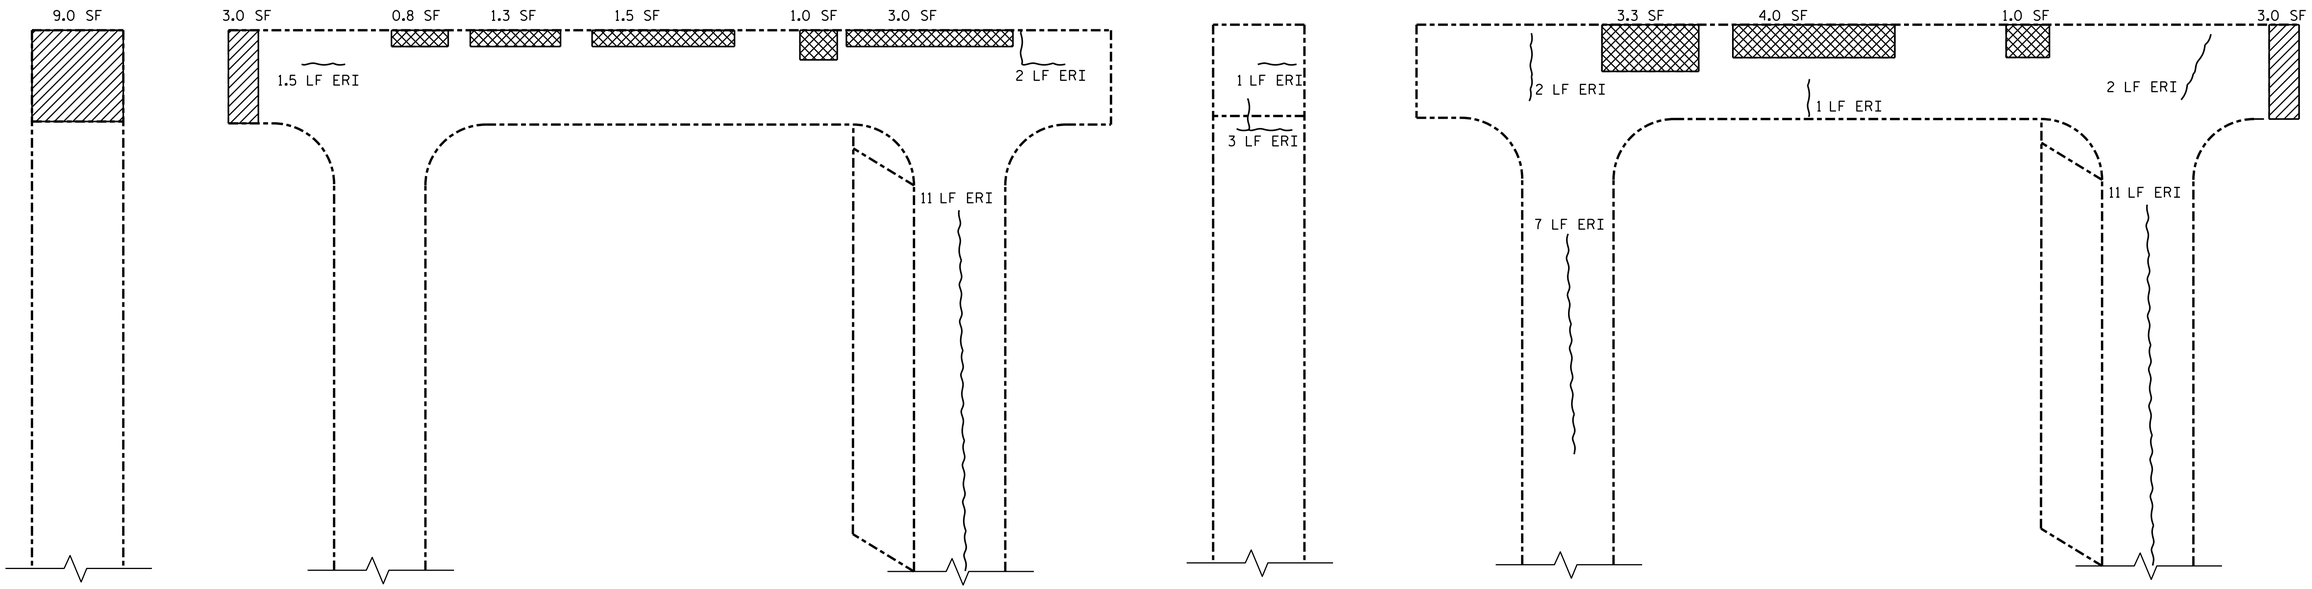
REPAIRS BENT 2	QUANTITIES			
	ESTIMATE		ACTUAL	
SHOTCRETE REPAIRS	AREA SF.	VOLUME CF.	AREA SF.	VOLUME CF.
CAP (VERTICAL FACE)	15.0	5.0		
CAP (HORIZONTAL FACE)	0.3	0.1		
COLUMN (VERTICAL FACE)	0	0		
CONCRETE REPAIRS	29.2	9.7		
EPOXY RESIN INJECTION		LN. FT.		LN. FT.
CAP		12.5		
COLUMN		29.0		
EPOXY COATING		SQ. FT.		SQ. FT.
TOP OF CAP		87

VALUES IN CHART REPRESENT ESTIMATED REPAIR TOTALS AFTER REMOVAL OF UNSOUND CONCRETE, MIN. OF 1" BEHIND REBAR AND MIN. 1" CL TO SAWCUT. SEE REPAIR DETAILS.

EPOXY COATING SHALL BE APPLIED TO THE TOP FACE OF THE BENT CAPS AND ENDS OF GIRDERS.
