PROJECT NO. I-0914BA

BRIDGE NO. 60

SUBSTRUCTURE REPAIR

BENT 2

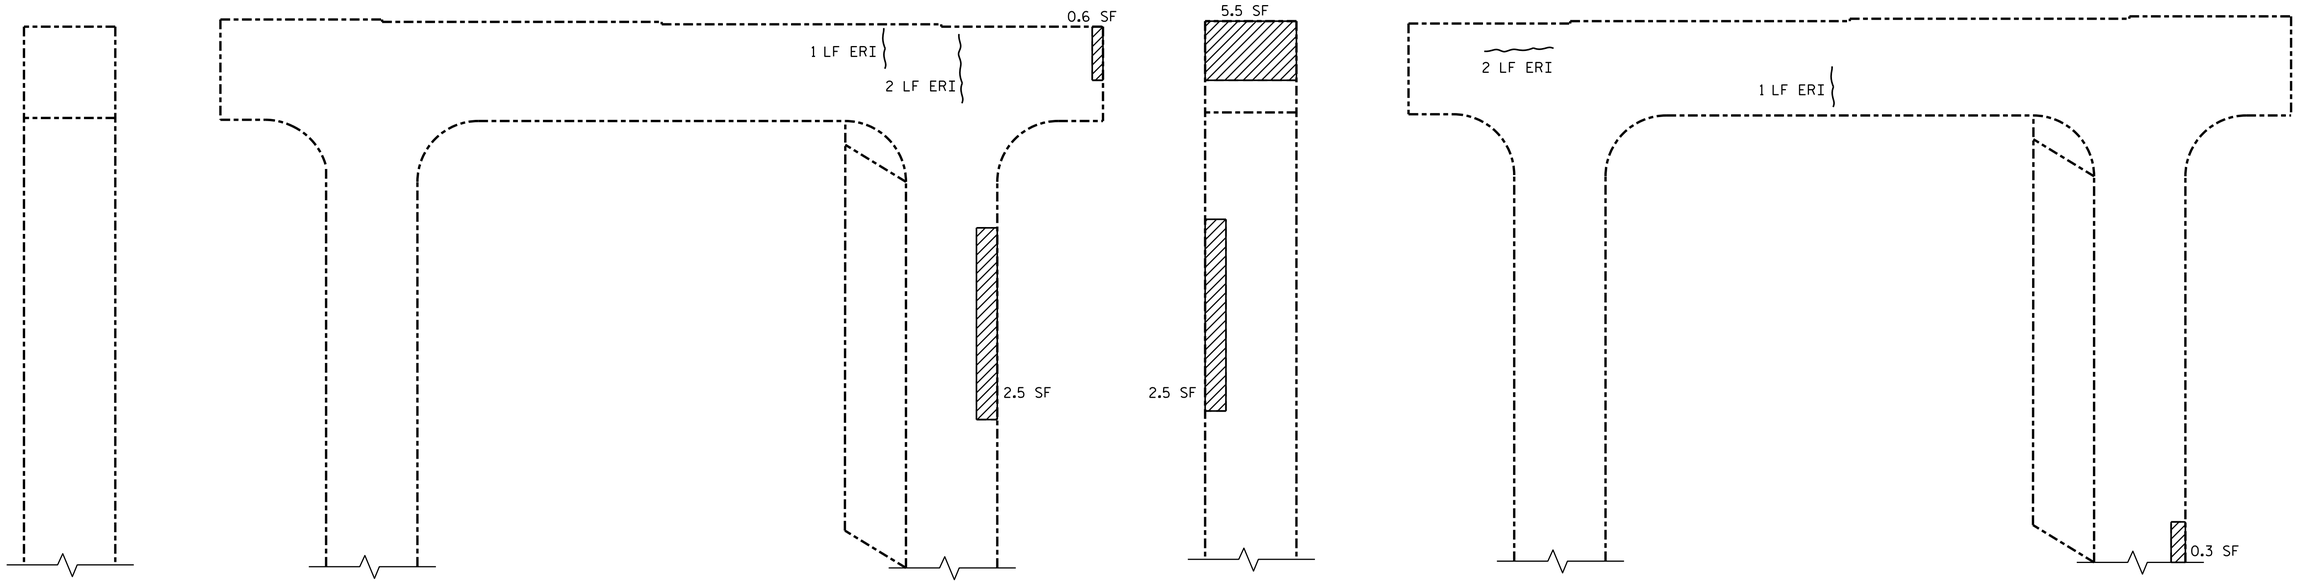
REPAIRS BENT 2	QUANTITIES			
	ESTIMATE		ACTUAL	
SHOTCRETE REPAIRS	AREA SF.	VOLUME CF.	AREA SF.	VOLUME CF.
CAP (VERTICAL FACE)	6.1	2.0		
CAP (HORIZONTAL FACE)	0	0		
COLUMN (VERTICAL FACE)	5.3	1.8		
CONCRETE REPAIRS	0	0		
EPOXY RESIN INJECTION		LN. FT.		LN. FT.
CAP		6		
COLUMN		0		
EPOXY COATING		SQ. FT.		SQ. FT.
TOP OF CAP		82.0

VALUES IN CHART REPRESENT ESTIMATED REPAIR TOTALS AFTER REMOVAL OF UNSOUND CONCRETE, MIN. OF 1" BEHIND REBAR AND MIN. 1" CL TO SAWCUT. SEE REPAIR DETAILS.

EPOXY COATING SHALL BE APPLIED TO THE TOP FACE OF THE BENT CAPS AND ENDS OF GIRDERS.
