PROJECT NO. I-0914BB
WARREN COUNTY
BRIDGE NO.: 40

STATE OF NORTH CAROLINA
DEPARTMENT OF TRANSPORTATION
RALEIGH

SUBSTRUCTURE REPAIR
BENT 1

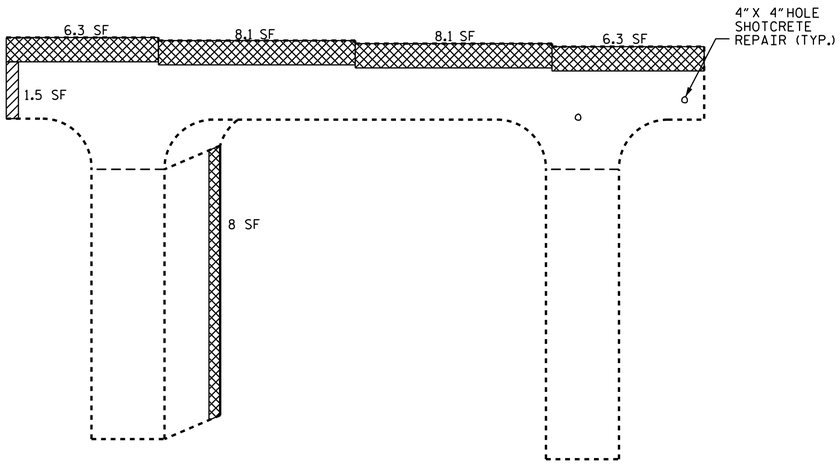
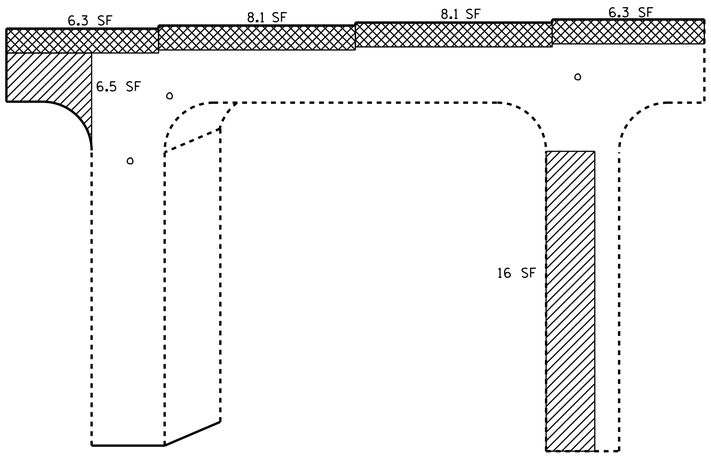
REPAIRS BENT 1	QUANTITIES			
	ESTIMATE		ACTUAL	
SHOTCRETE REPAIRS	AREA SF.	VOLUME CF.	AREA SF.	VOLUME CF.
CAP (VERTICAL FACE)	32.9	8.2		
CAP (HORIZONTAL FACE)	0.0	0.0		
COLUMN (VERTICAL FACE)	16.1	4.0		
CONCRETE REPAIRS	65.6	16.4		
EPOXY RESIN INJECTION		LN. FT.		LN. FT.
CAP		0.0		
COLUMN		0.0		
EPOXY COATING		SQ. FT.		SQ. FT.
TOP OF CAP		82.0

VALUES IN CHART REPRESENT ESTIMATED REPAIR TOTALS AFTER REMOVAL OF UNSOUND CONCRETE, MIN. OF 1" BEHIND REBAR AND MIN. 1" CL TO SAWCUT. SEE REPAIR DETAILS.

FOR STRUCTURE REPAIRS, SEE "TYPICAL CAP & COLUMN REPAIRS" SHEET.

EPOXY COATING SHALL BE APPLIED TO THE TOP FACE OF THE BENT CAP.
