PROJECT NO. I-0914BB

WARREN COUNTY

BRIDGE NO.: 2

SUBSTRUCTURE
REPAIR
BENT 2

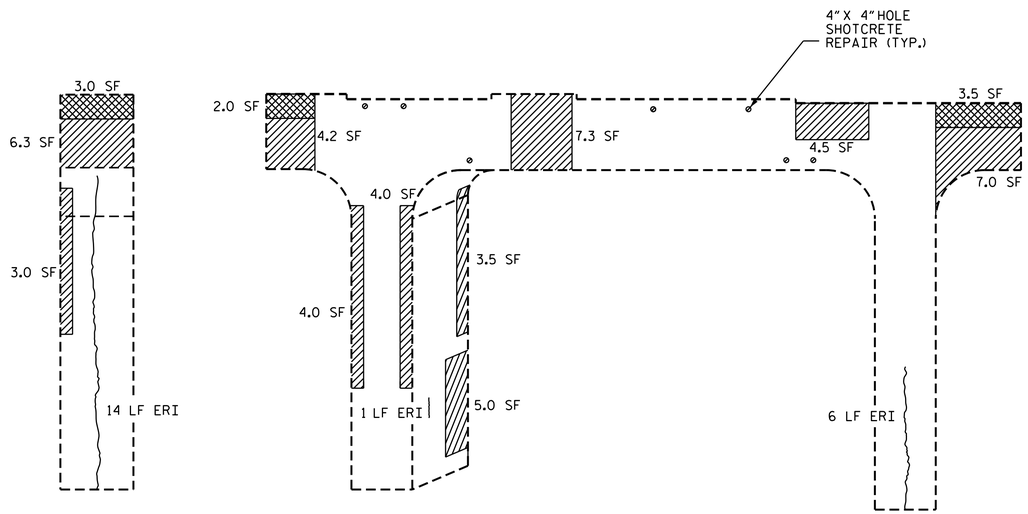
CONCRETE REPAIR

SHOTCRETE REPAIR

ERI – EPOXY RESIN INJECTION

EPOXY COATING SHALL BE APPLIED TO THE TOP FACE OF THE BENT CAP.
