PROJECT NO. I-0914BB
WARREN COUNTY
BRIDGE NO.: 40

STATE OF NORTH CAROLINA
DEPARTMENT OF TRANSPORTATION
RALEIGH

SUBSTRUCTURE REPAIR
BENT 2

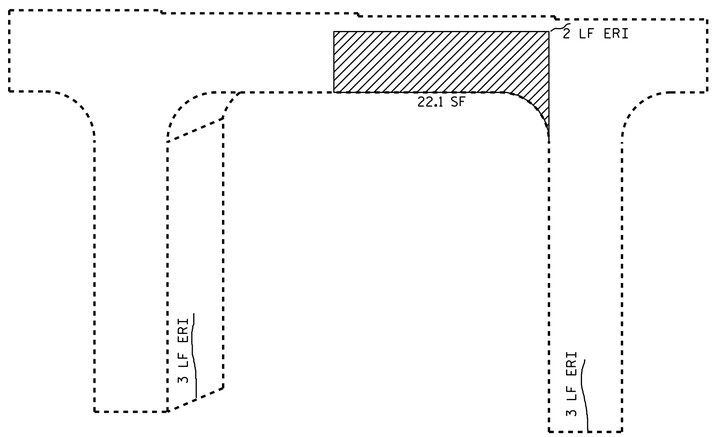
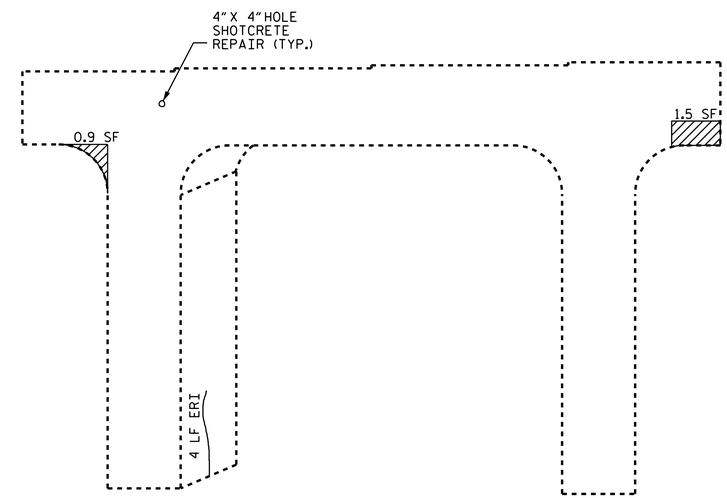
EPOXY COATING SHALL BE APPLIED TO THE TOP FACE OF THE BENT CAP.

REPAIRS BENT 2	QUANTITIES			
	ESTIMATE		ACTUAL	
SHOTCRETE REPAIRS	AREA SF.	VOLUME CF.	AREA SF.	VOLUME CF.
CAP (VERTICAL FACE)	34.4	8.6		
CAP (HORIZONTAL FACE)	21.0	5.3		
COLUMN (VERTICAL FACE)	0.0	0.0		
CONCRETE REPAIRS	0.0	0.0		
EPOXY RESIN INJECTION		LN. FT.		LN. FT.
CAP		2.0		
COLUMN		16.5		
EPOXY COATING		SQ. FT.		SQ. FT.
TOP OF CAP		82.0

VALUES IN CHART REPRESENT ESTIMATED REPAIR TOTALS AFTER REMOVAL OF UNSOUND CONCRETE, MIN. OF 1" BEHIND REBAR AND MIN. 1" CL TO SAWCUT. SEE REPAIR DETAILS.

FOR STRUCTURE REPAIRS, SEE "TYPICAL CAP & COLUMN REPAIRS" SHEET.
