PROJECT NO. I-0914BB
WARREN COUNTY
BRIDGE NO.: 40

STATE OF NORTH CAROLINA
DEPARTMENT OF TRANSPORTATION
RALEIGH

SUBSTRUCTURE REPAIR
END BENTS 1 & 2

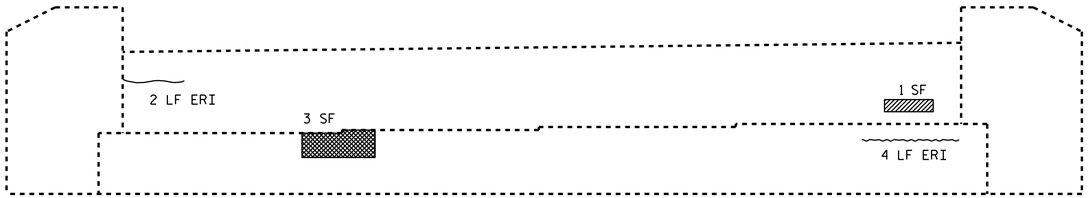
REPAIRS END BENT 1	QUANTITIES			
	ESTIMATE		ACTUAL	
SHOTCRETE REPAIRS	AREA SF.	VOLUME CF.	AREA SF.	VOLUME CF.
CAP (VERTICAL FACE)	0.0	0.0		
CAP (HORIZONTAL FACE)	0.0	0.0		
CURTAIN WALL	1.0	0.3		
CONCRETE REPAIRS	6.0	1.5		
EPOXY RESIN INJECTION		LN. FT.		LN. FT.
CAP		4.0		
CURTAIN WALL		2.0		
EPOXY COATING		SQ. FT.		SQ. FT.
TOP OF CAP		48.0

EPOXY COATING SHALL BE APPLIED TO THE TOP FACE OF THE END BENT CAP.

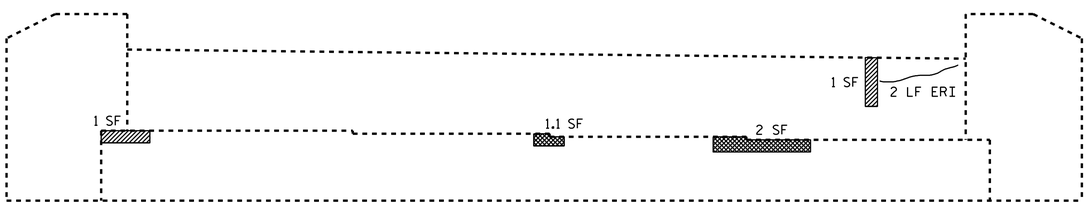
REPAIRS END BENT 2	QUANTITIES			
	ESTIMATE		ACTUAL	
SHOTCRETE REPAIRS	AREA SF.	VOLUME CF.	AREA SF.	VOLUME CF.
CAP (VERTICAL FACE)	1.0	0.3		
CAP (HORIZONTAL FACE)	3.0	0.8		
CURTAIN WALL	1.0	0.3		
CONCRETE REPAIRS	3.1	0.8		
EPOXY RESIN INJECTION		LN. FT.		LN. FT.
CAP		0.0		
CURTAIN WALL		2.0		
EPOXY COATING		SQ. FT.		SQ. FT.
TOP OF CAP		48.0
