PROJECT NO. I-0914BB

WARREN COUNTY

BRIDGE NO.: 40

SUPERSTRUCTURE AND BENT DIAPHRAGMS REPAIRS

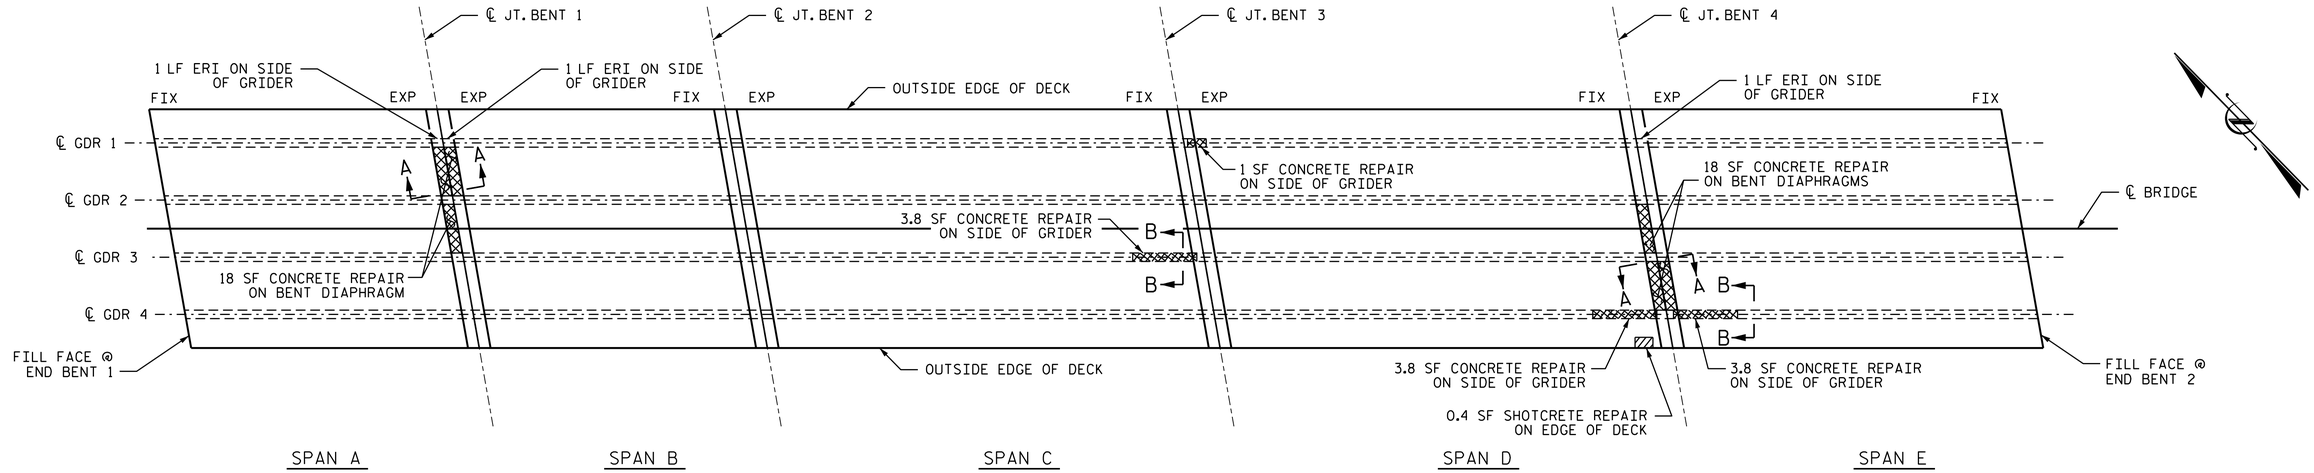
PLAN VIEW

REPAIR CONCRETE BENT DIAPHRAGMS AS DIRECTED BY THE ENGINEER.
