PROJECT NO. I-0914BB
WARREN COUNTY
BRIDGE NO.: 40

STATE OF NORTH CAROLINA
DEPARTMENT OF TRANSPORTATION
RALEIGH

SUBSTRUCTURE REPAIR
BENT 4

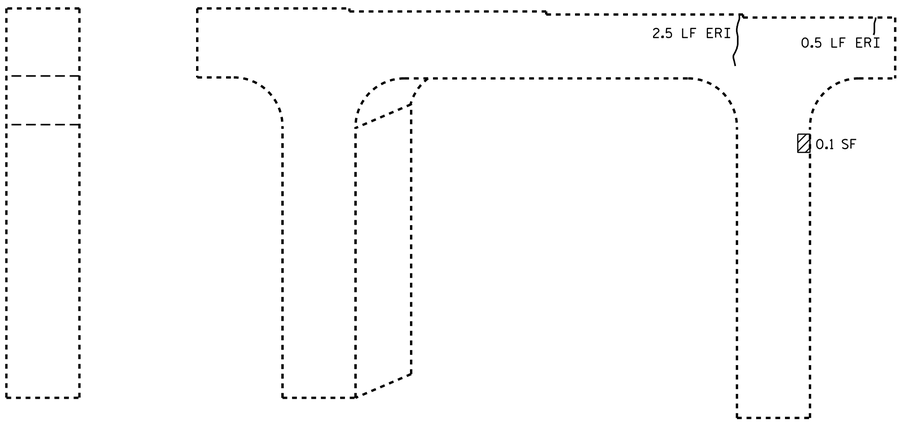
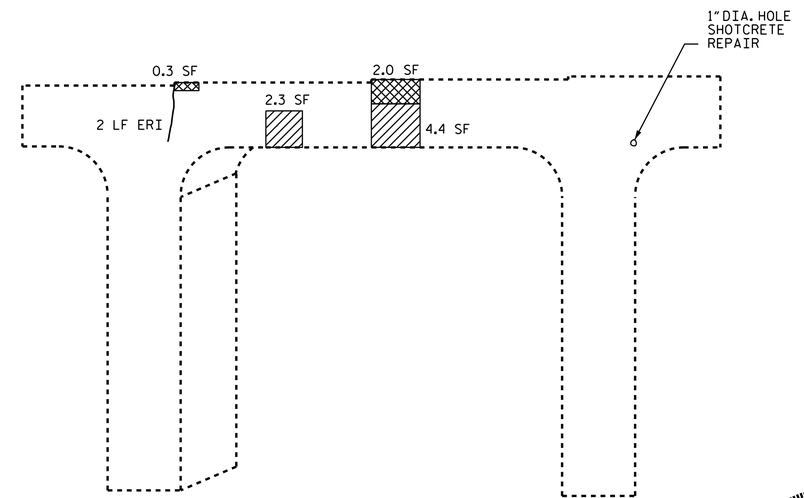
REPAIRS BENT 4	QUANTITIES			
	ESTIMATE		ACTUAL	
SHOTCRETE REPAIRS	AREA SF.	VOLUME CF.	AREA SF.	VOLUME CF.
CAP (VERTICAL FACE)	6.8	1.7		
CAP (HORIZONTAL FACE)	3.0	0.8		
COLUMN (VERTICAL FACE)	0.2	0.1		
CONCRETE REPAIRS	2.3	0.6		
EPOXY RESIN INJECTION		LN. FT.		LN. FT.
CAP		7.0		
COLUMN		0.0		
EPOXY COATING		SQ. FT.		SQ. FT.
TOP OF CAP		82.0

EPOXY COATING SHALL BE APPLIED TO THE TOP FACE OF THE BENT CAP.
