REFERENCE: BR-0029

STRUCTURE SUBSURFACE INVESTIGATION

COUNTY MACON

PROJECT DESCRIPTION REPLACE BRDG #0026 ON NC-106 (DILLARD RD) over MIDDLE CREEK

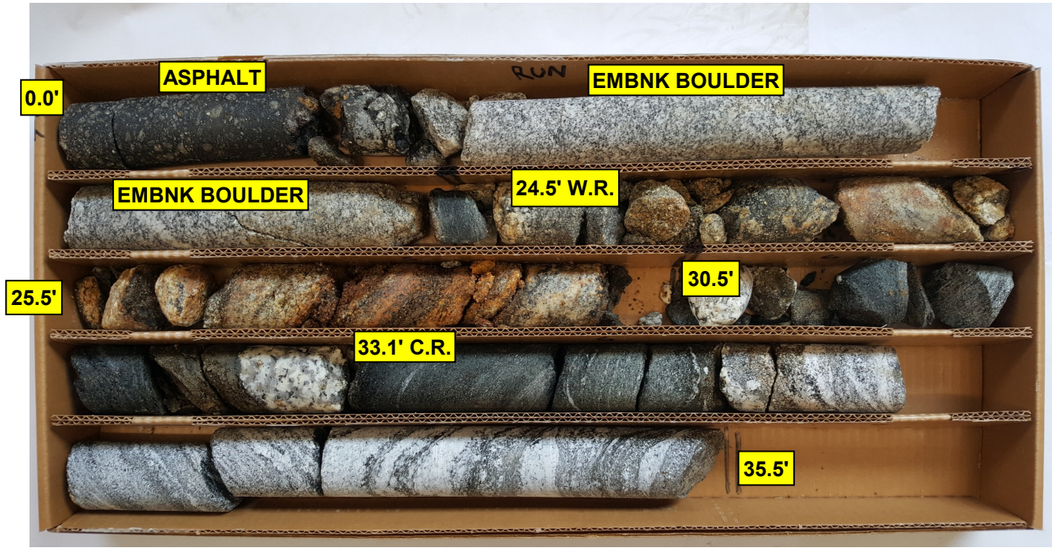
BOX 1 of 2 : 0.0 - 35.5 FEET

GEOLOGICAL STRENGTH INDEX: GSI
0.0' - 24.5' : N/A : embnk materials, w/ boulders
24.5' - 33.1' : 10-25
33.1' - 35.5' : 40-50

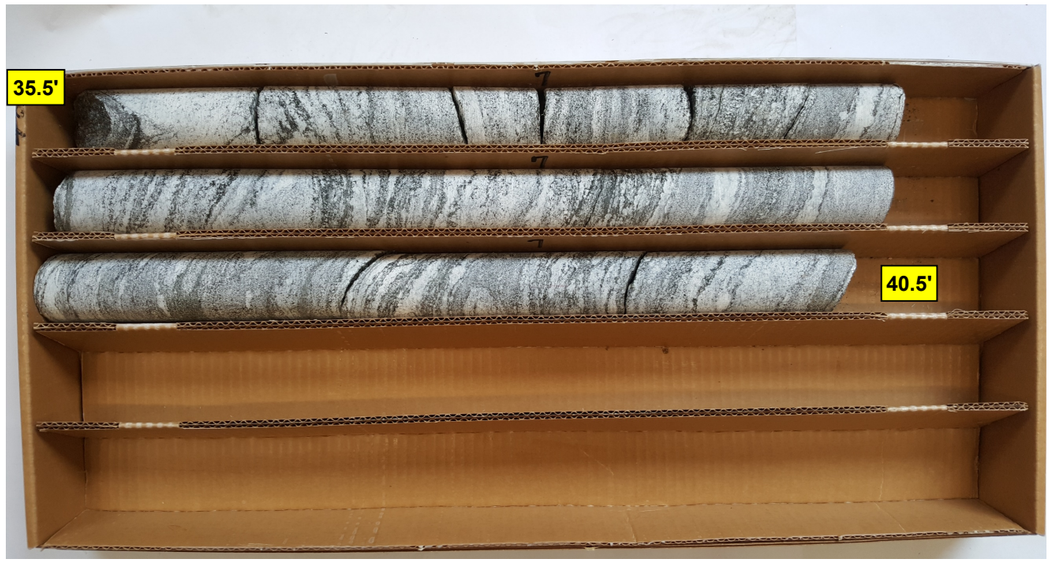
BOX 2 of 2 : 35.5 - 40.5 FEET

GEOLOGICAL STRENGTH INDEX: GSI
35.5' - 40.5' : 75-85
