Reference: **Preliminary Site Assessment for the Joshua A. Myer Property (Parcel 46)**
1810 W Wilson Street
Tarboro, Edgecombe County, North Carolina
State Project: U-4424
WBS Element 39062.1.2
DAA Project No. 20080204-010103

Geophysical Study
For Possible USTs
1810 West Wilson Street
Tarboro, North Carolina

RE: Geophysical Study for Possible USTs
1810 West Wilson Street, Tarboro, North Carolina
Draper Aden Associates Project No. 20080204-010203

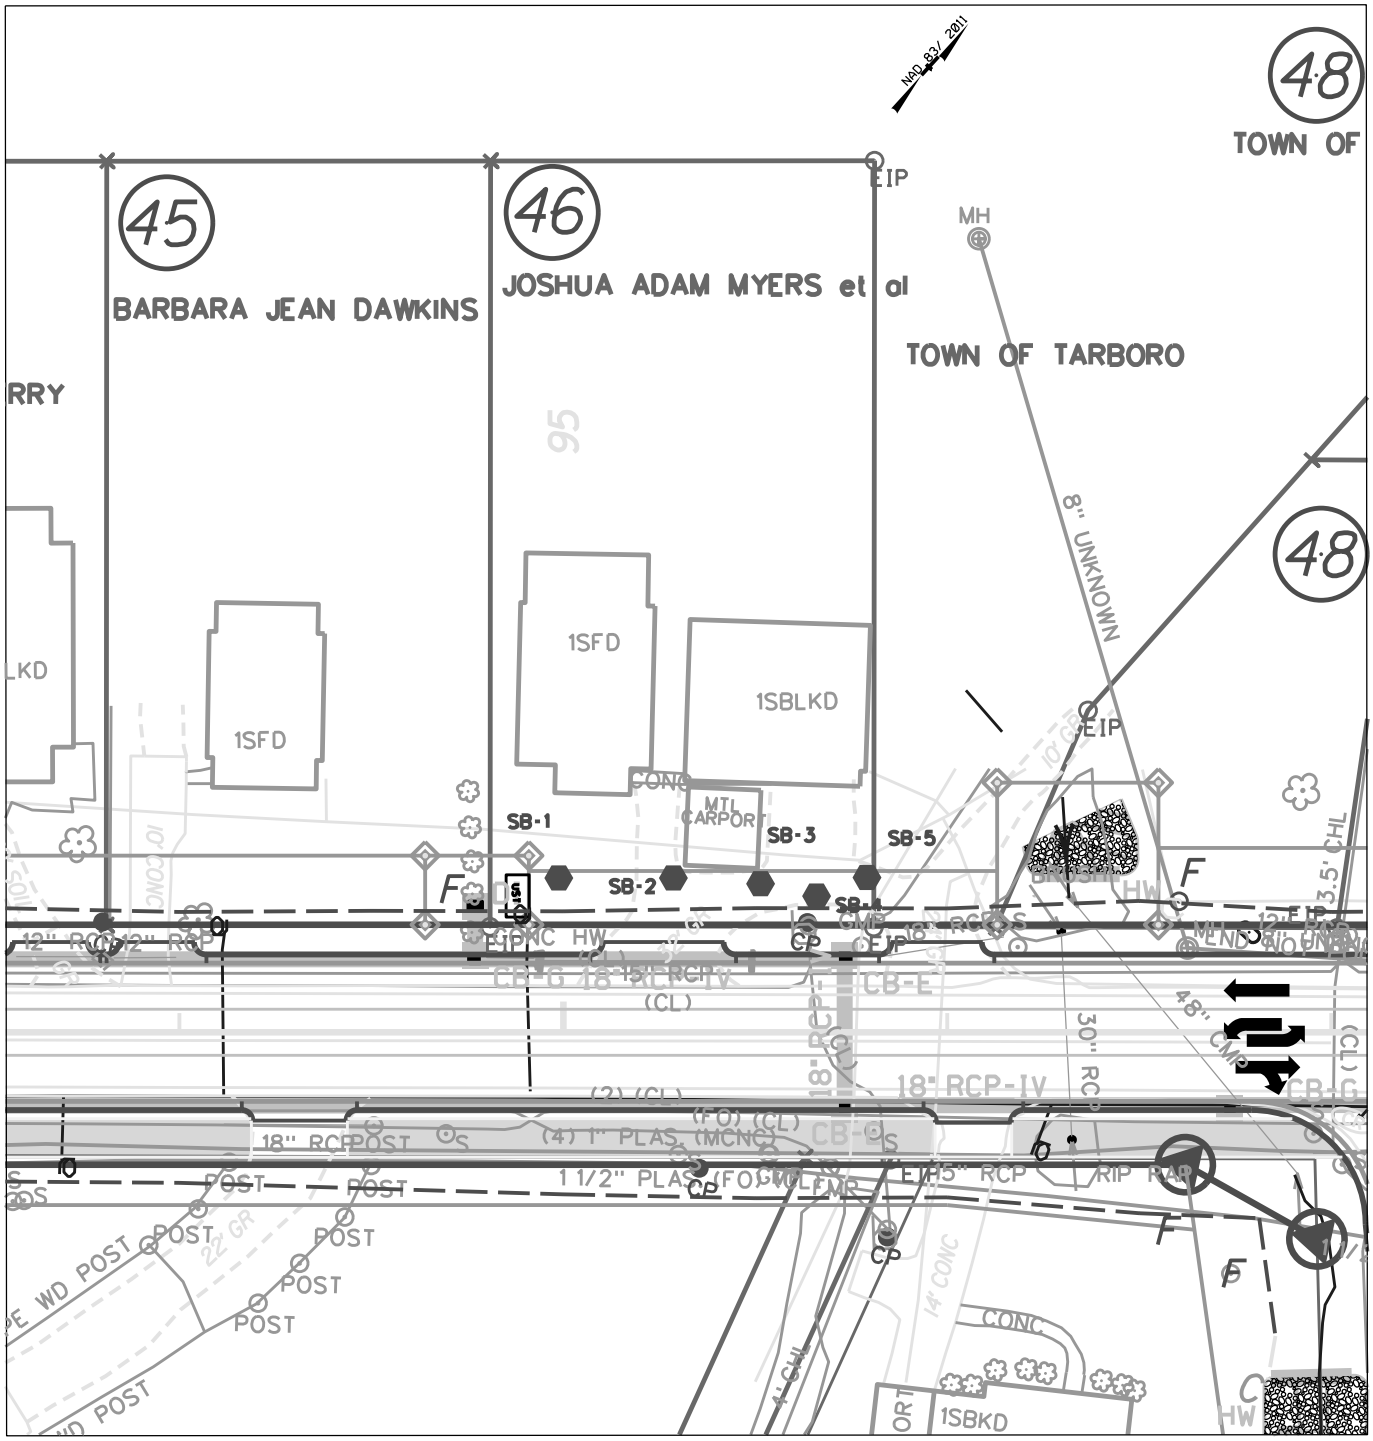
FIGURE
2

The garage, a single-story block structure with metal carport canopy in front, was the former fueling station. According to the property owner, one UST was located under the concrete former dispenser island in front of the building and has not been removed.

DAA conducted a Preliminary Site Assessment to evaluate the NCDOT proposed ROW/easement on the Joshua A. Myers Property (Parcel #46) located at 1810 W. Wilson Street in Tarboro, Edgecombe County, North Carolina. A geophysical survey indicated the presence of a possible UST within the proposed ROW/easement; however, no visual signs of a UST were noted.

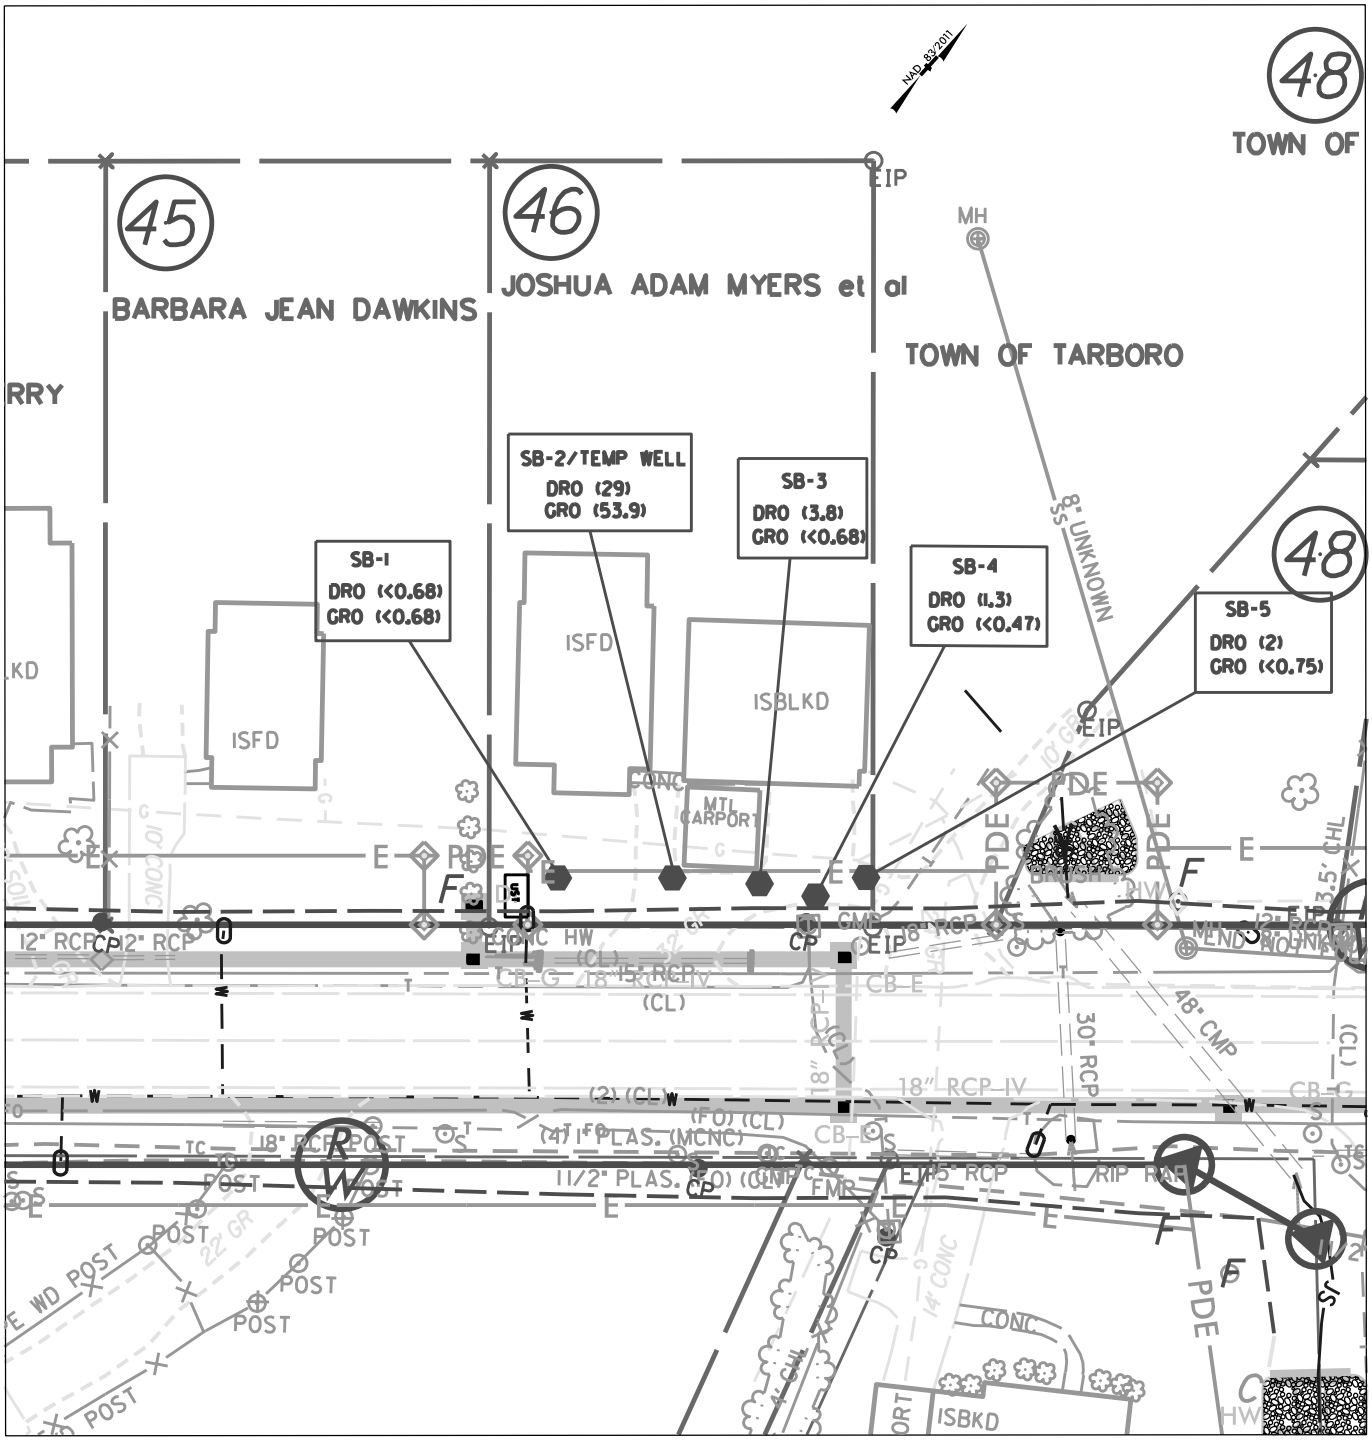
FIGURE
3

Table 1 and **Figure 3** summarize the soil laboratory results for the five soil samples for TPH DRO/GRO. **Table 2** and **Figure 4** summarize the groundwater laboratory results, and **Attachment D** presents the complete laboratory reports**.**

One soil sample, SB-2, contained a detectable GRO concentration of 53.9 milligrams per kilogram (mg/kg). No other sample contained detectable GRO concentrations. Four soil samples (SB-2 through SB-5) contained detectable DRO concentrations ranging from 1.3 to 29 mg/kg. The action levels are 50 mg/kg for GRO and 100 mg/kg for DRO[1]. None of the soil samples analyzed for this site contained DRO concentrations above their respective action levels.

The GRO concentration in SB-2 nominally exceeds the action level and from a soil sample collected in the apparent smear zone of the groundwater. Based on the field screening results, the PID readings increased at the depth just above the groundwater. As such, groundwater contamination may be the likely source of the GRO detected in the soil sample SB-2. Therefore, no estimate of the volume of soil necessitating possible remediation was required for this report.

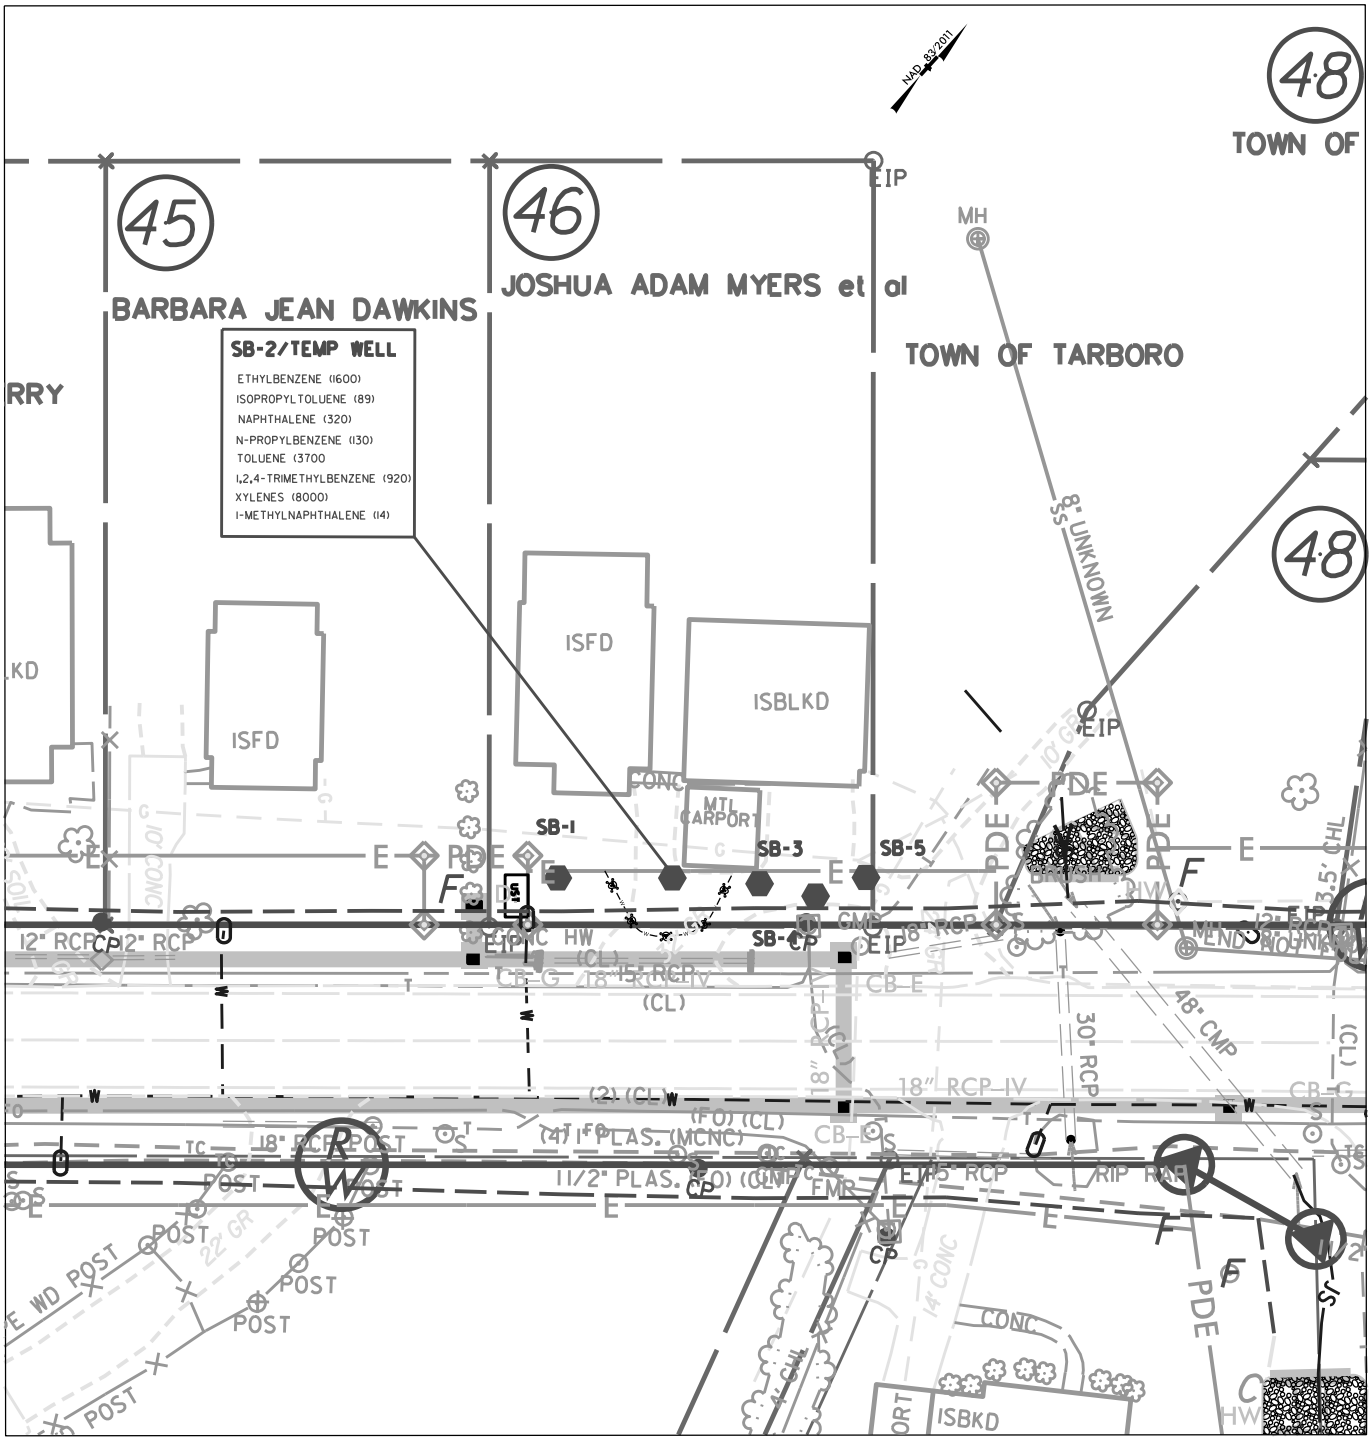
FIGURE
4

The groundwater analytical results (**Table 2**) indicate the detection of several petroleum compounds. DAA compared these concentrations to the Groundwater Quality Standards established in 15A NCAC 2L (2L Standards). The compounds detected above the 2L Standards were associated with gasoline constituents. These included ethylbenzene, isopropylbenzene, naphthalene, n-propylbenzene, toluene, 1,2,4-trimethylbenzene, 1,3,5-trimethylbenzene, and total xylenes. Of the SVOC compounds detected, only 1-methylnaphthalenen and naphthalene were present are concentrations greater than the 2L Standards.

of the soil samples analyzed contained a GRO concentration above the action level; however, the compounds are likely from groundwater contamination and no contaminated soil calculations were conducted. Groundwater contained several compounds, many above the 2L Standards.

Because compounds were detected above the action level in the soil and groundwater samples, DAA recommends that a copy of this report be submitted to the Division of Waste Management, UST Section, in the Raleigh Regional Office.

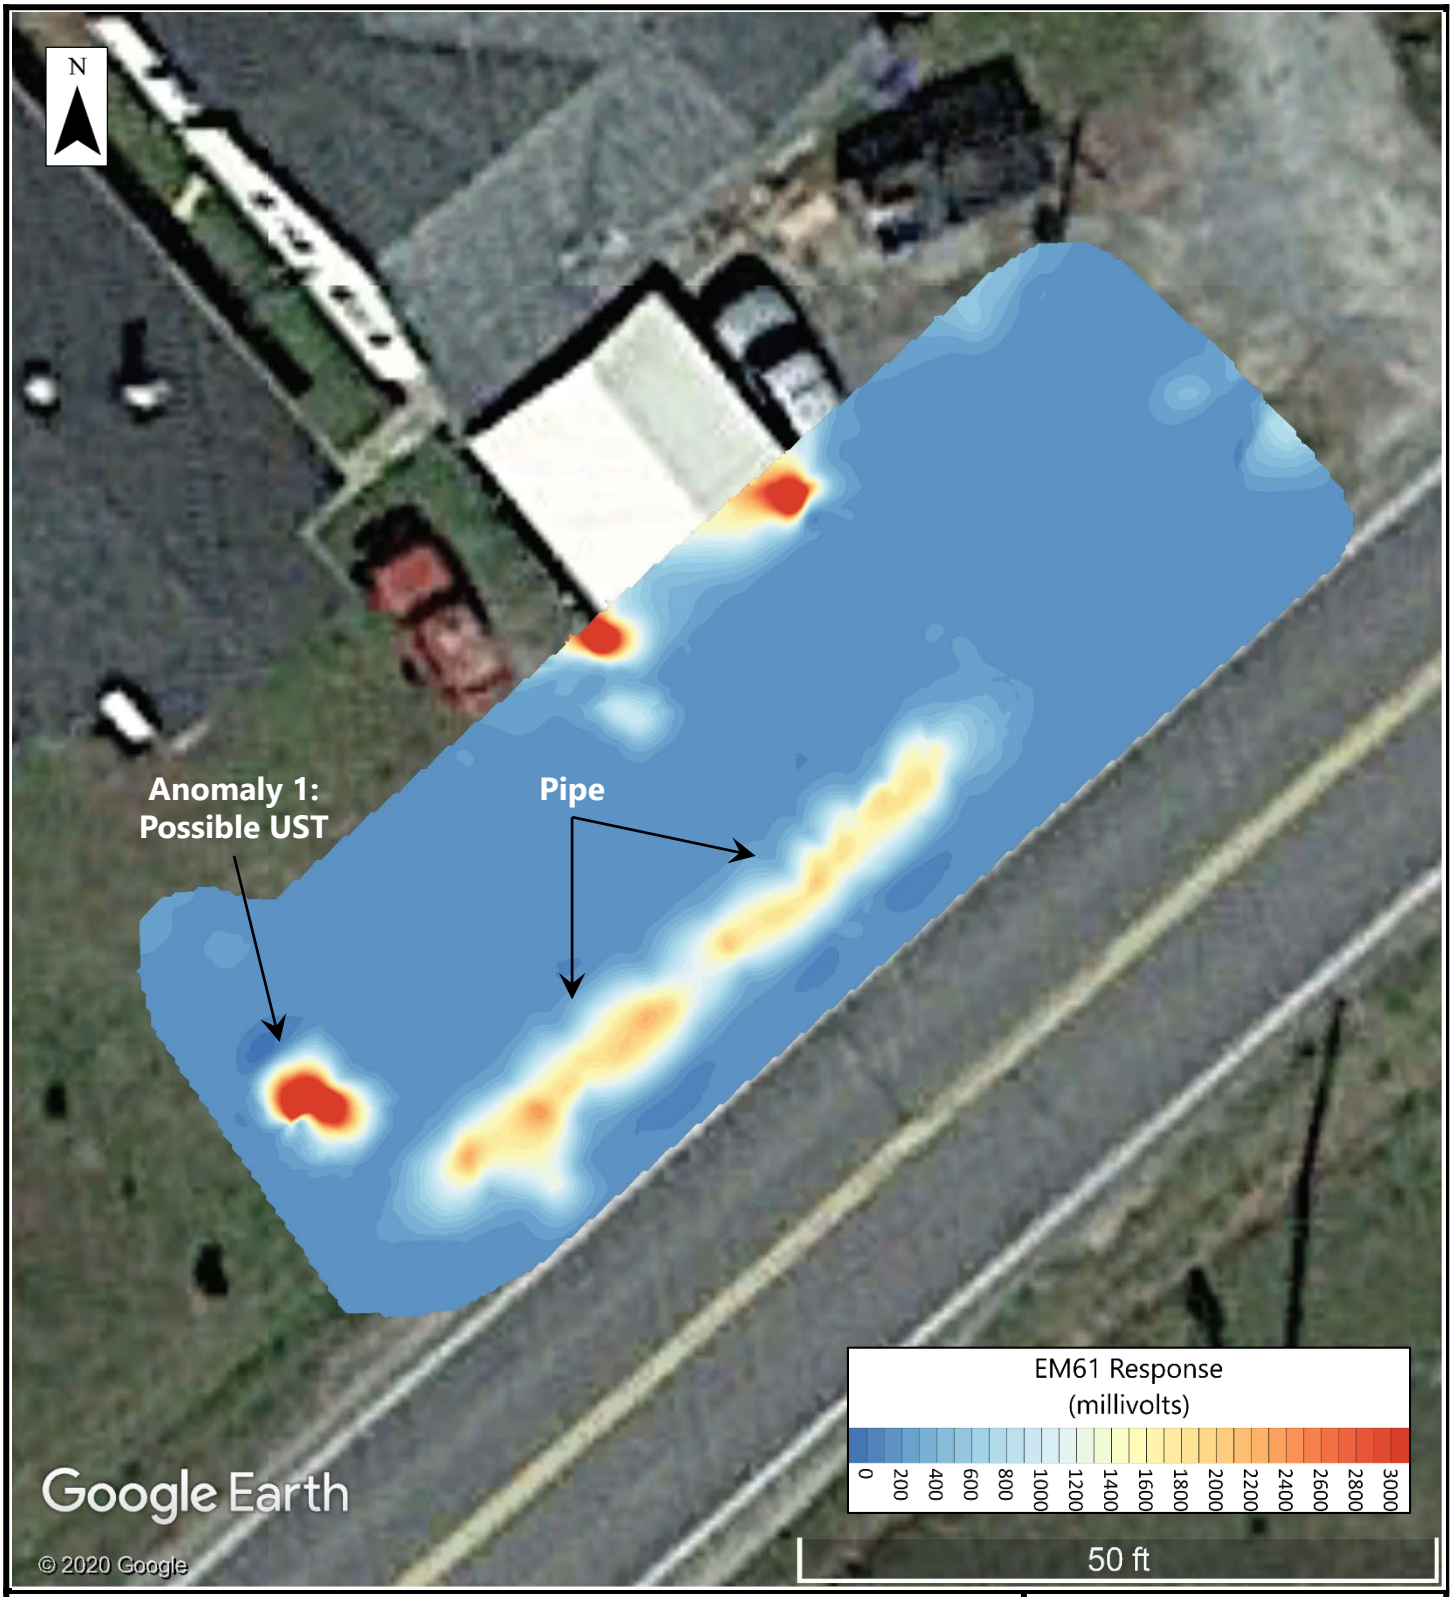
FIGURE
3

The contoured results from the EM61 data are presented in Figure 3, overlain onto Google Earth aerial imagery. The data reveals a "hotspot" (isolated areas of elevated EM response) which may represent a possible UST. This feature is identified as Anomaly 1 and located approximately 45 feet southwest of the southwest corner of the carport. It is uncertain if the EM anomaly represent a UST, but of the collected data, this feature is most likely to possibly represent a UST. Since the EM61 instrument is particularly sensitive to buried metallic materials or objects, we consider it likely that the anomaly is metallic in composition.

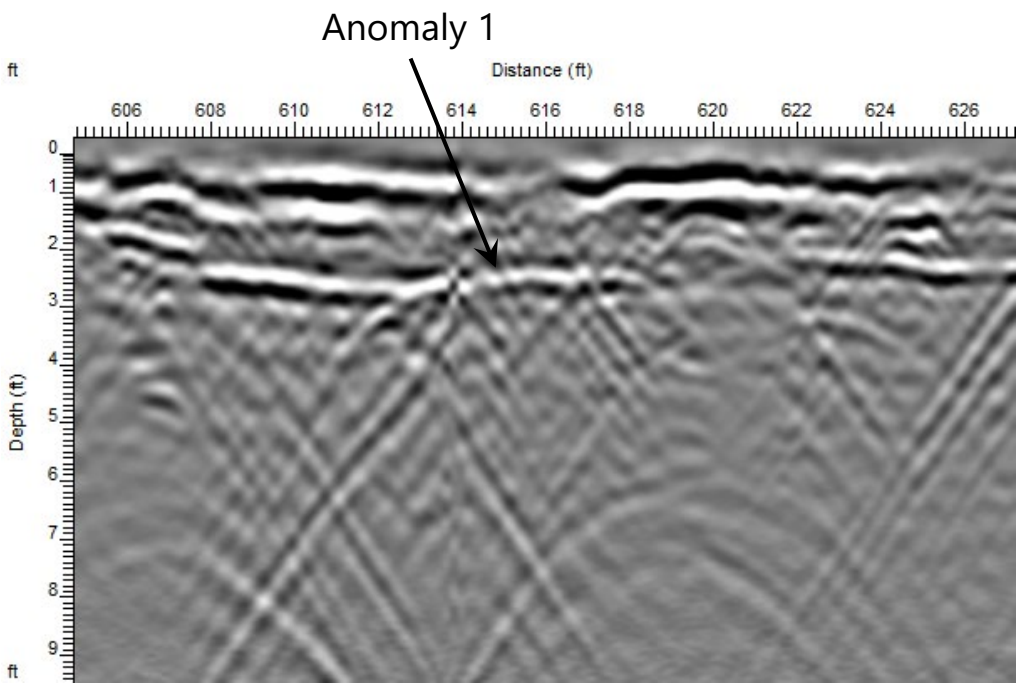
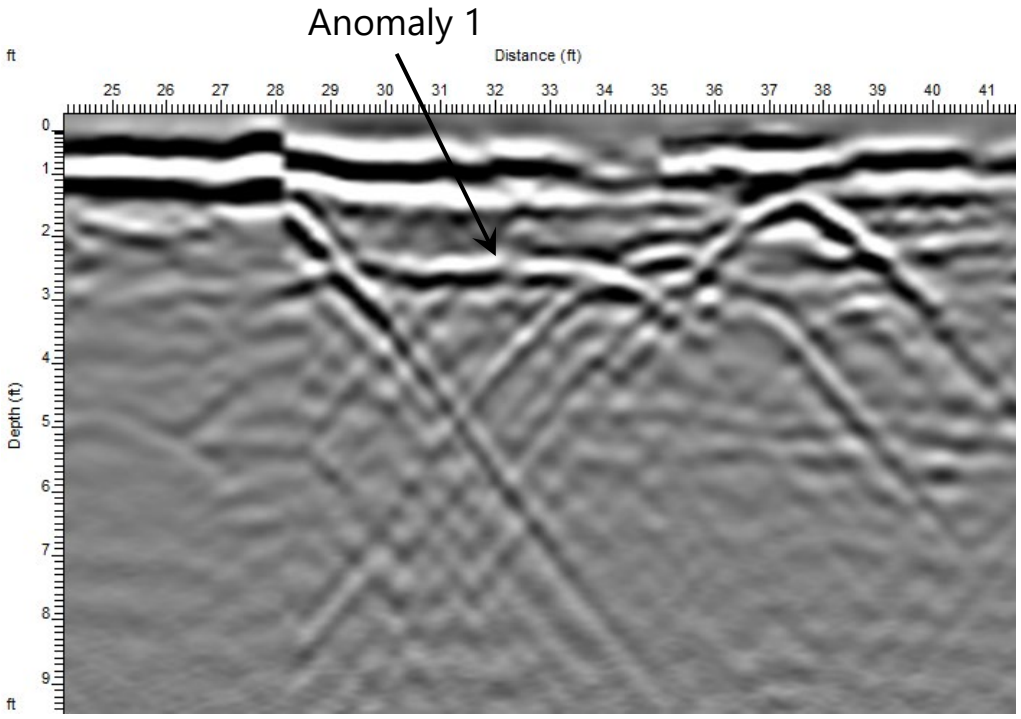
FIGURE
5

The GPR data were analyzed as vertical cross-sections and as depth slices, or plan-view maps of the GPR response from various depth intervals for evidence of possible USTs. Figure 5 depicts two sample GPR cross-sections from the collected data which contain broad hyperbolic reflectors consistent with a possible UST located approximately 2.5 feet below the ground surface. These features correlate to Anomaly 1 identified in the EM61 data.

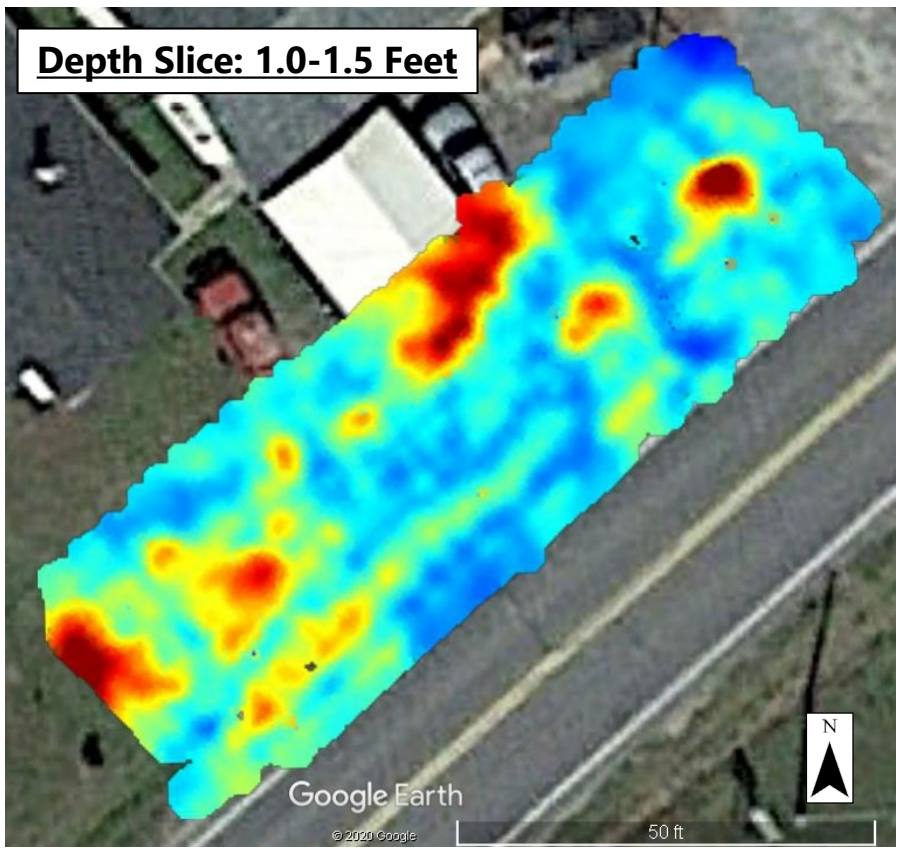
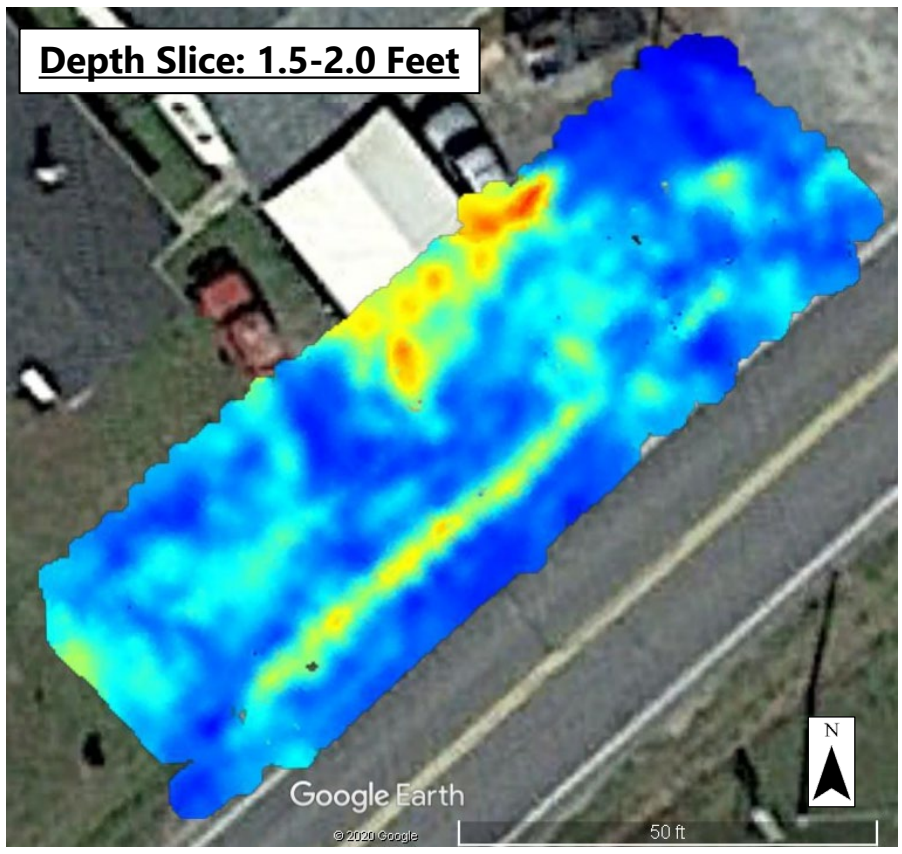
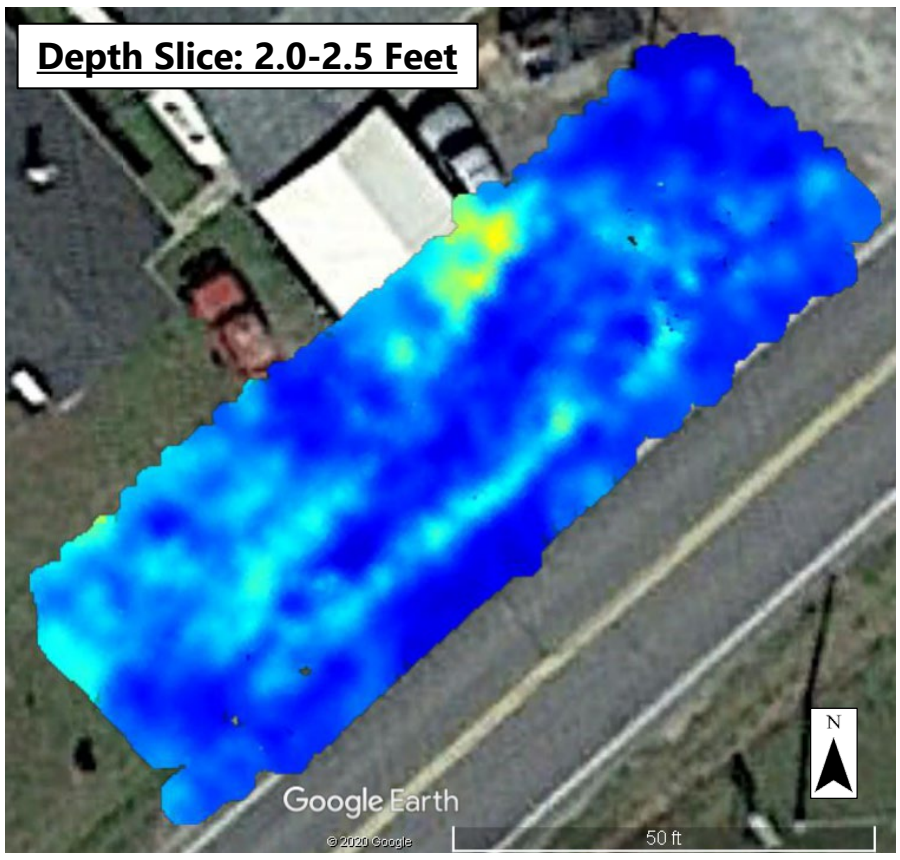
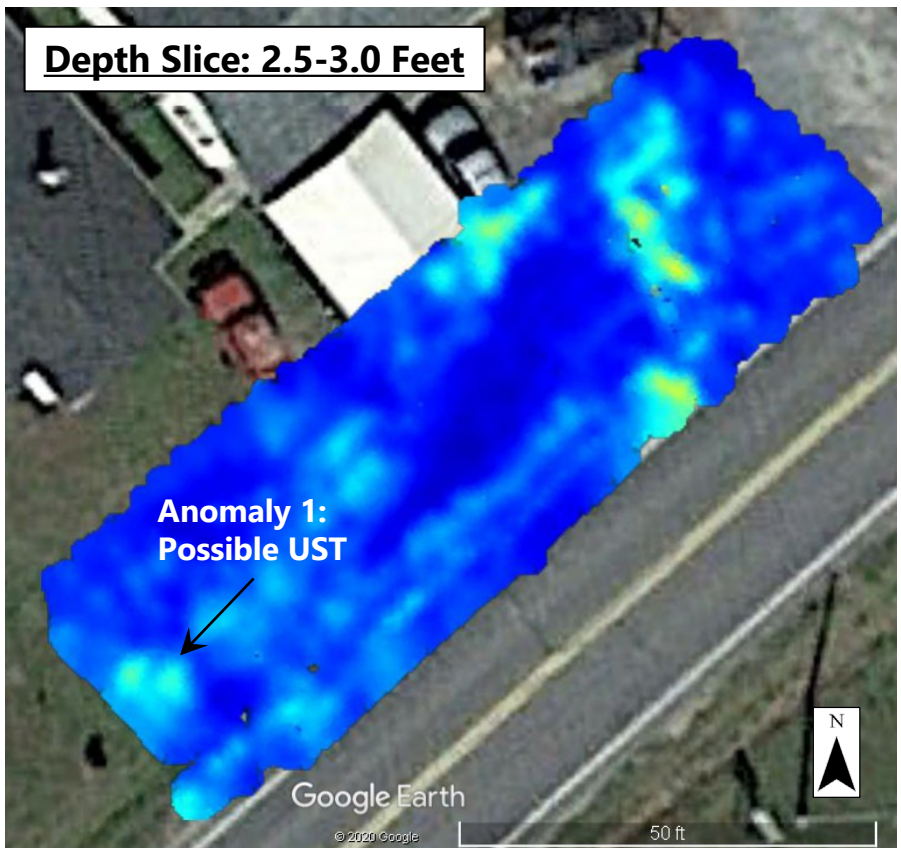
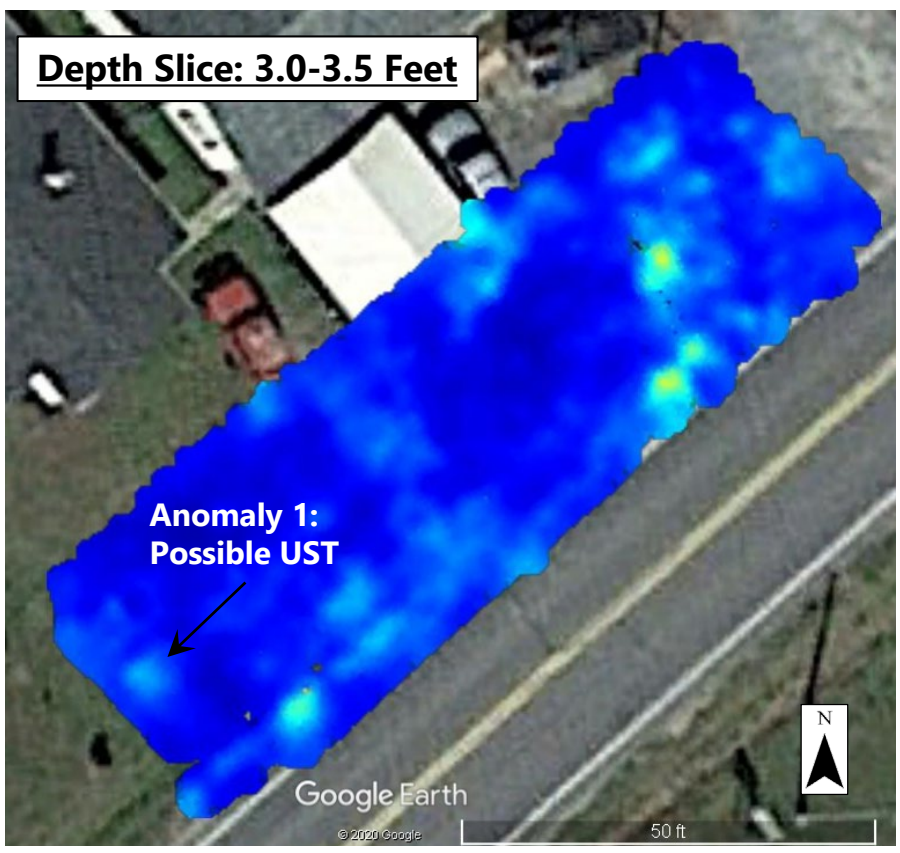
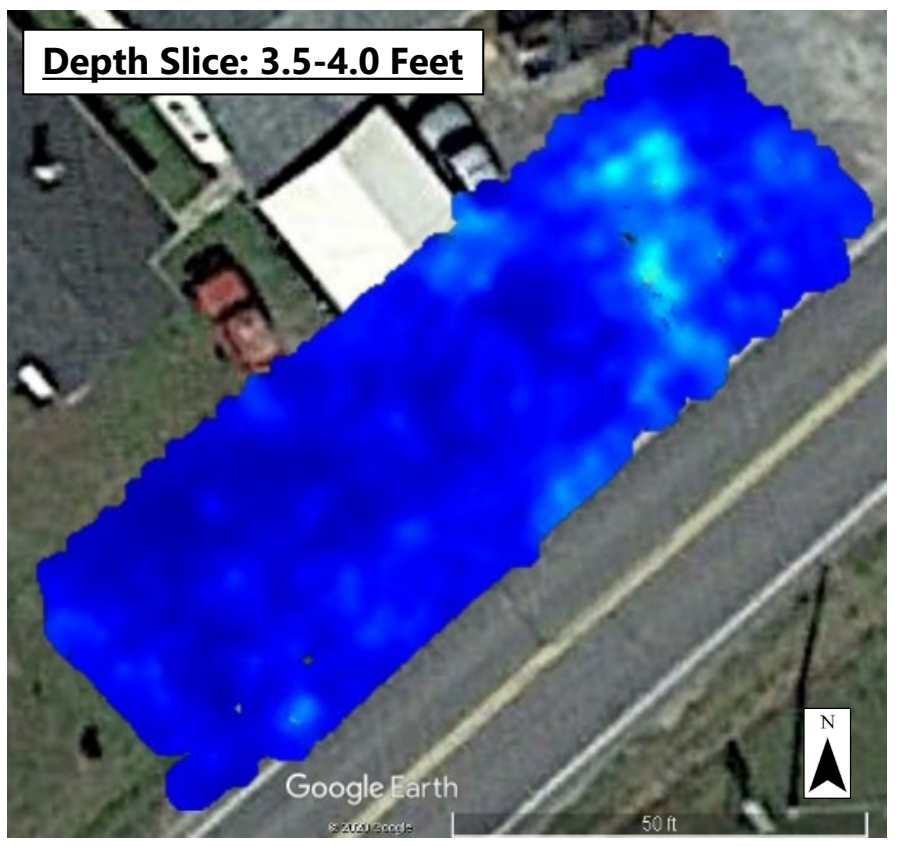
FIGURE
6

Figures 6 and Figure 7 illustrate the plan-view GPR response in 6-inch-thick depth intervals spanning from 1.0 to 6.0 feet depth. An anomaly in the depth slice from 2.5 to 3.0 feet depth correlates well with EM Anomaly 1. Numerous other areas of elevated GPR response observed throughout the depth slices may represent miscellaneous buried objects, materials, or conditions, such as intermittent clay layers or zones of wet soil. However, due to a general lack of elevated EM response in other areas (beyond the vicinity of Anomaly 1), these other areas of anomalous GPR response are considered likely to not be metallic in composition.

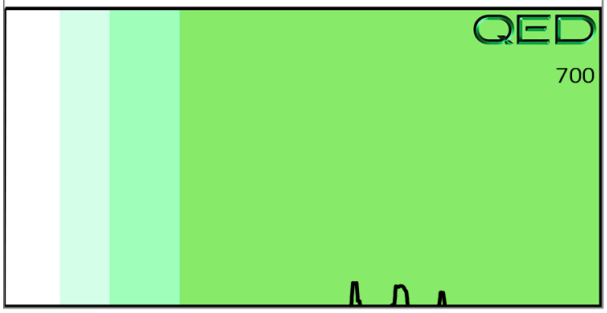
SB-1 : PHC not detected,(BO)

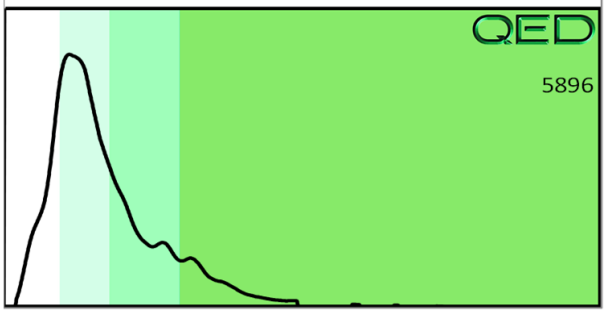
SB-2 : Deg Gas 82.2%,(FCM)

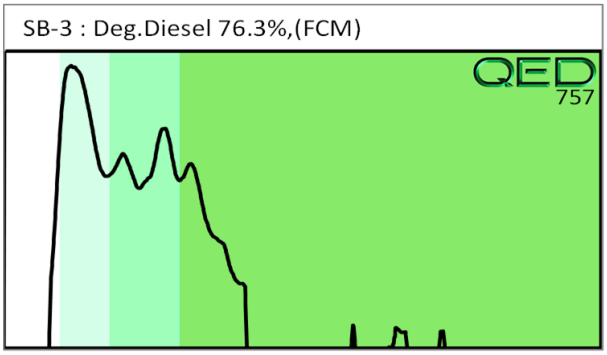
SB-3 : Deg.Diesel 76.3%,(FCM)

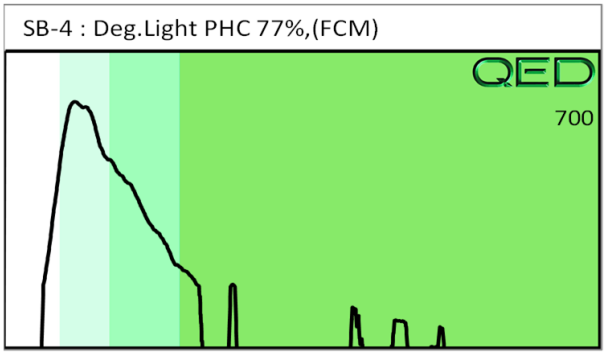
SB-4 : Deg.Light PHC 77%,(FCM)

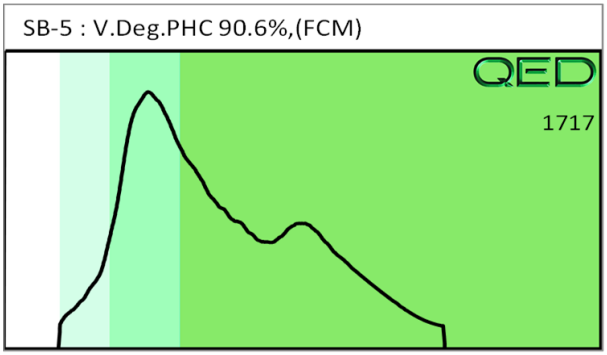
SB-5 : V.Deg.PHC 90.6%,(FCM)
