PROJECT SPECIAL PROVISIONS
GEOENVIRONMENTAL

Reference: **Preliminary Site Assessment for the Joshua A. Myer Property (Parcel 46)**
1810 W Wilson Street
Tarboro, Edgecombe County, North Carolina
State Project: U-4424
WBS Element 39062.1.2
DAA Project No. 20080204-010103

Geophysical Study
For Possible USTs
1810 West Wilson Street
Tarboro, North Carolina

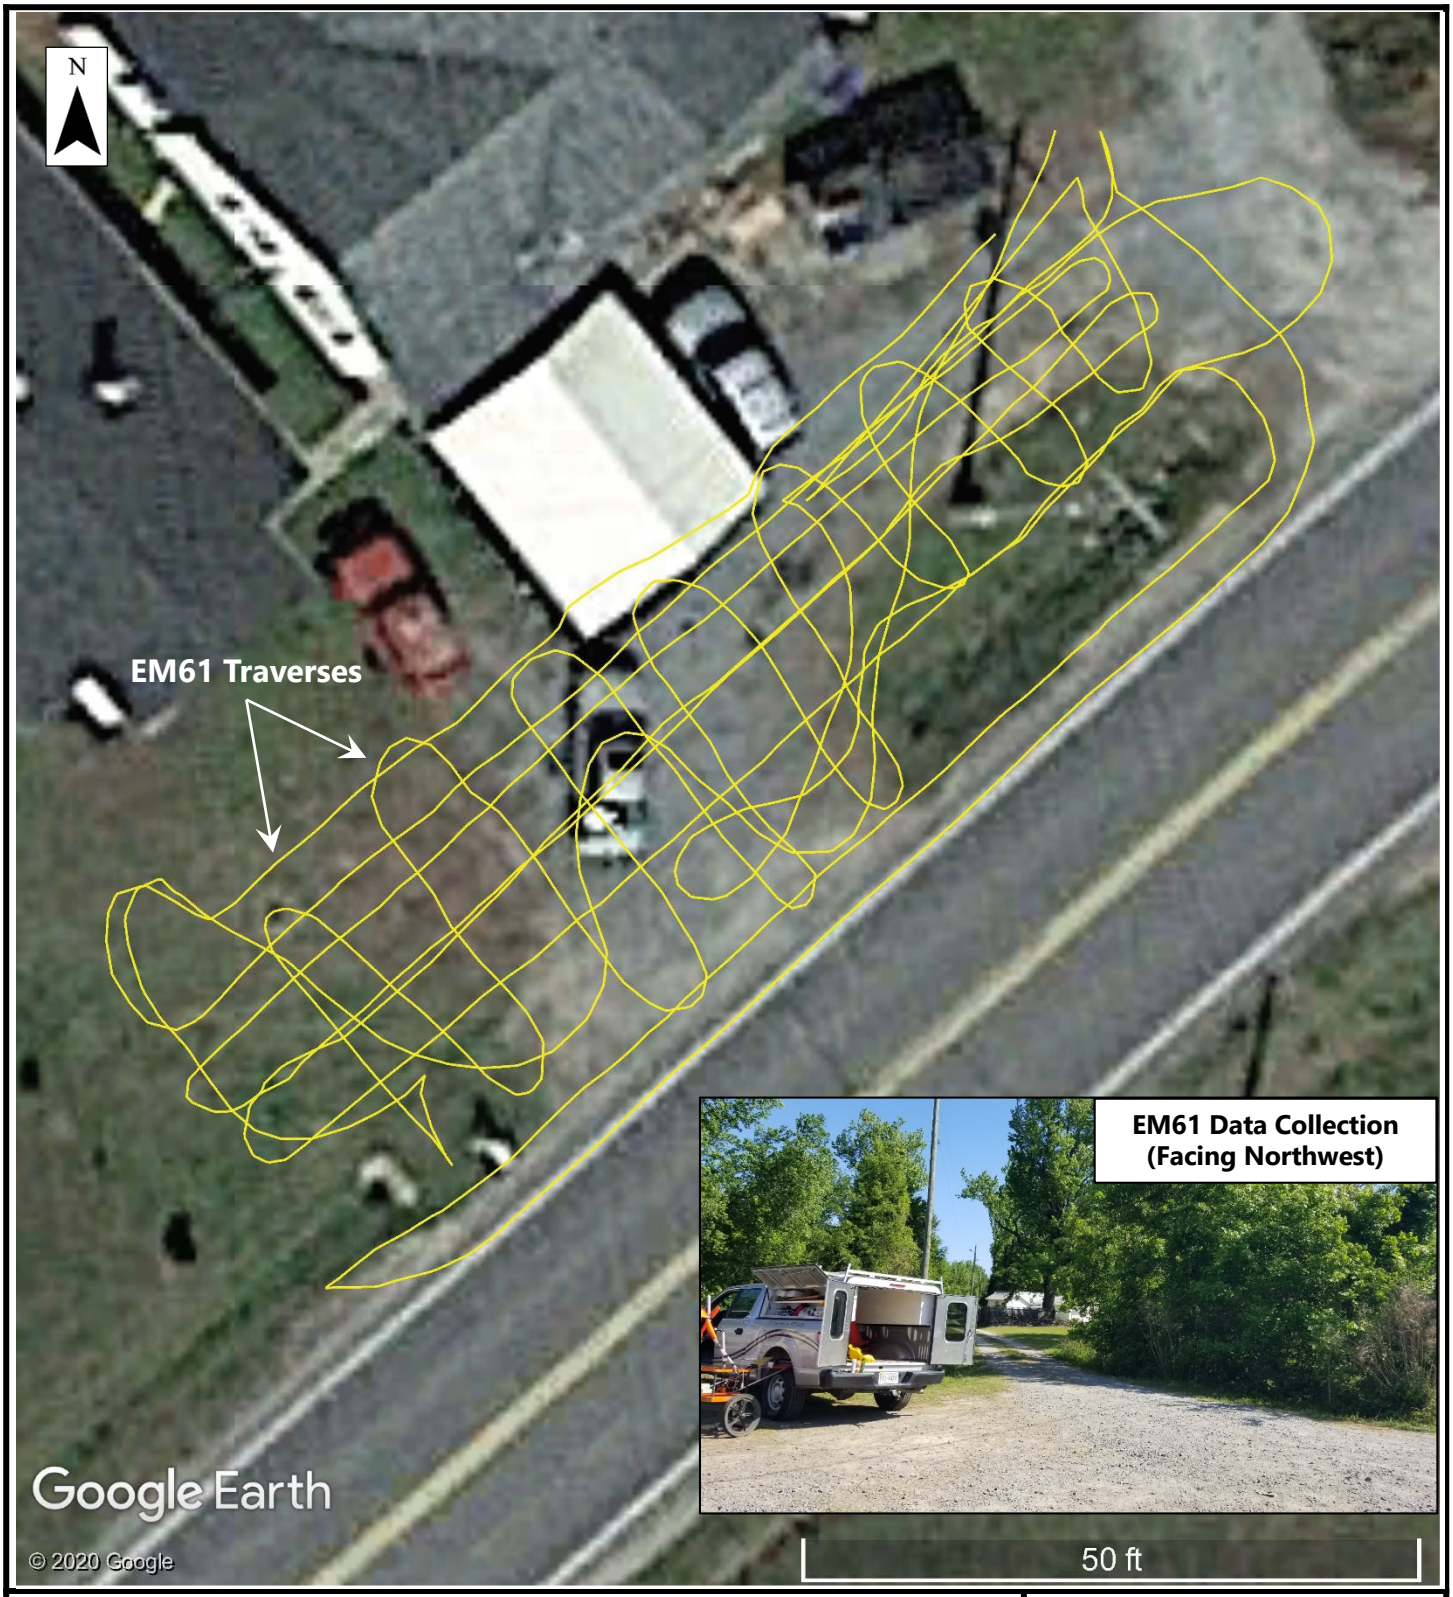
EM61 Traverse Map

The combined analysis of the EM61 and GPR data reveals good correlation between the two methods, with a coincident anomaly observed in the data from each method (Anomaly 1). It is uncertain if Anomaly 1 represents a UST, but of the collected geophysical data, this feature is most likely to represent a potential UST.
