North Carolina Department of Transportation

Phase II Investigation
State Project: R-5709
WBS Element: 50205.1.1
Hoke County

Parcel 335
Wayne Michael George Property
8692 NC 211 Hwy
Aberdeen, North Carolina
November 3, 2021

Wood Environment & Infrastructure Solutions, Inc.
Project: 20478R5709

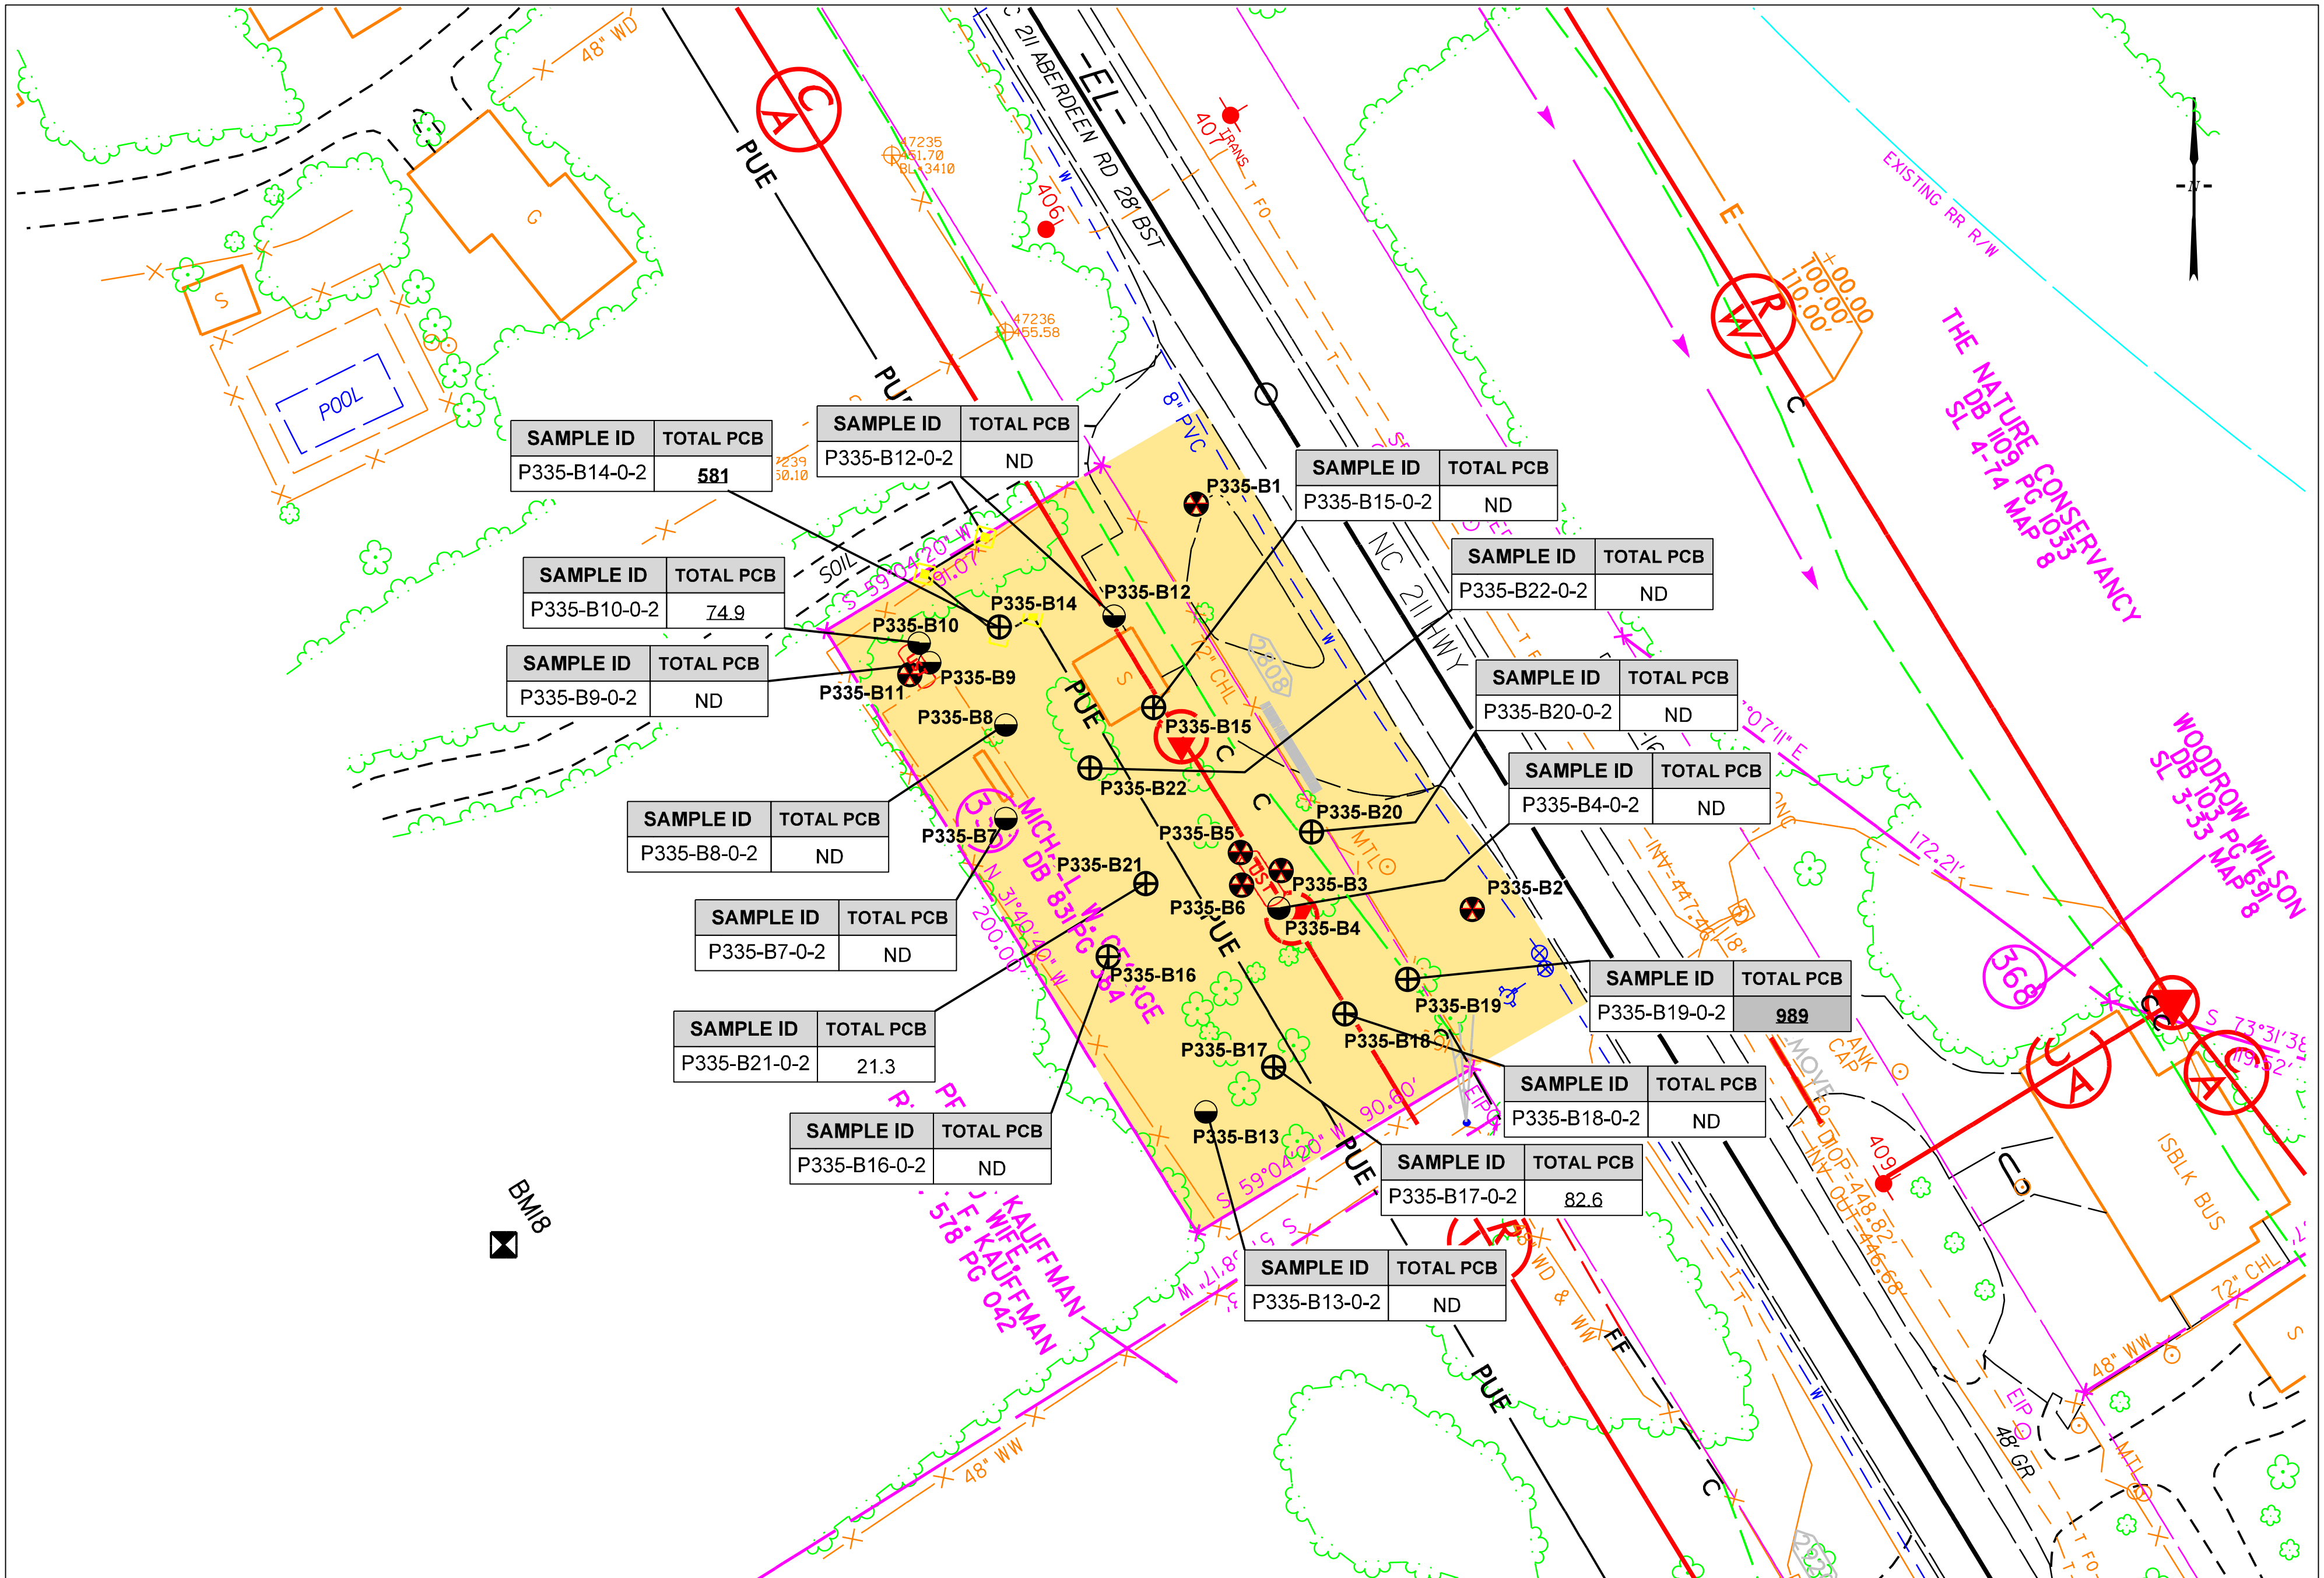
Based on the off-Site PCB analyses, PCB-impacted soil contamination was identified as defined by localized exceedances of the NCDEQ IHSB PSRGs. Since the PCB source is uncertain/unknown and since initial sample results for total PCBs are less than 50 mg/kg, the sampled soil would be considered non-hazardous and could go to a subtitle D landfill.

- The highest total PCB concentration (sample P335-B19-0-2) was used to evaluate cumulative exposure risk for the Site. Two exposure pathways were evaluated for the Site: direct contact with soil for construction workers and direct contact with soil for trespassers/recreators. The NCDEQ Risk Calculator results show that neither the cumulative carcinogenic risk threshold nor the cumulative target hazard index was exceeded for the Site.

Wood does recommend further soil sampling for definition of PCB concentrations in shallow soils prior to construction in the expanded ROW and/or disturbance in the PUE. The largest measured PCB concentration of 989 µg/kg, sample P335-B19 - 0-2 ft, was collected along the proposed cut line. However, a considerable area between the cut line and edge of parcel along NC 211 Hwy has not yet been assessed for potential PCB impact. Wood notes that the PCB impacts identified in borings P335-B10, P335-B14, and P335-B17 are located outside of the proposed ROW. Special handling of PCB-impacted soil should occur during construction activities, which may include excavation and disposed off-Site.

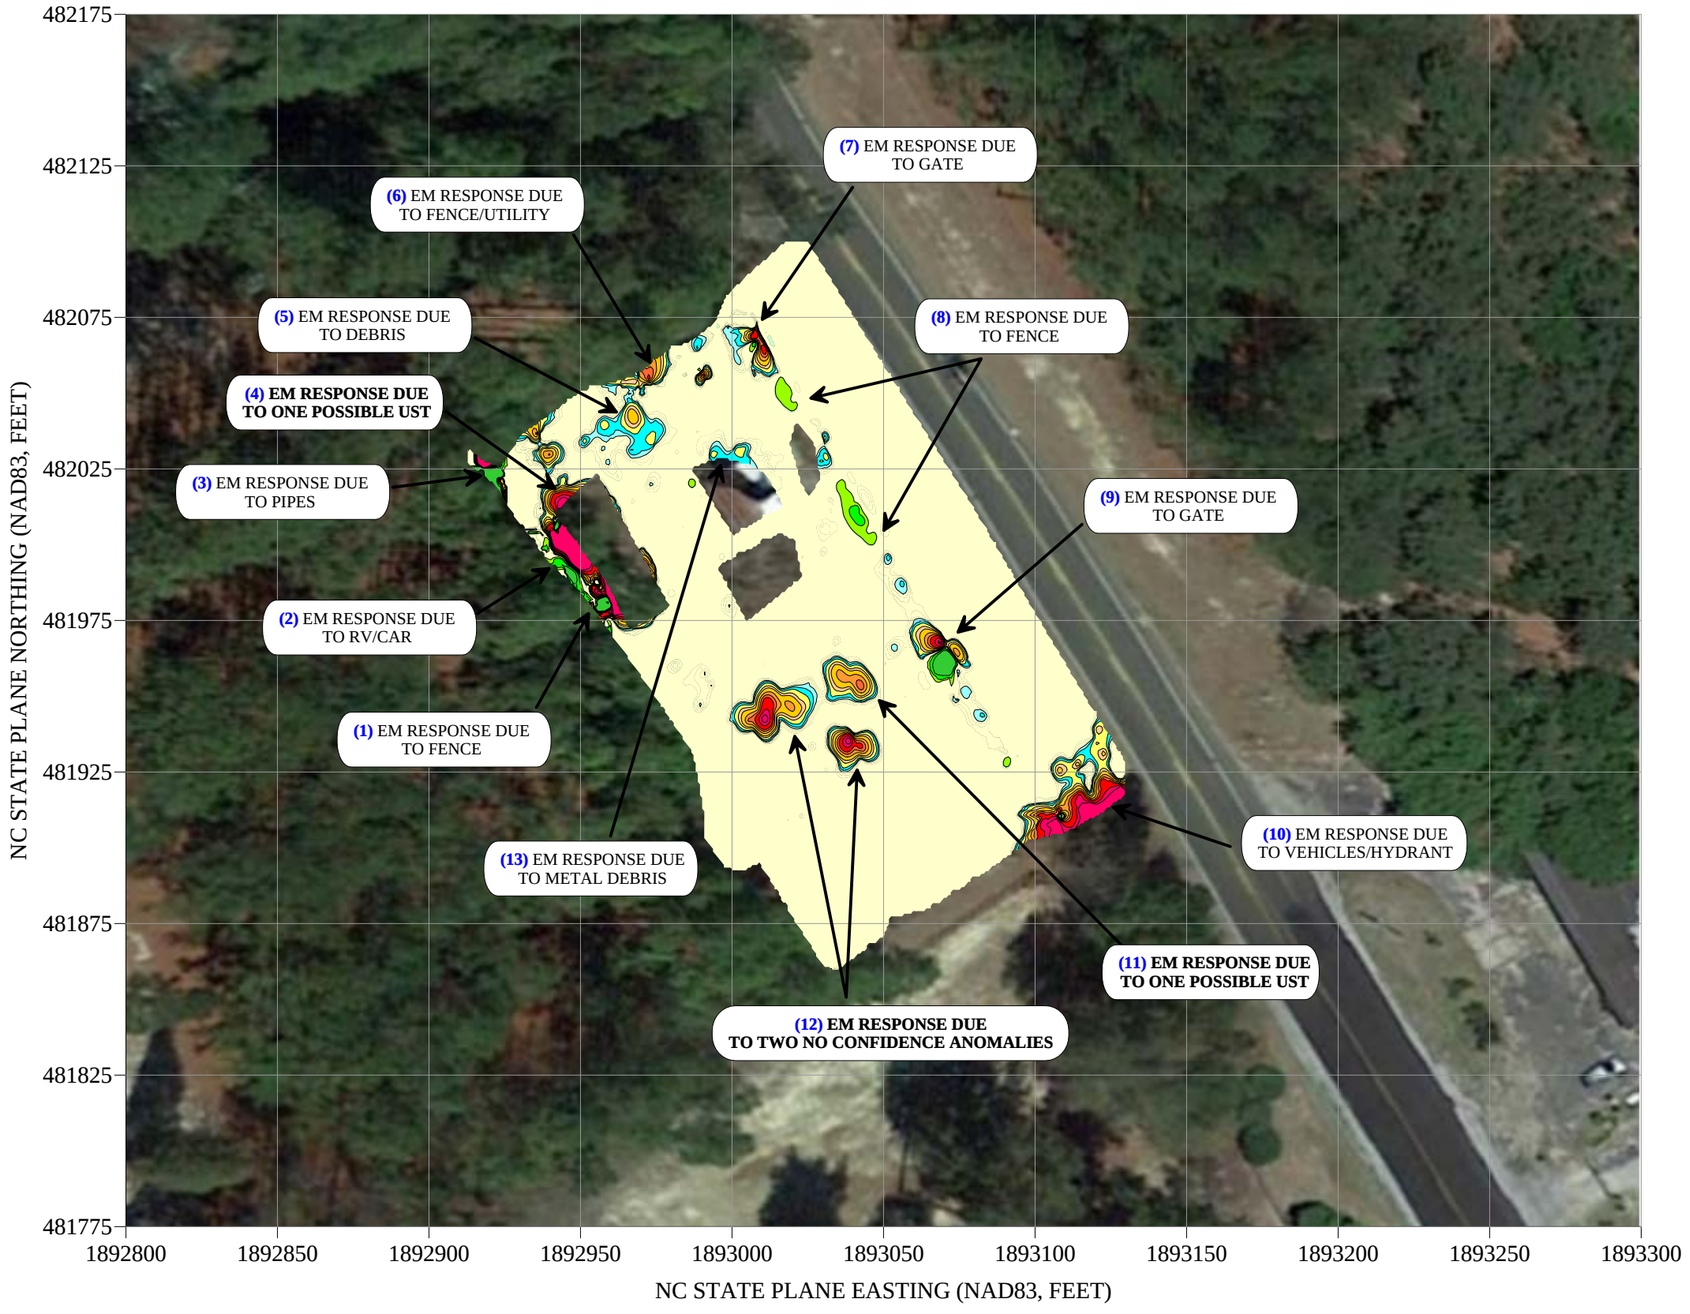
EM61 METAL DETECTION RESULTS

EVIDENCE OF TWO POSSIBLE USTs AND TWO NO CONFIDENCE ANOMALIES WAS OBSERVED.

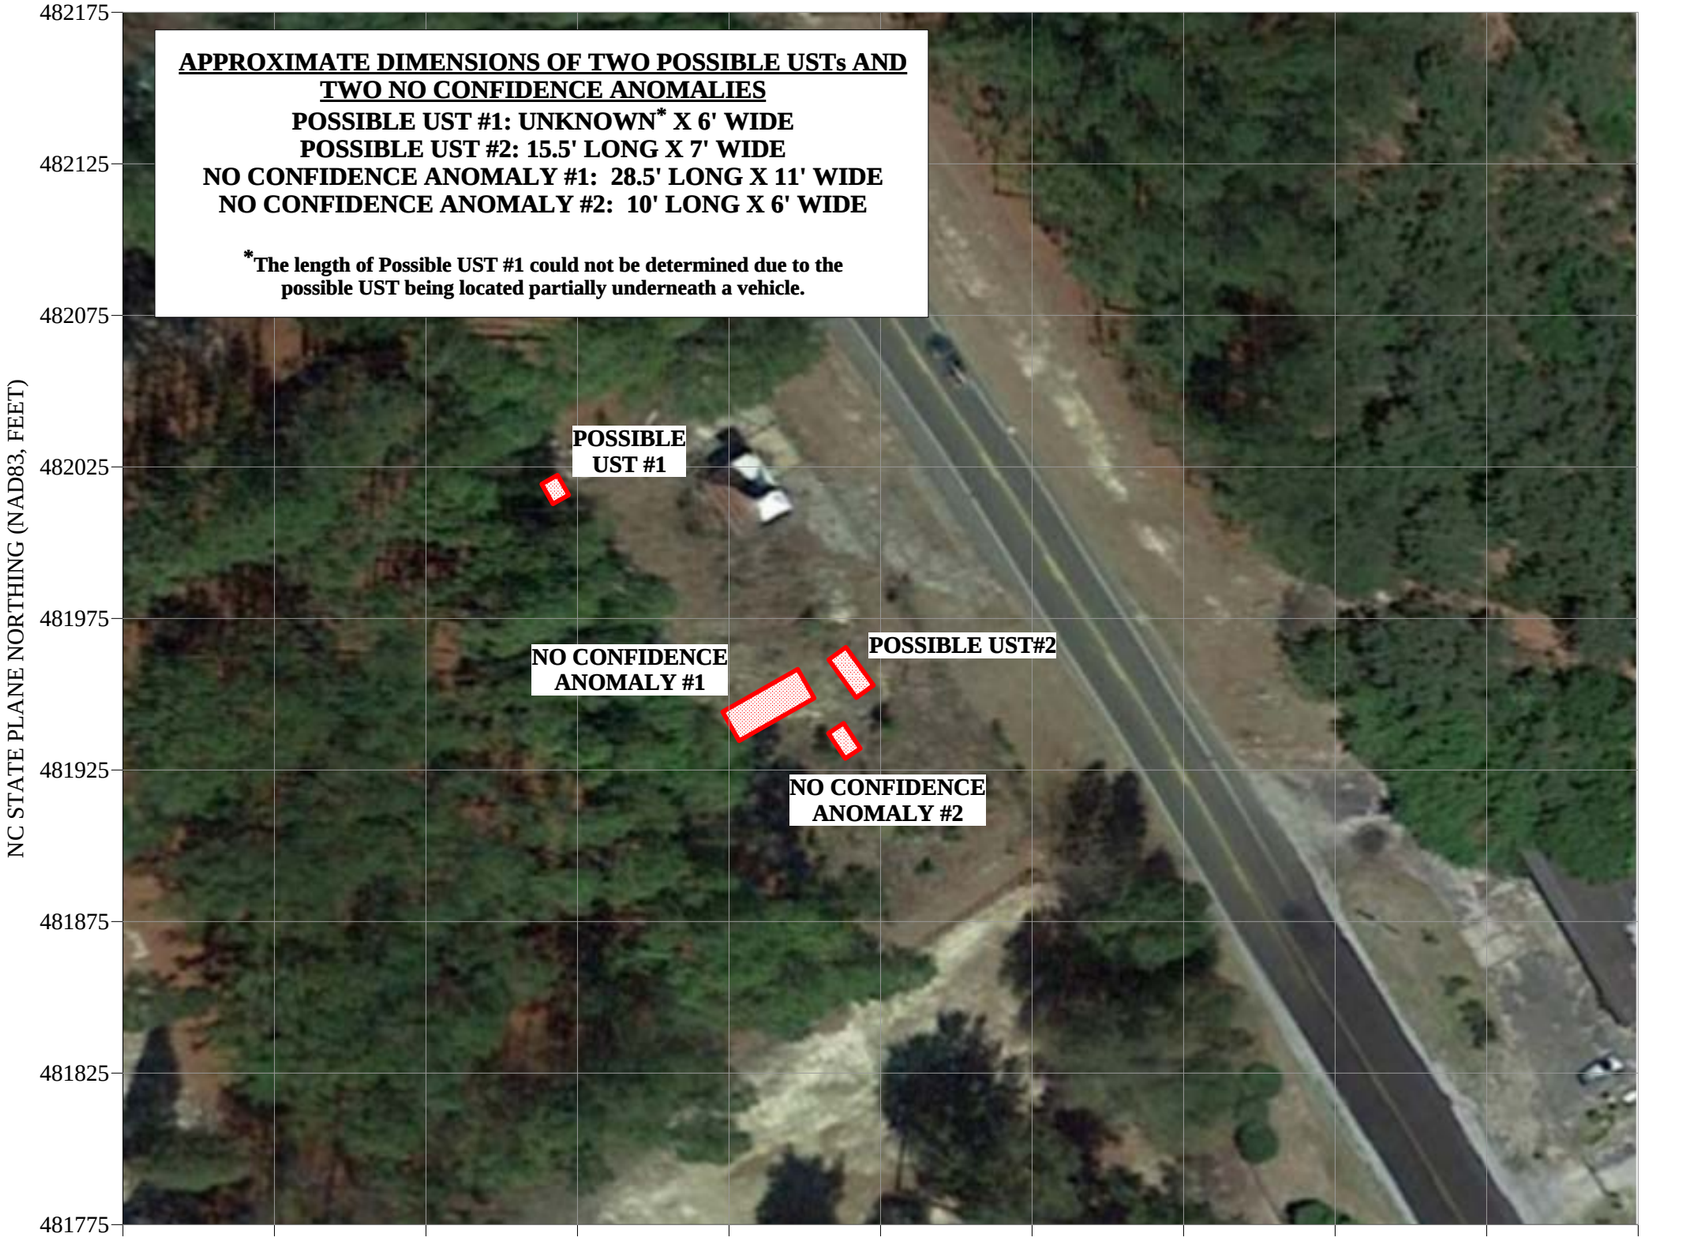
LOCATIONS OF TWO POSSIBLE USTs AND TWO NO CONFIDENCE ANOMALIES

GPR Transects 1-2 were performed across the north metallic feature associated with EM Anomaly 10. These transects recorded a relatively distinct hyperbolic reflector and an intermittent, discreet lateral reflector that are typical of a UST. Due to the somewhat deteriorated nature of these reflectors, this structure is being classified as one possible UST. The possible UST is approximately 15.5 feet long and 7 feet wide.

GPR Transects 3-6 were performed across the remaining two metallic features associated with EM Anomaly 10. These transects recorded discreet, isolated lateral reflectors in both directions that are suggestive of buried structures such as former foundations or other infrastructure. The sizes and shapes of these features are not characteristic of USTs. Therefore, the two features are being classified as two no confidence anomalies. The west feature (No Confidence Anomaly #1) is approximately 28.5 feet long and 11 feet wide. The south feature (No Confidence Anomaly #2) is approximately 10 feet long and 6 feet wide.

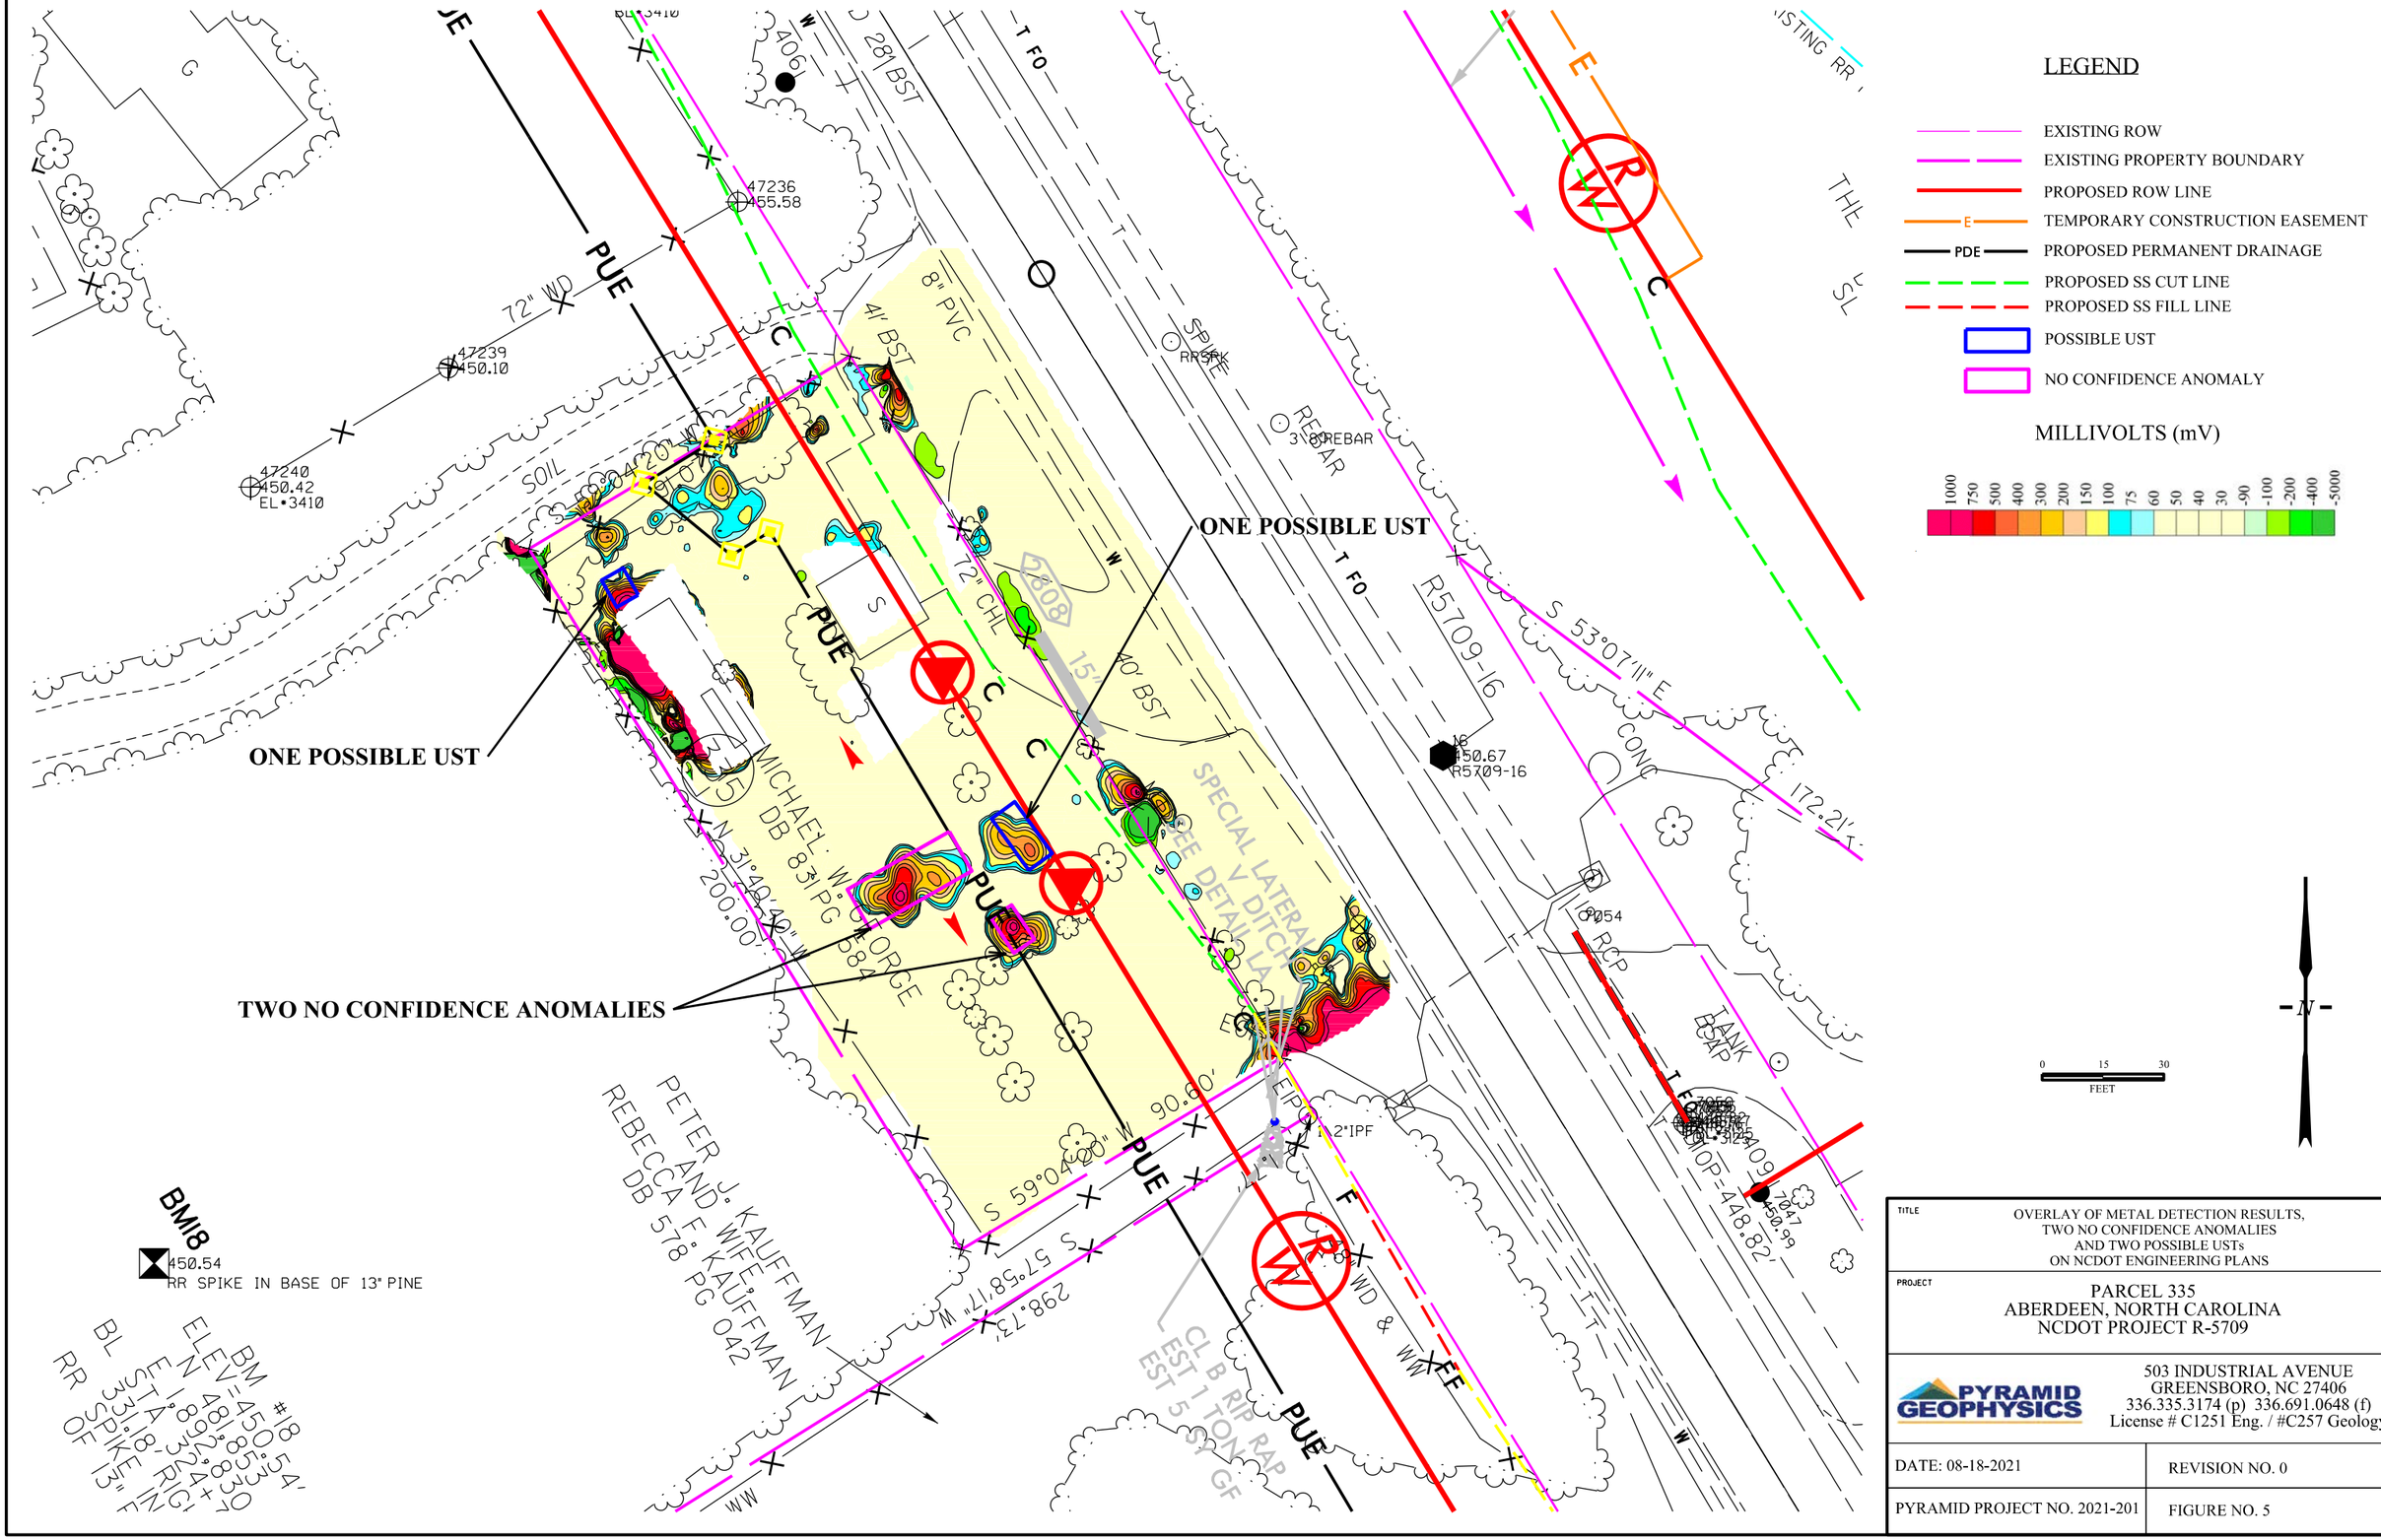
Additionally, Wood personnel used a stainless-steel hand auger and a shovel to confirm the depths of the two possible USTs. Two holes were dug above possible UST #1 and three holes were dug above possible UST #2. The tops of possible USTs #1 and #2 were measured at approximately 1.5 feet and 2 feet bgs, respectively. It was noted that the tops of each possible UST were flatter in shape than would be expected for a buried tank and may indicate objects other than tanks at these locations; however, further excavation is needed to determine the full nature of the buried objects.
