N.C. DEPARTMENT OF TRANSPORTATION
DIVISION OF HIGHWAYS
BRIDGE MAINTENANCE UNIT

BRIDGE INSPECTION REPORT

COUNTY PASQUOTANK BRIDGE NUMBER 690019 INSPECTION CYCLE 2 YRS

ROUTE US158 ACROSS PASQUOTANK RIVER M.P. 000+000

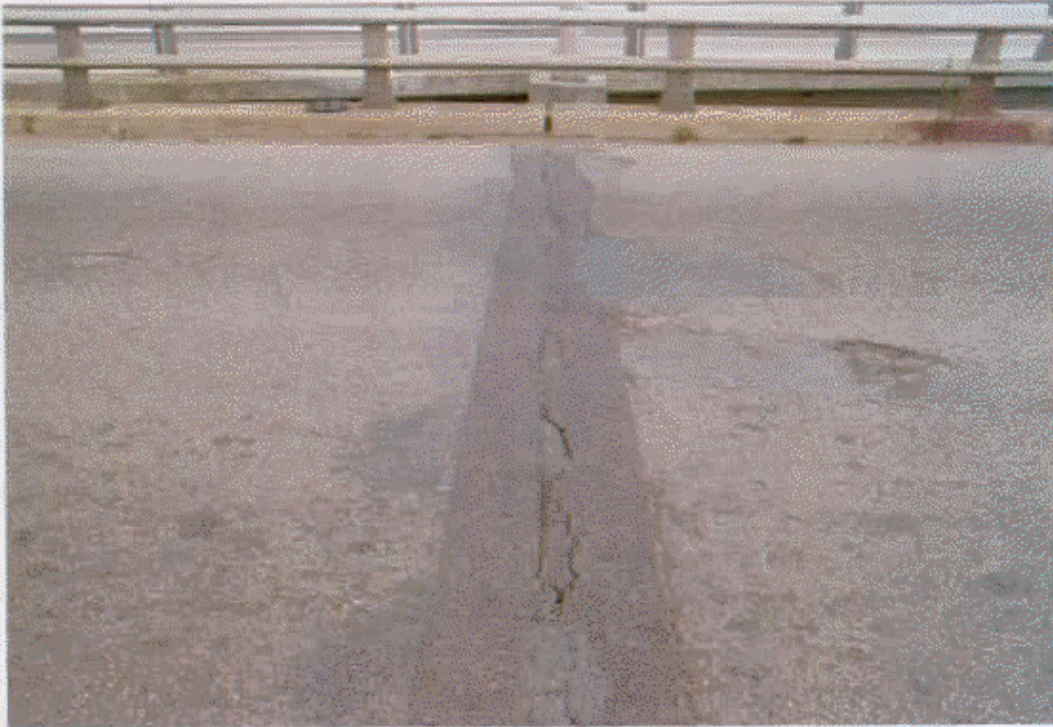
EXPANSION JOINT AT BT#1

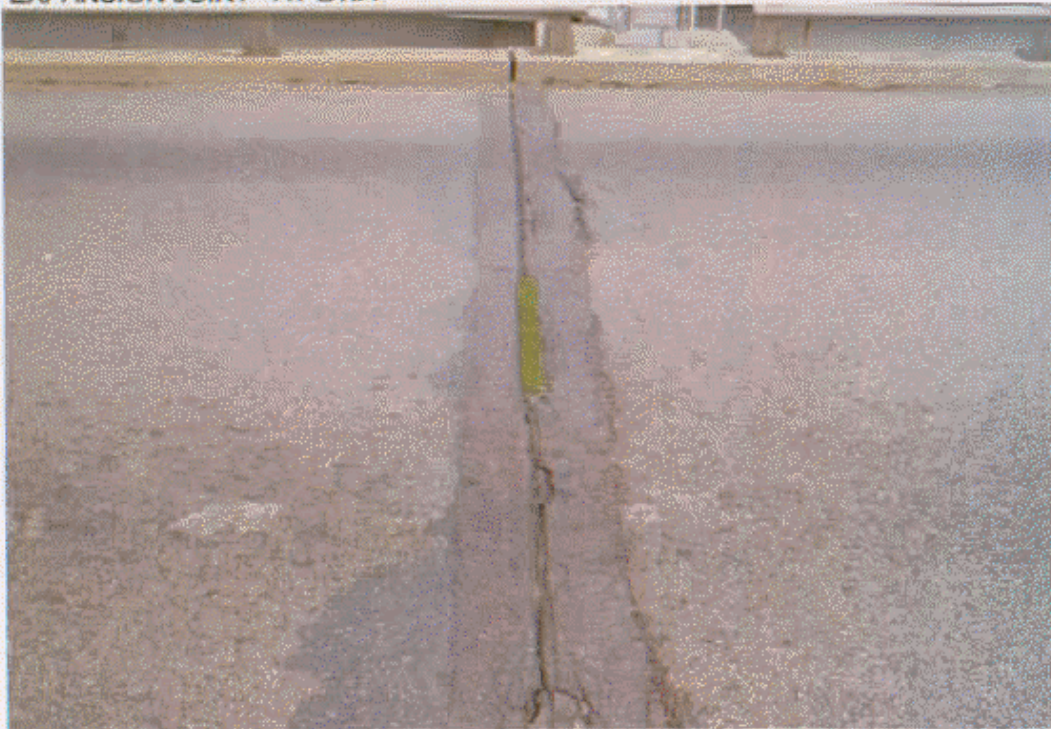
EXPANSION JOINT #3 AT BT#5

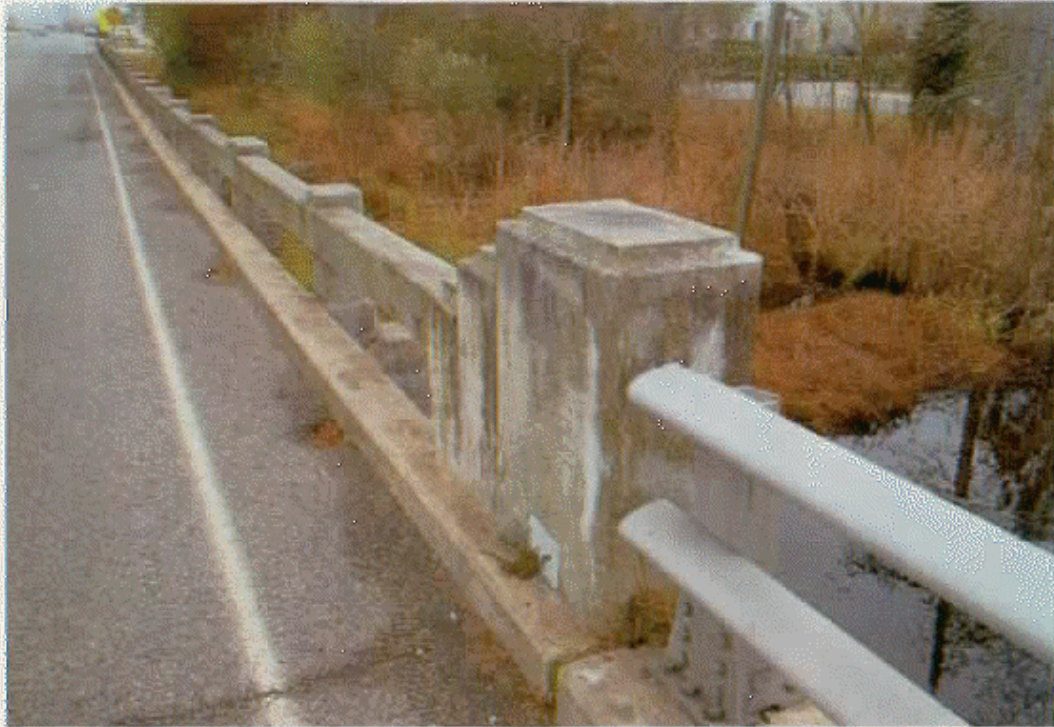
STEEL RAIL STOPS AND RC RAIL STARTS AT BENT#11

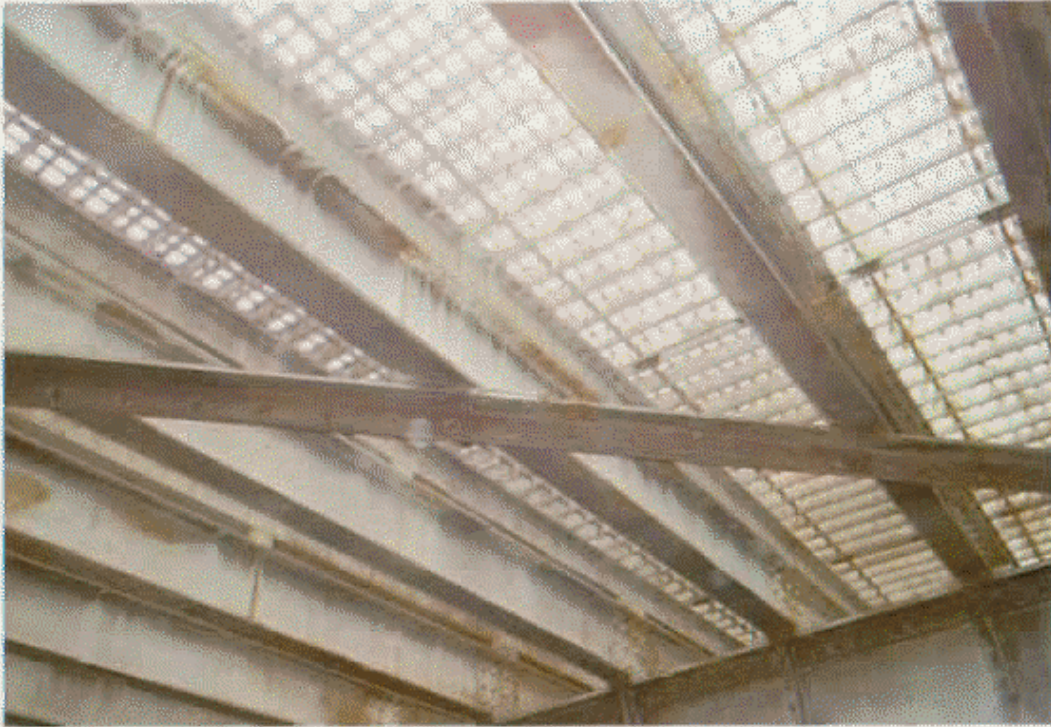
BOTTOM OF STEEL GRID

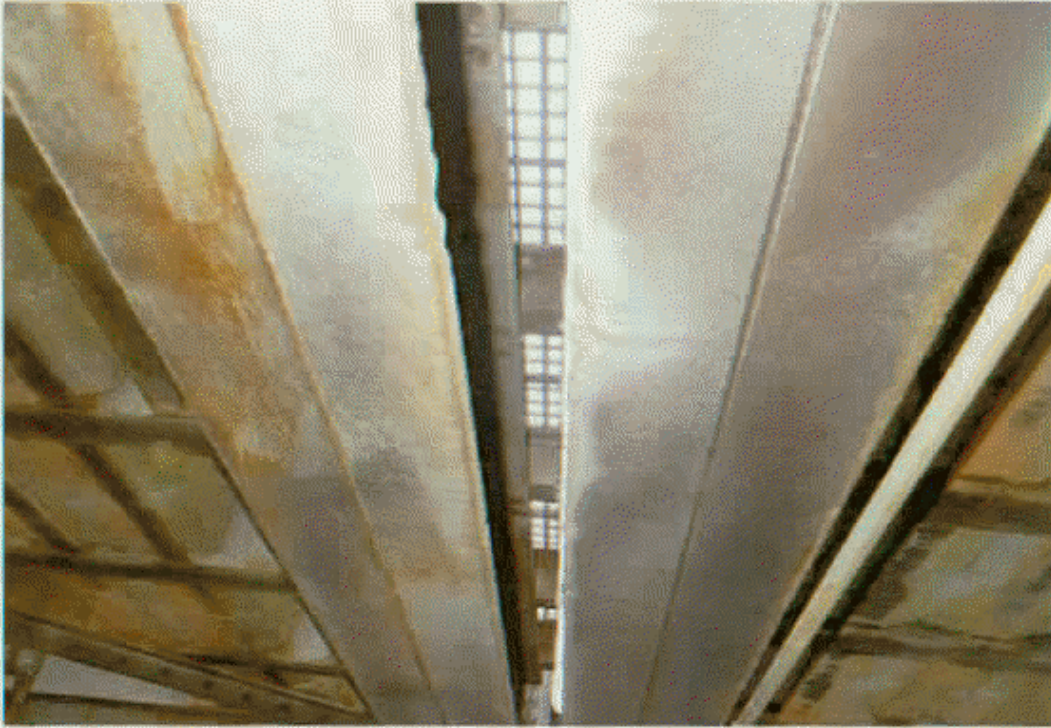
CENTER JOINT BETWEEN EAST AND WEST LIFT

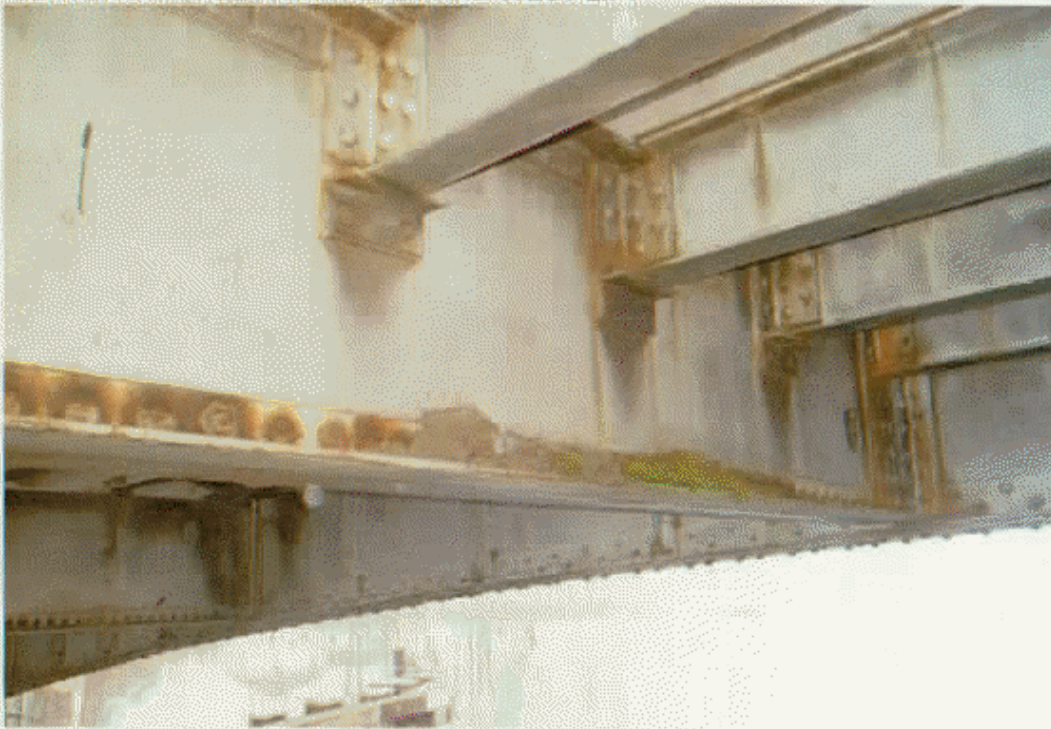
EXCESS DIRT ON BOTTOM FLANGE OF FLOOR BEAMS

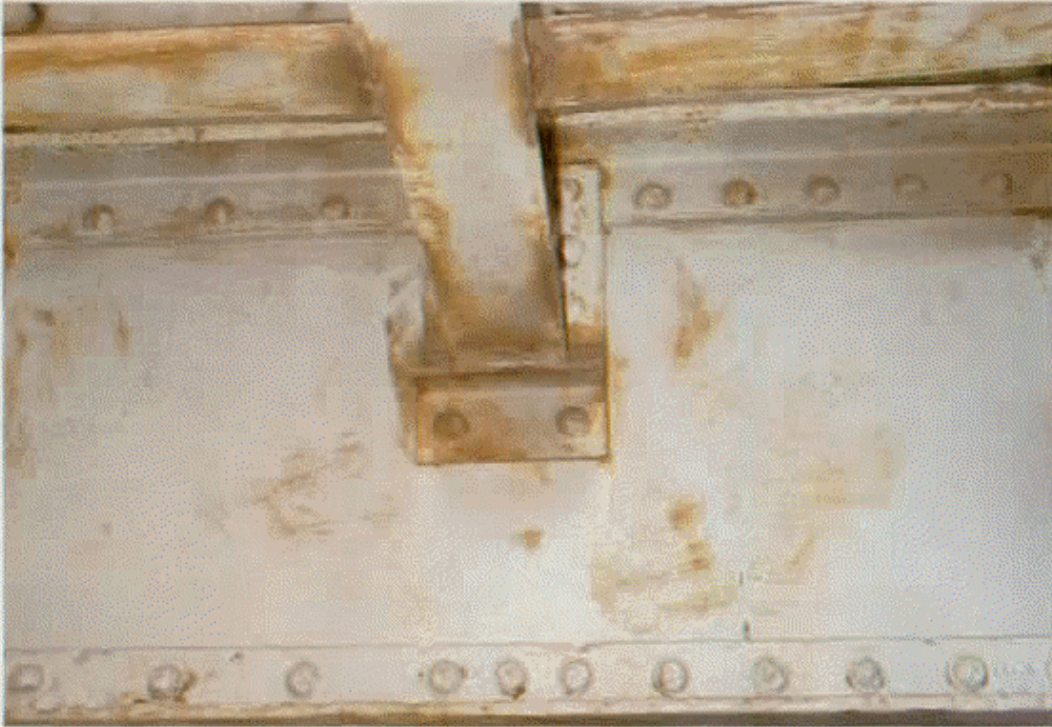
| Item No. | Description |
|---|--|
| 11 | STRINGERS - BASCULE LIFT SPAN - 5 - RUSTY WITH HEAVY SECTION LOSS AT FLOOR BEAM CONNECTIONS. SEE PHOTOS. BEAM #4 HAS HEAVY SECTION LOSS AT WEST END AND HAS TWO HOLES AT CONCRETE . HOLES ARE 2" ROUND 4" FROM TOP FLANG AND ONE HOLE IS 5" FROM BOTTOM FLANGE. PROMPT ACTION ISSUED |

STRINGER ATTACHED TO FLOORBEAM

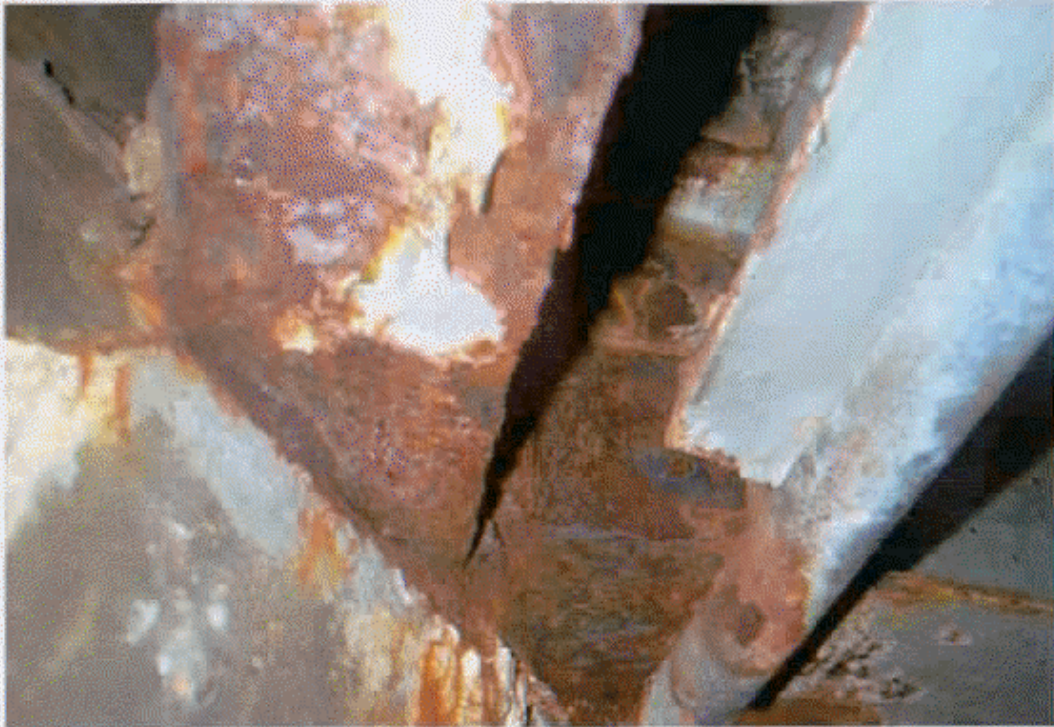
| Item No. | Description |
|---|--|
| 14 | FLOOR BEAMS & CONN. BASCULE LIFT SPAN - 5 RUSTY WITH HEAVY SECTION LOSS AT STRINGER CONNECTIONS AND AREAS NEAR CONCRETE COUNTER WEIGHT SECTION . SEE PHOTO. |

CENTER OF FLOOR BEAM AT BEAM #4 WEST END

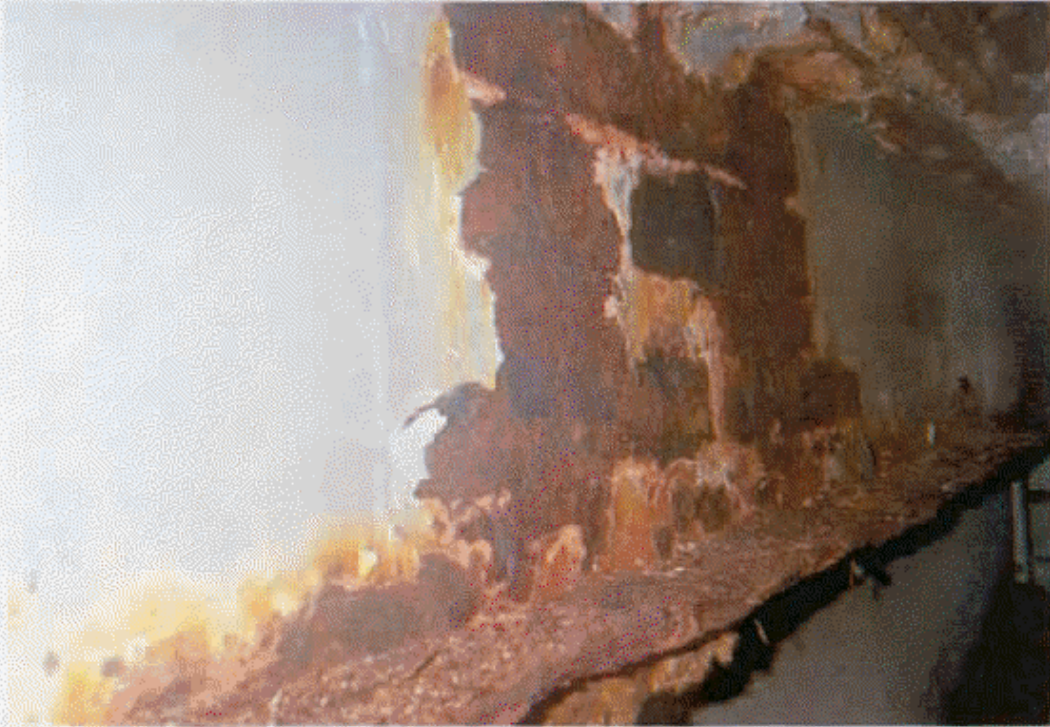
STRINGER #6 AT WEST END HEAVY SECTION LOSS WEBB 3/16" FLANGE 5"

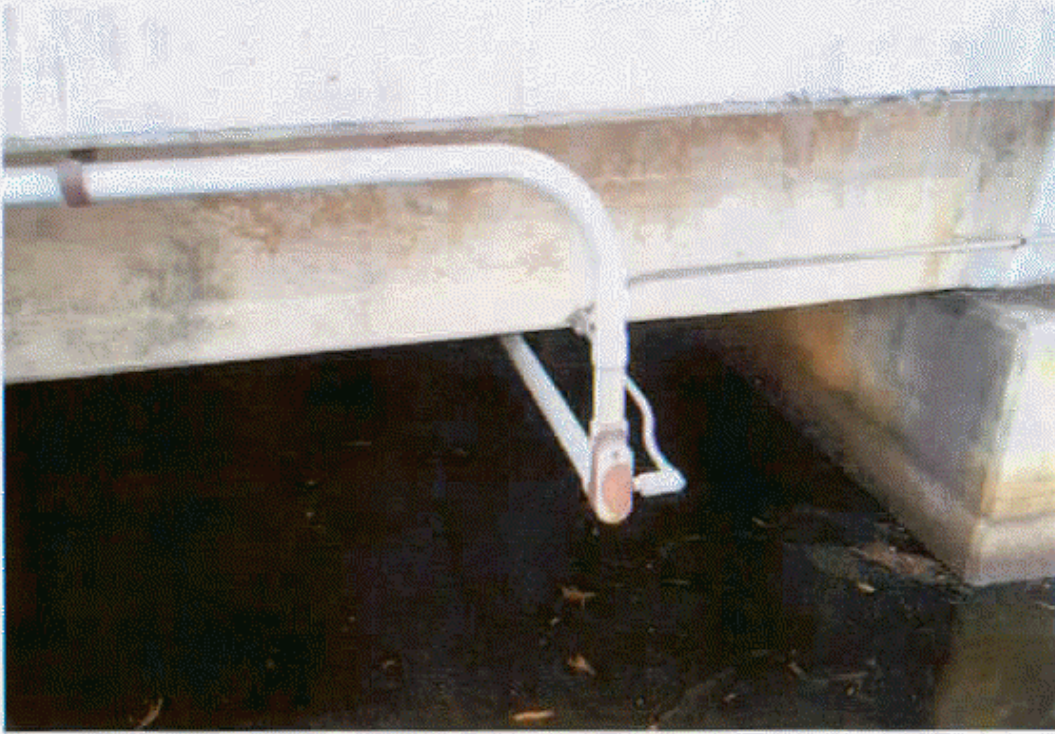
UTILITIES RIGHT SIDE
