AS-BUILT REPAIR QUANTITY TABLE

PROJECT NO. I-5756 HAYWOOD COUNTY 208 BRIDGE NO.

STATE OF NORTH CAROLINA DEPARTMENT OF TRANSPORTATION

BENT 2

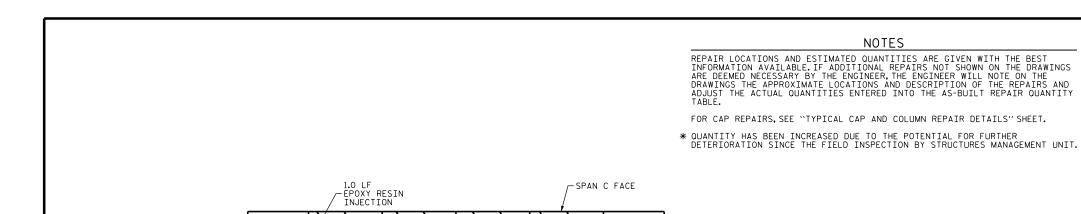
TOP OF CAP

REPAIRS BENT 2	QUANTITIES			
	ESTIMATE		ACTUAL	
SHOTCRETE REPAIRS	AREA SF	VOLUME CF	AREA SF	VOLUME CF
CAP	0.9	0.8 *		
COLUMN	5.0	4.2 *		
	•			
EPOXY RESIN INJECTION		LN. FT		LN. FT
CAP		20.1		
COLUMN		5.0		
EPOXY COATING		SQ. FT		SQ. FT
TOP OF BENT CAP		0

VALUES IN CHARTS REPRESENT ESTIMATED REPAIR TOTALS AFTER REMOVAL OF UNSOUND CONCRETE, MIN. OF 1" BEHIND REBAR AND MIN.1" CLEAR TO SAWCUT.
