PROJECT NO. I-5809 McDOWELL COUNTY 138 BRIDGE NO. SHEET 1 OF 2 -DocuSigned by: STATE OF NORTH CAROLINA SEAL 32492 DEPARTMENT OF TRANSPORTATION . NOINEE? BENT 1 9/27/2016 REVISIONS DATE: BY: DATE: S-8 DOCUMENT NOT CONSIDERED FINAL UNLESS ALL SIGNATURES COMPLETED TOTAL SHEETS 68

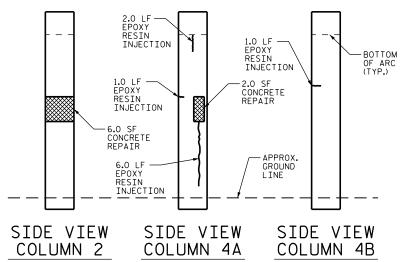
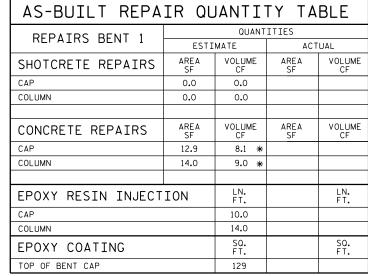
VALUES IN CHART REPRESENT ESTIMATED REPAIR TOTALS AFTER REMOVAL OF UNSOUND CONCRETE, MINIMUM OF 1" BEHIND REBAR AND MINIMUM 2" CLEAR TO SAWCUT. SEE REPAIR DETAILS.

\* QUANTITY HAS BEEN INCREASED DUE TO THE POTENTIAL FOR FURTHER DETERIORATION SINCE THE FIELD INSPECTION BY STRUCTURES MANAGEMENT UNIT.

CLEAN AND REMOVE DEBRIS FROM TOP OF CAP AND APPLY EPOXY PROTECTIVE COATING.EPOXY COATING SHALL BE APPLIED TO THE TOP FACE OF THE CAP. THE CONTRACTOR SHALL NOT COAT THE AREA OF THE CAP BENEATH THE MASONRY PLATES. FOR EPOXY COATING, SEE SPECIAL PROVISIONS.

FOR REPAIR DETAILS, SEE "TYPICAL CAP AND COLUMN REPAIR DETAILS" SHEET.
