PLAN - BOTTOM OF CAP

AS-BUILT REPAIR QUANTITY TABLE				
REPAIRS BENT 1	QUANTITIES			
REPAIRS BENT I	ESTIMATE		ACTUAL	
SHOTCRETE REPAIRS	AREA SF	VOLUME CF	AREA SF	VOLUME CF
CAP	0.0	0.0		
COLUMN	0.0	0.0		
CONCRETE REPAIRS	AREA SF	VOLUME CF	AREA SF	VOLUME CF
CAP	15.7	9.8 *		
COLUMN	0.0	0.0		
EPOXY RESIN INJECTION		LN. FT		LN. FT
CAP		2.0		
COLUMN		0.0		
EPOXY COATING		SQ. FT		SQ. FT
TOP OF BENT CAP		192

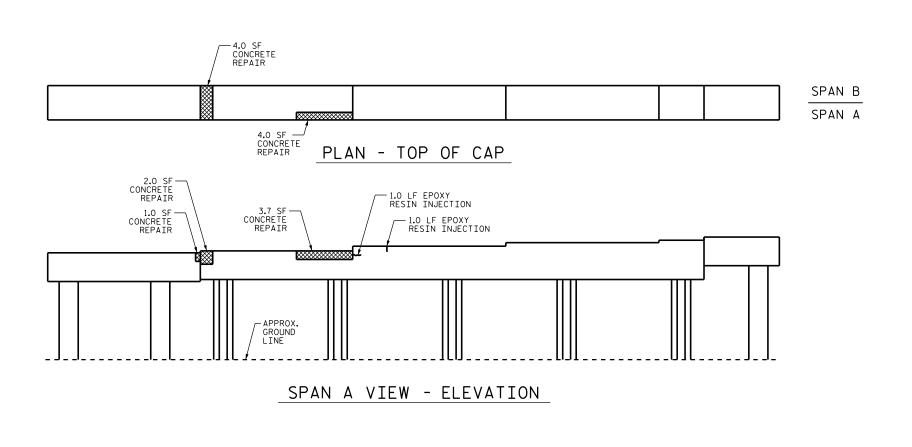
DAMAGED AREA

CLEAN AND REMOVE DEBRIS FROM TOP OF CAP AND APPLY EPOXY PROTECTIVE COATING.EPOXY COATING SHALL BE APPLIED TO THE TOP FACE OF THE CAP. THE CONTRACTOR SHALL NOT COAT THE AREA OF THE CAP BENEATH THE MASONRY PLATES. FOR EPOXY COATING.SEE SPECIAL PROVISIONS.

EPOXY RESIN INJECTION
