NC DEPARTMENT OF TRANSPORTATION
 DIVISION OF HIGHWAYS
 STRUCTURE MANAGEMENT UNIT

Structure Safety Report

Fracture Critical and Machinery Element Inspection

COUNTY: NEW HANOVER STRUCTURE NUMBER: 640013 FREQUENCY: 24 MONTHS

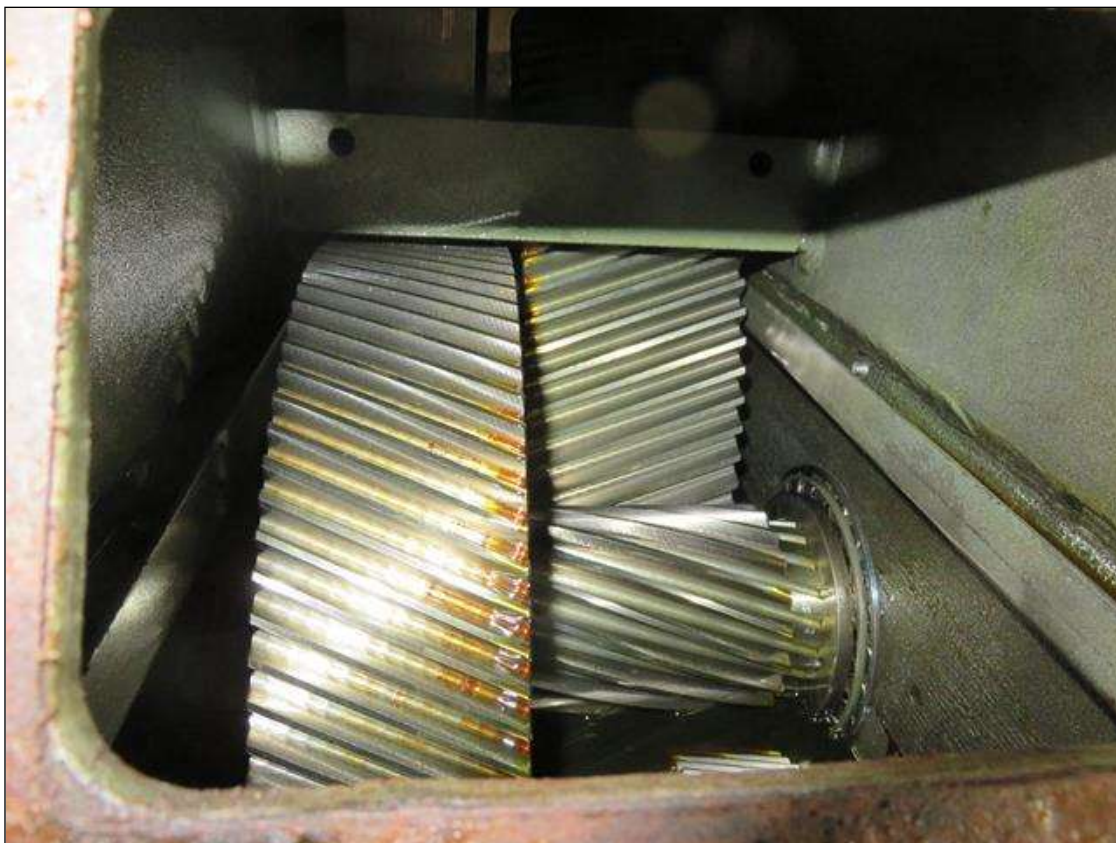
WEST END SPEED REDUCER GEARS GOOD ,FLUID LEVELS GOOD (FLUID SAMPLE TAKEN)

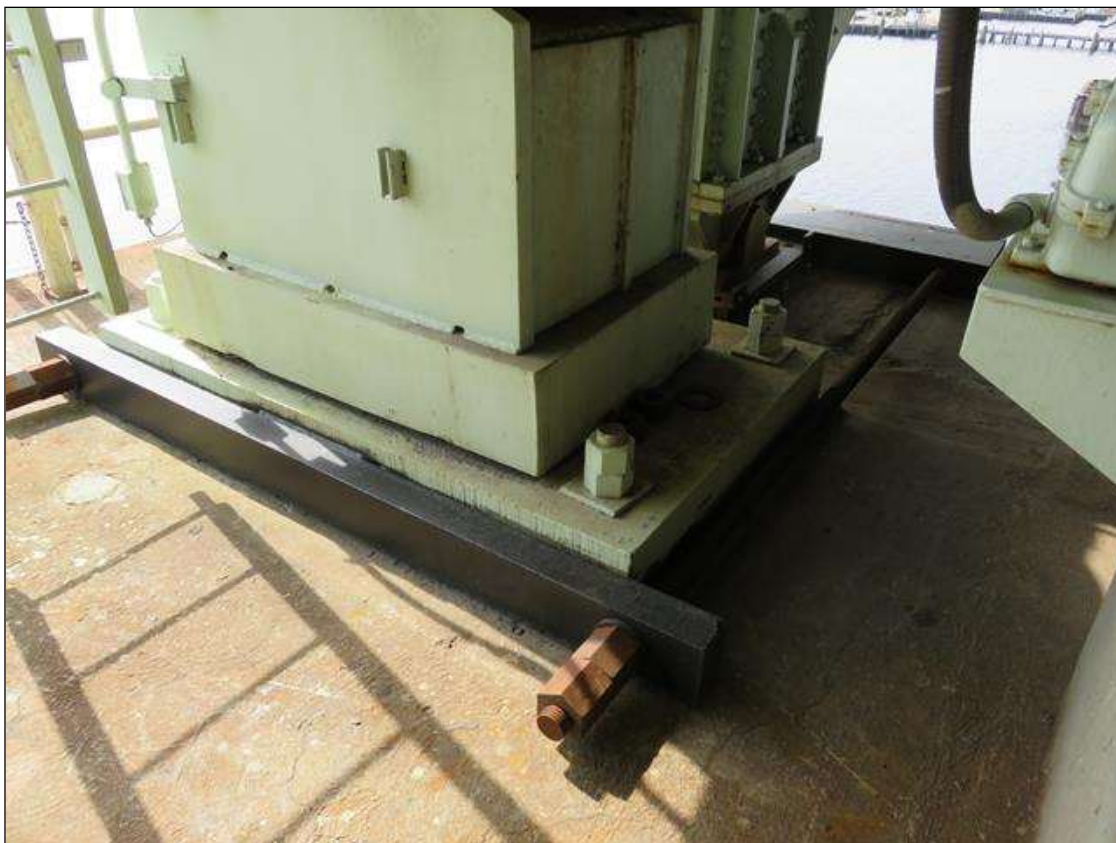
NEW SUPPORT TO SOUTH EAST FIXED BEARING HAS BEEN ADDED (NORTHEAST SIDE SAME) NOTE: STILL HAS VERTICAL MOVEMENT UNDER LIVELOAD.

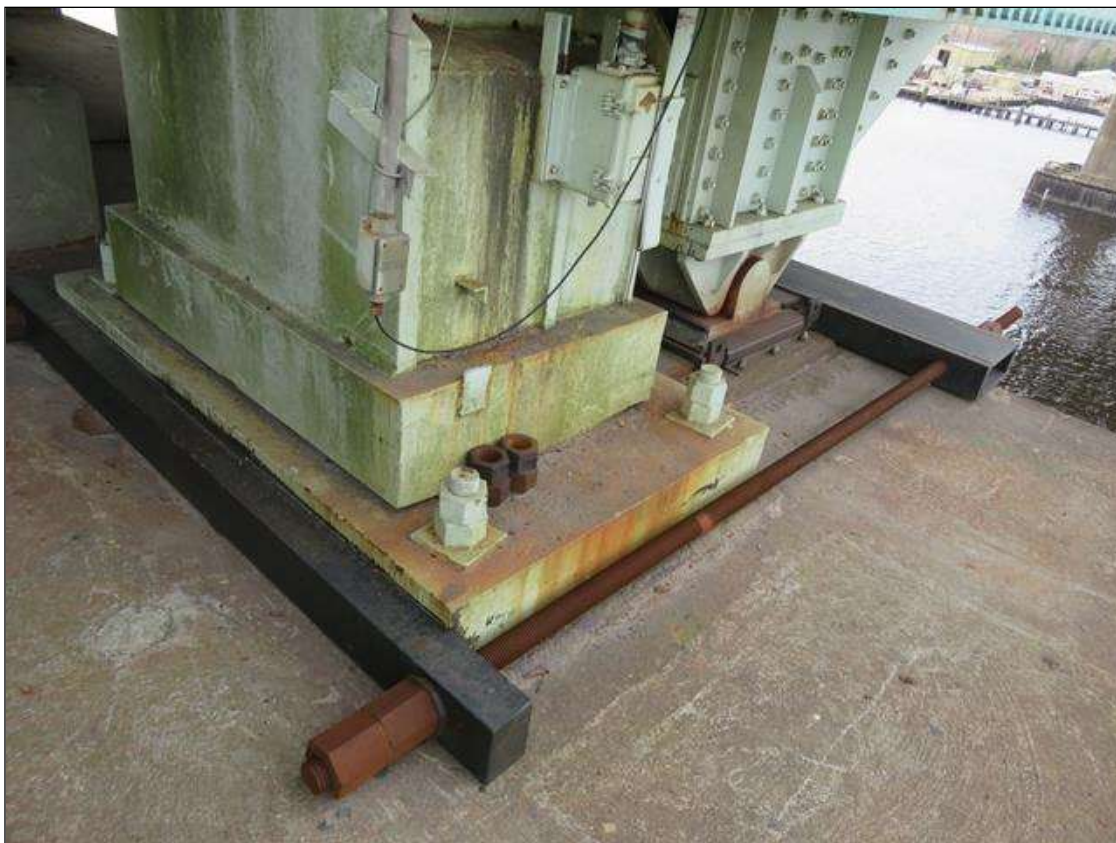
NEW SUPPORT TO NORTH EAST FIXED BEARING HAS BEEN ADDED. (NOTE: STILL HAS VERTICAL MOVEMENT UNDER LIVELOADS)

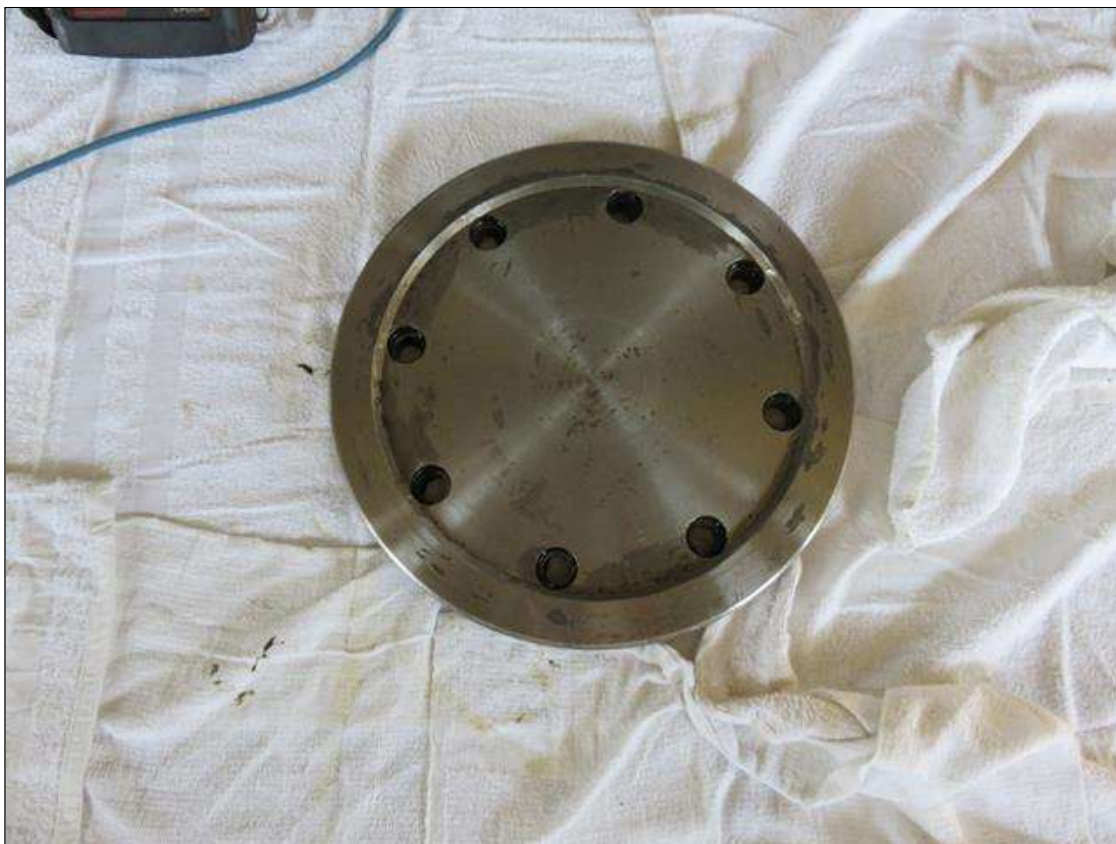
NORTH EAST ROOM OUTSIDE (SOUTH INNER PLATE GOOD NO PROBLEMS FOUND)

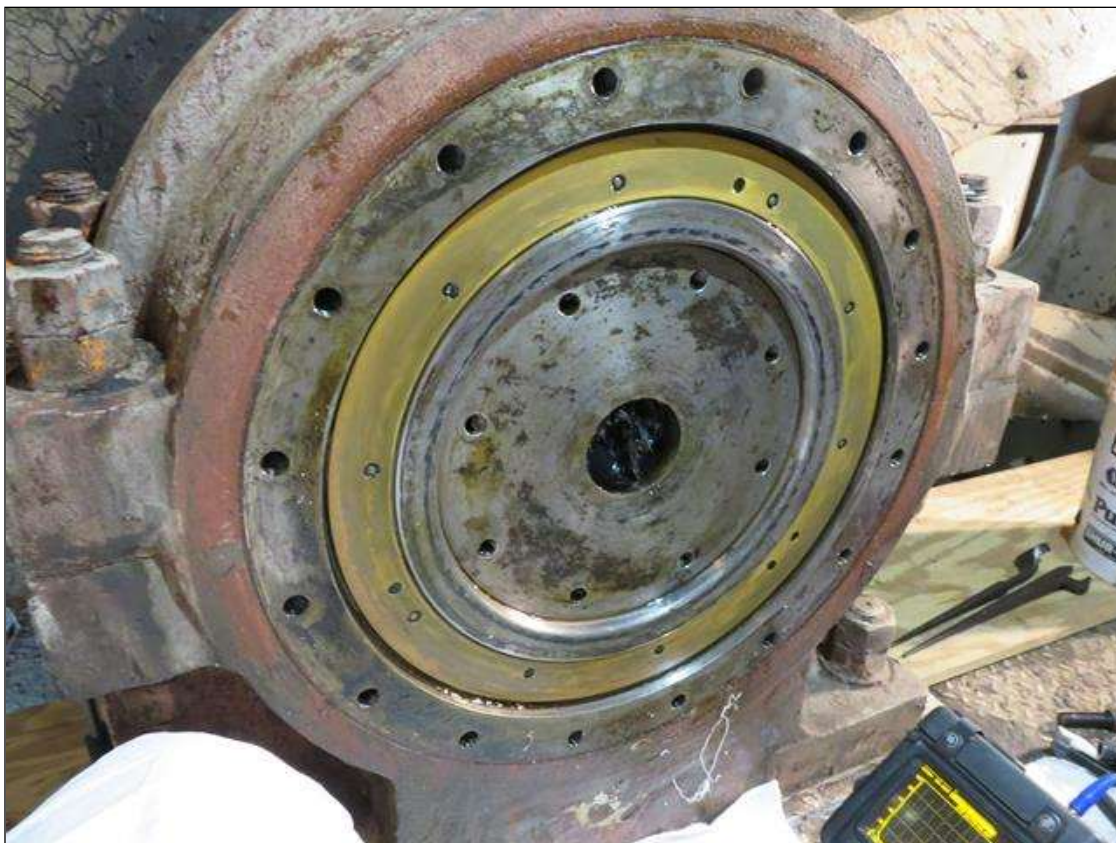
NORTH EAST ROOM SOUTH OUTSIDE TRUNNION WITH INNER PLATE REMOVED FOR TESTING.

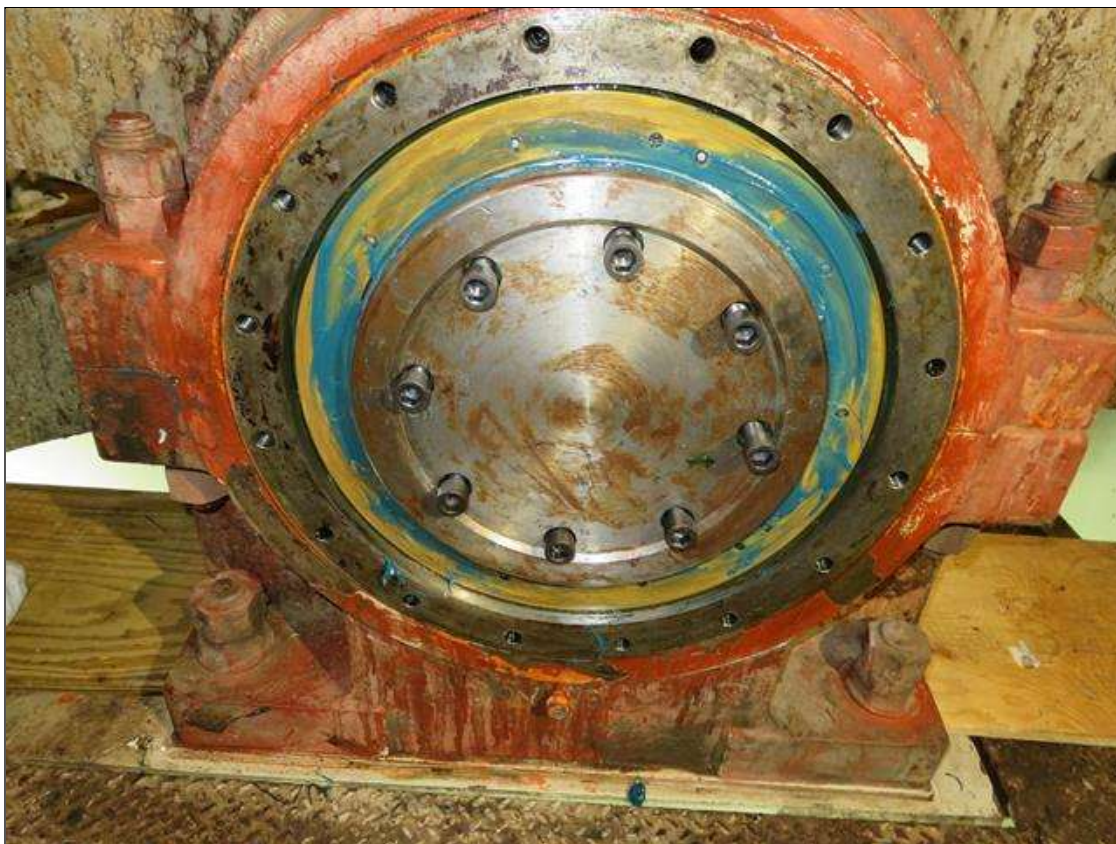
SOUTH EAST ROOM, SOUTH OUTSIDE TRUNNION BEING REASSEMBLED AND LUBED AFTER BEING TESTED WITH ULTRA SONICS MACHINE.

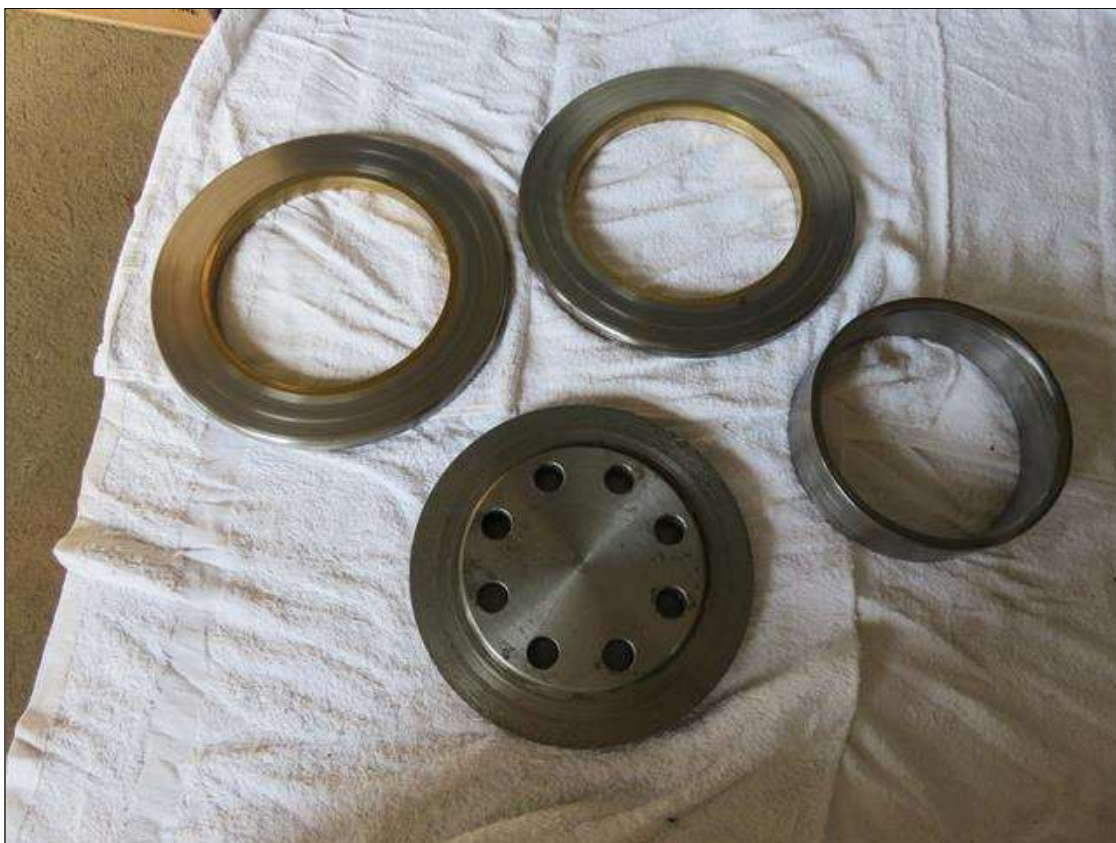
SOUTH EAST ROOM, INNER SOUTH SIDE CAP, RACE BUSHING, BRONZE BUSHINGS (NO PROBLEMS FOUND)

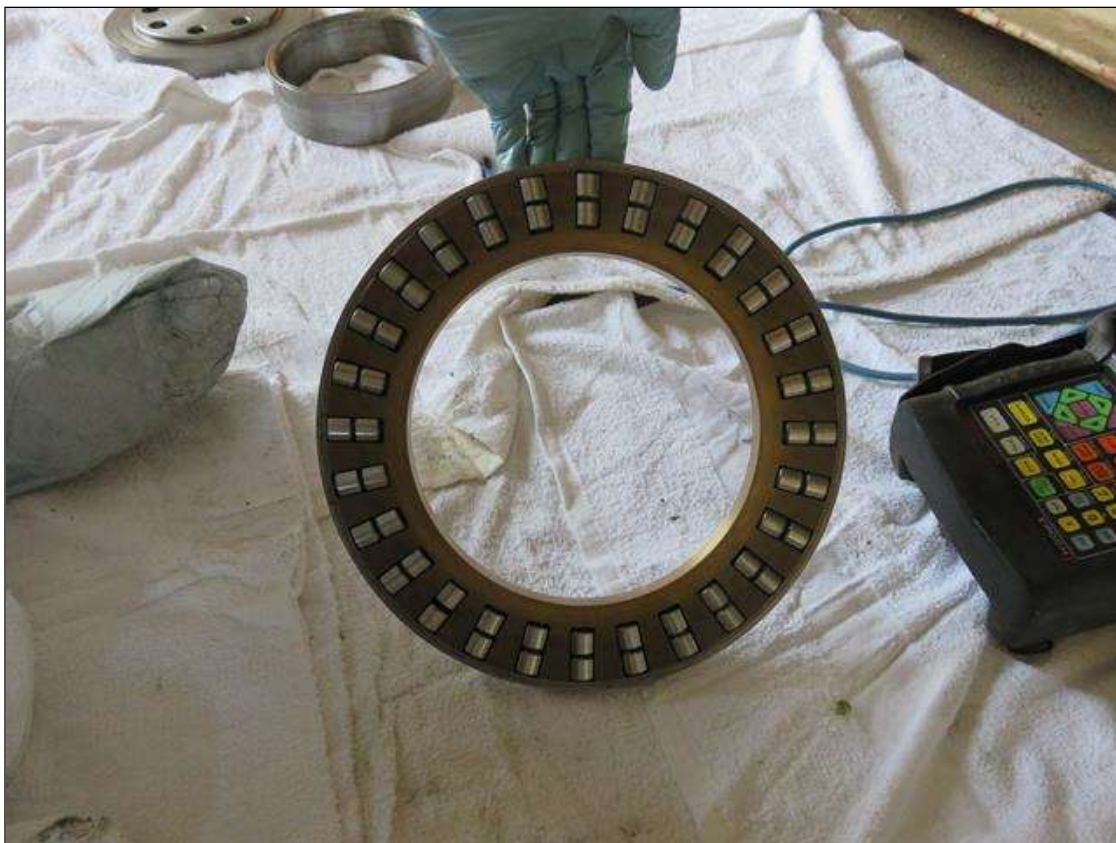
SOUTH EAST ROOM INNER SOUTH SIDE BEARING RACE (GOOD)

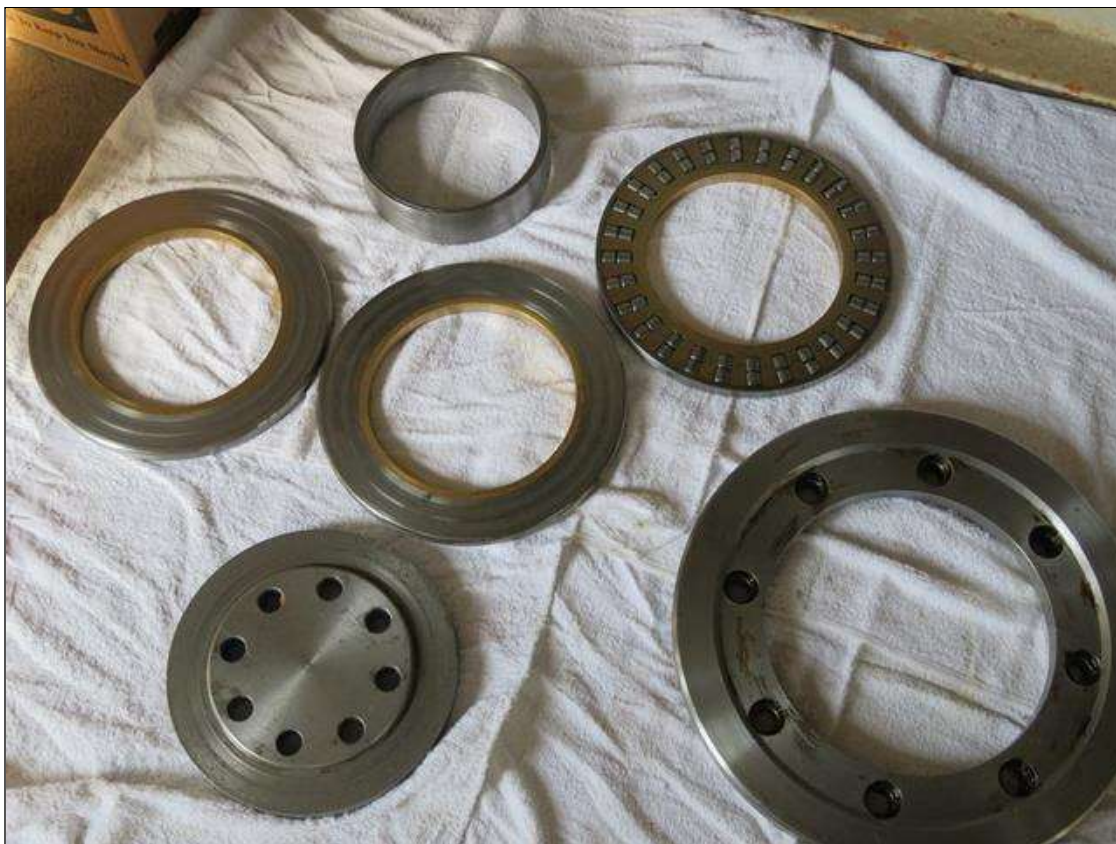
SOUTH EAST ROOM INNER SOUTH SIDE TRUNNION PARTS.

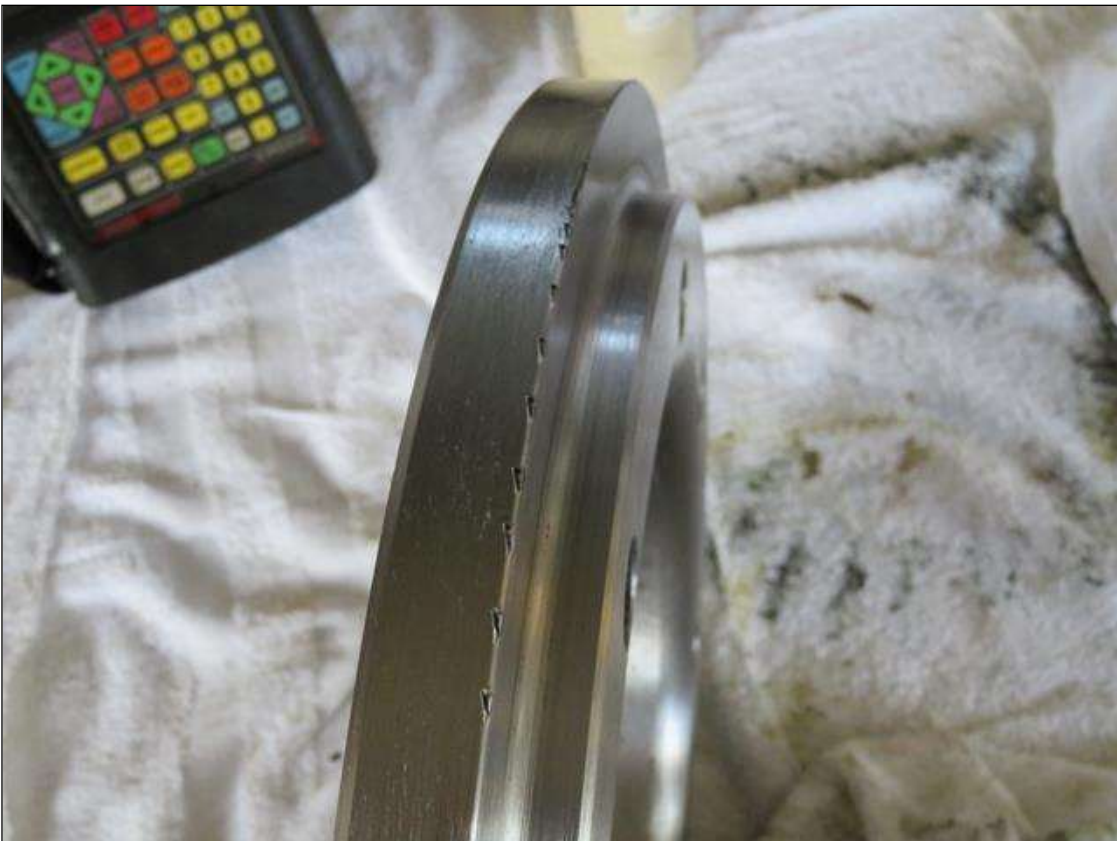
NORTH EAST ROOM SOUTH SIDE INNER PLATE HAS A SERIES OF 1/16" KNICKS ALONG EDGE FOR A LENGTH OF 9"

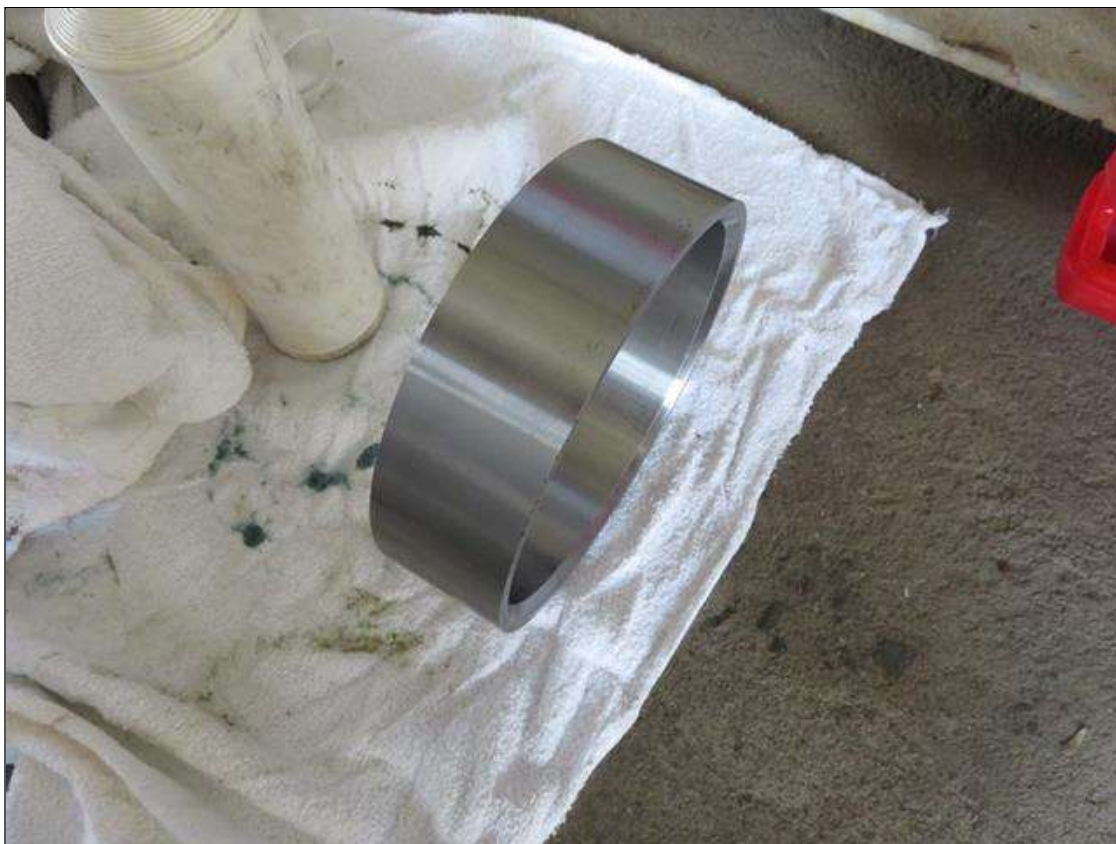
NORTH EAST ROOM INNER SOUTH SIDE TRUNNION REPLACEMENT RACE BUSHING (NEW)

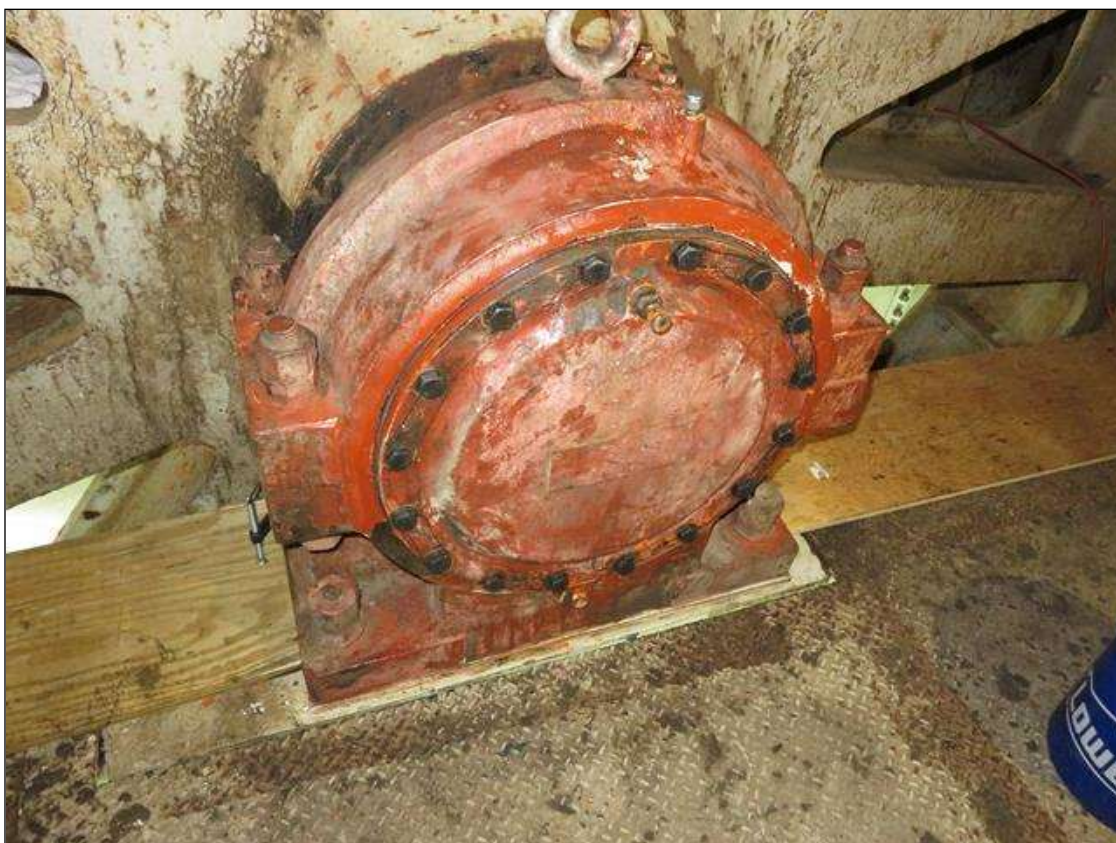
SOUTH EAST ROOM SOUTH SIDE OUTSIDE TRUNNION REASSEMBLED AFTER TEAR DOWN AND UT INSPECTION.

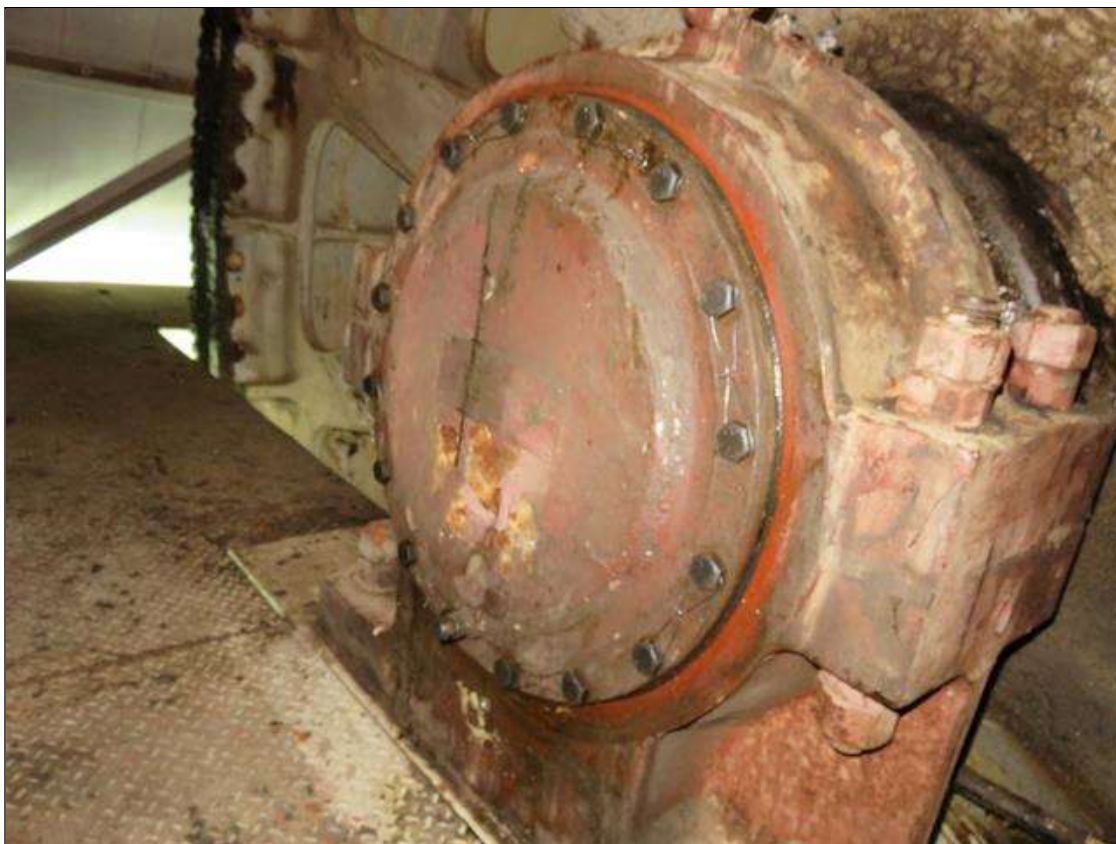
NORTH EAST ROOM SOUTH SIDE OUTSIDE TRUNNION REASSEMBLED AFTER TEAR DOWN AND UT INSPECTION.

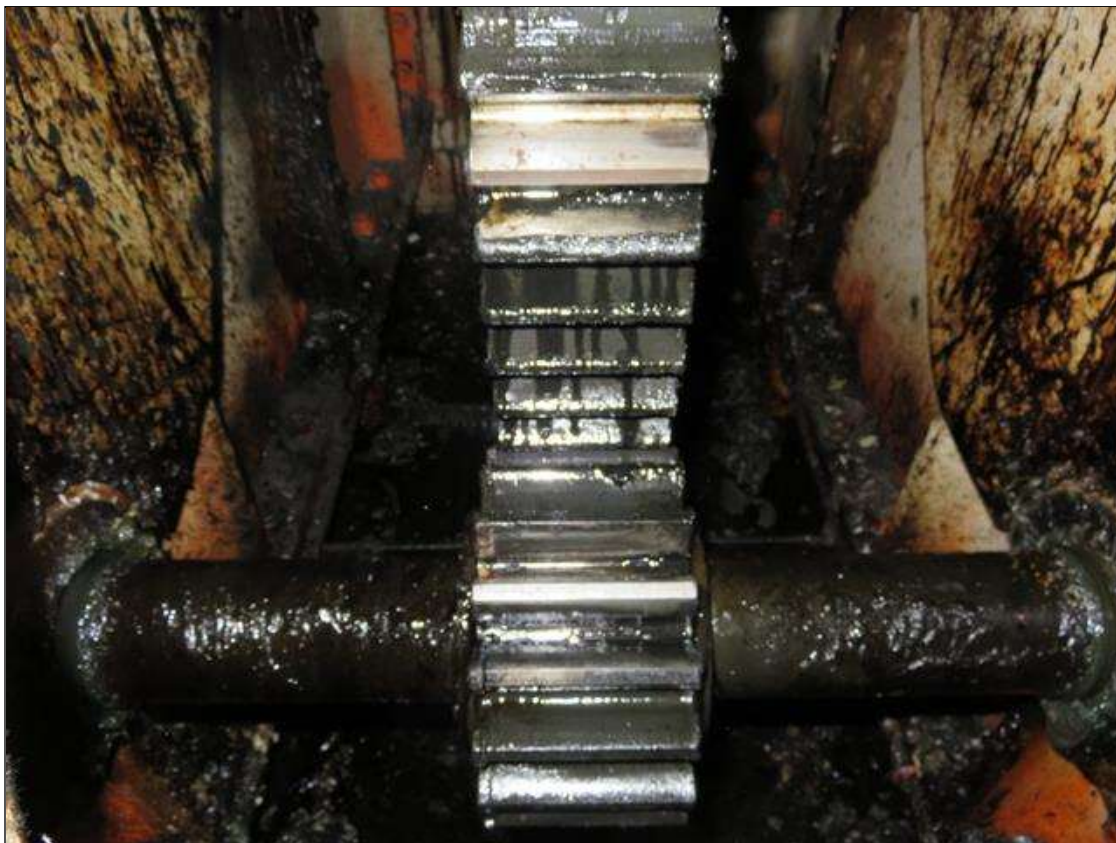
GEARS #279 & 358 OPERATING MACHINERY EAST TOWER (GOOD CONDITION)

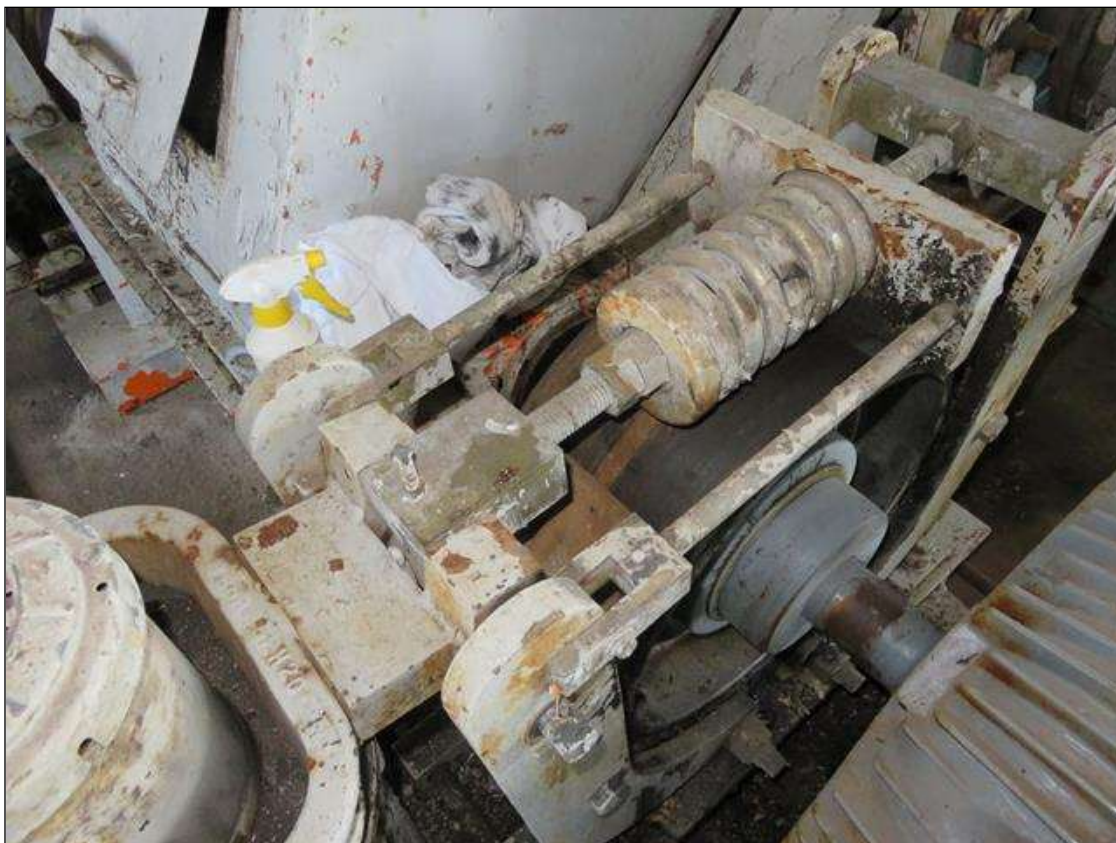
BRAKE #2 EAST OPERATING MACHINERY DRUM AND PADS GOOD. (FLUID LEVEL GOOD BUT DIRTY)

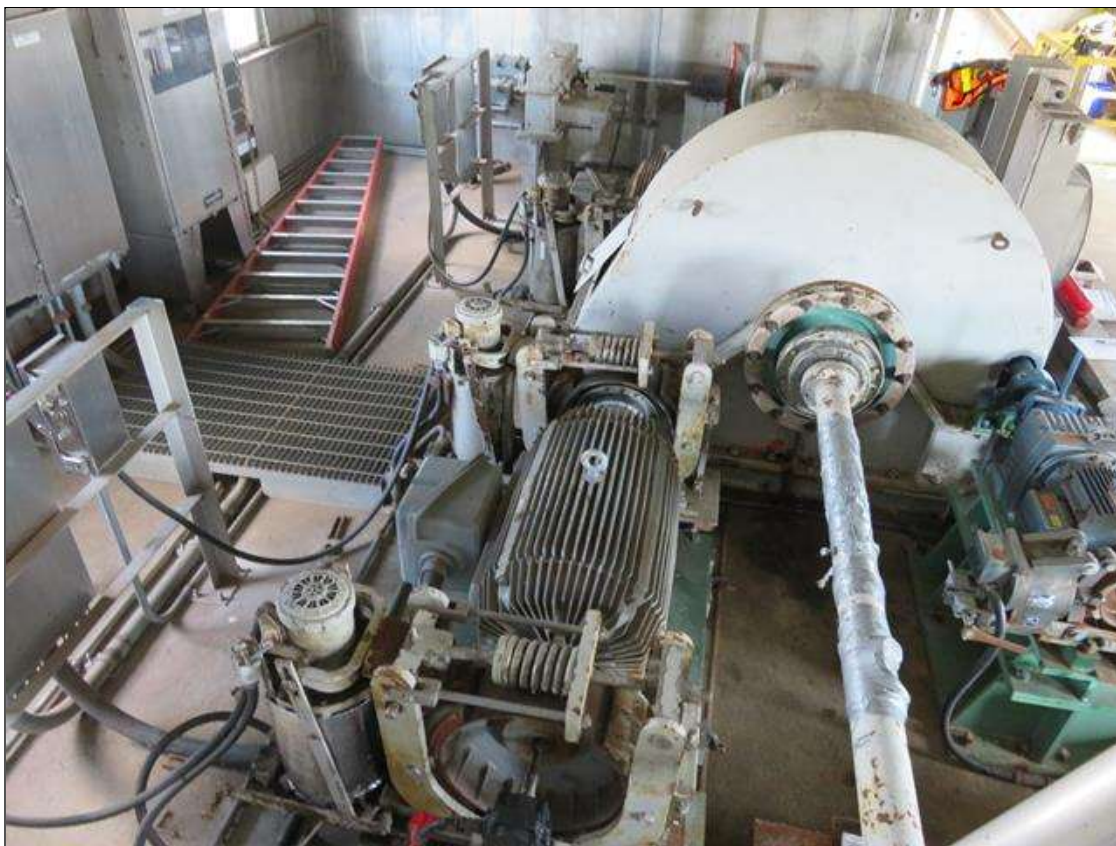
EAST TOWER OPERATING MACHINERY .

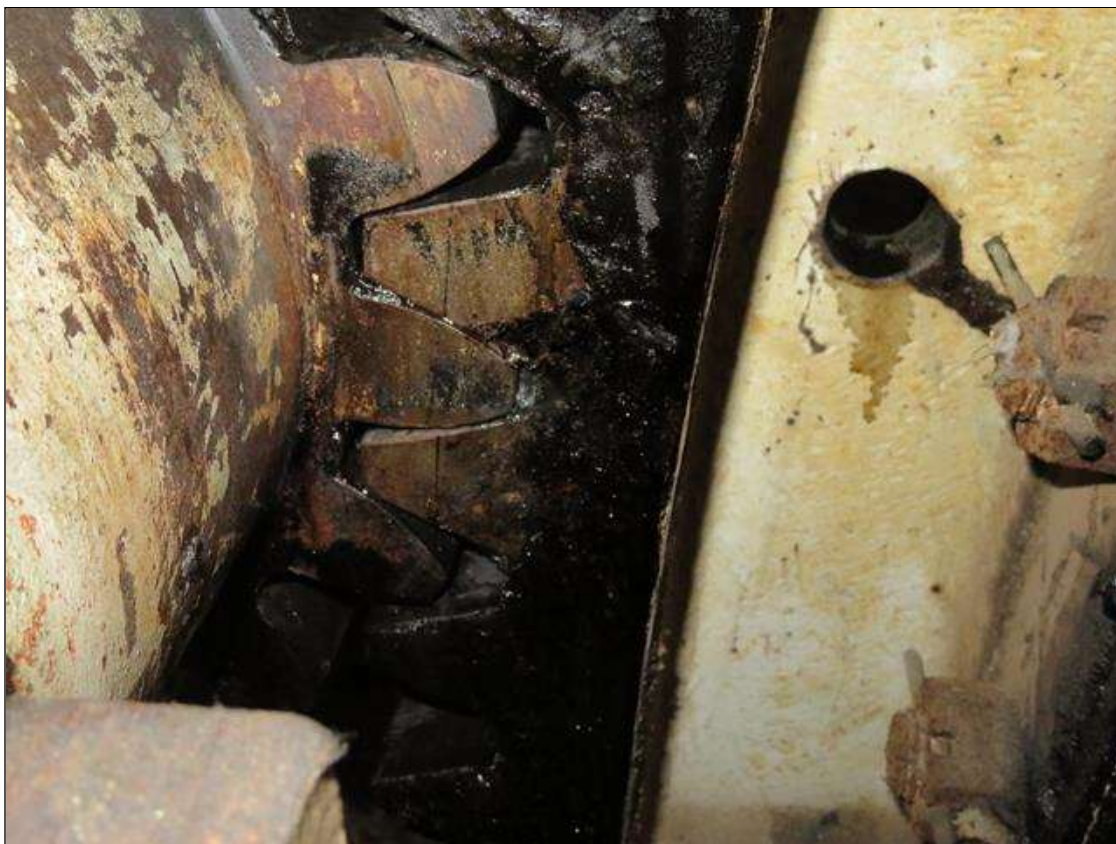
BACKLASH OF .072 WAS MEASURED FOR #277 & 271-1 GEARS IN SOUTH EAST ROOM.

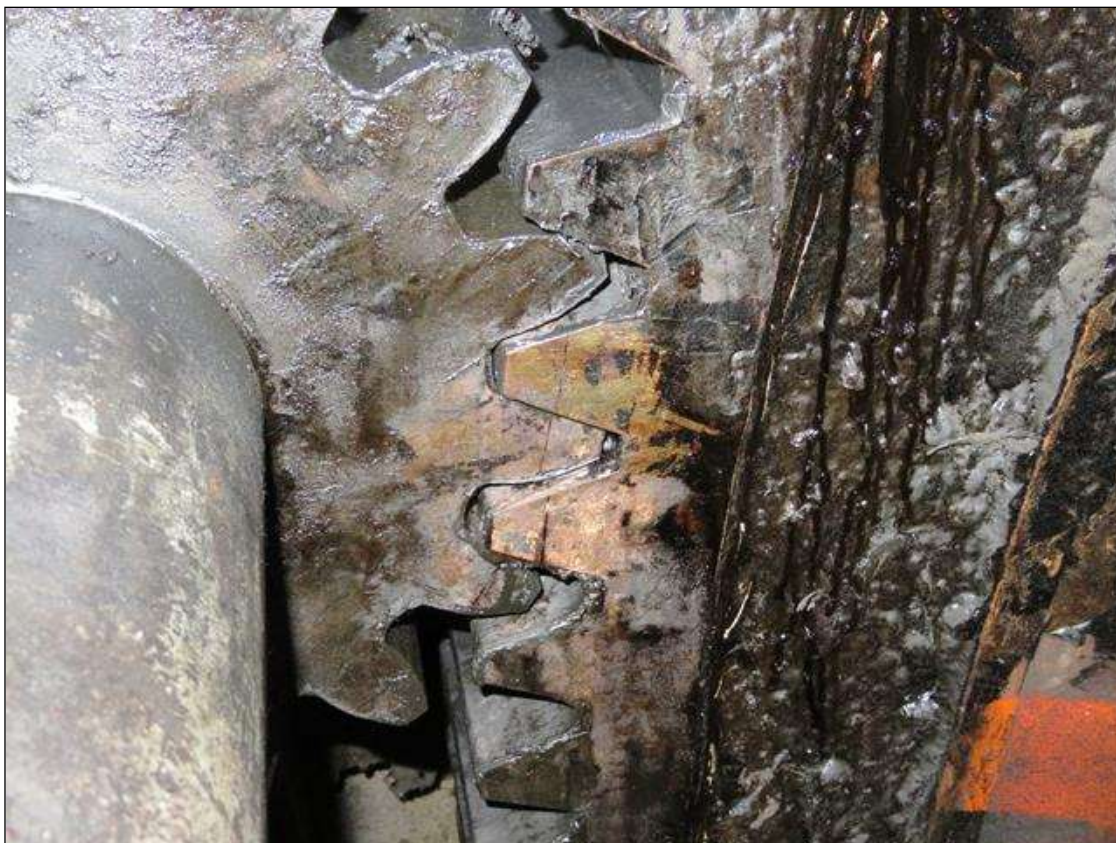
BACKLASH OF .084 WAS MEASURED FOR #276 & 271-2 GEARS IN SOUTH EAST ROOM.

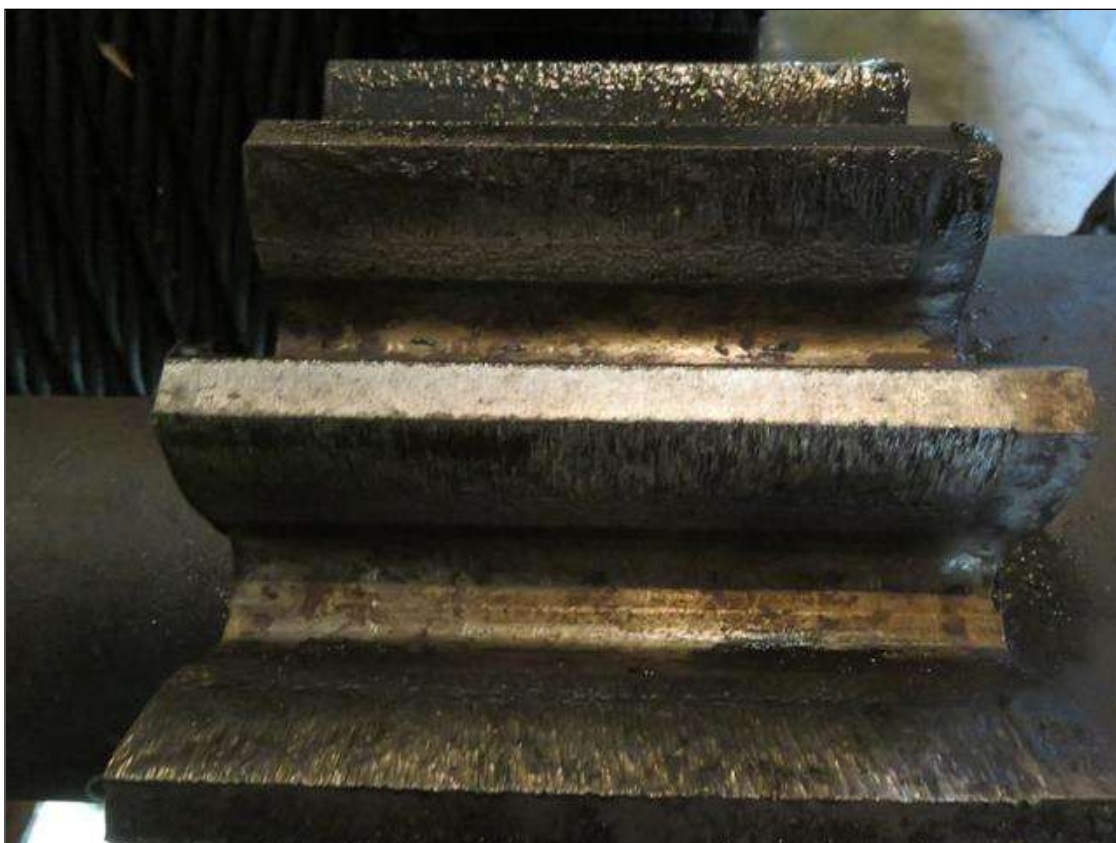
NORTH EAST ROOM GEAR 276 HAS 1/32" GROOVES ON OPEN AND CLOSING SIDE OF TEETH.

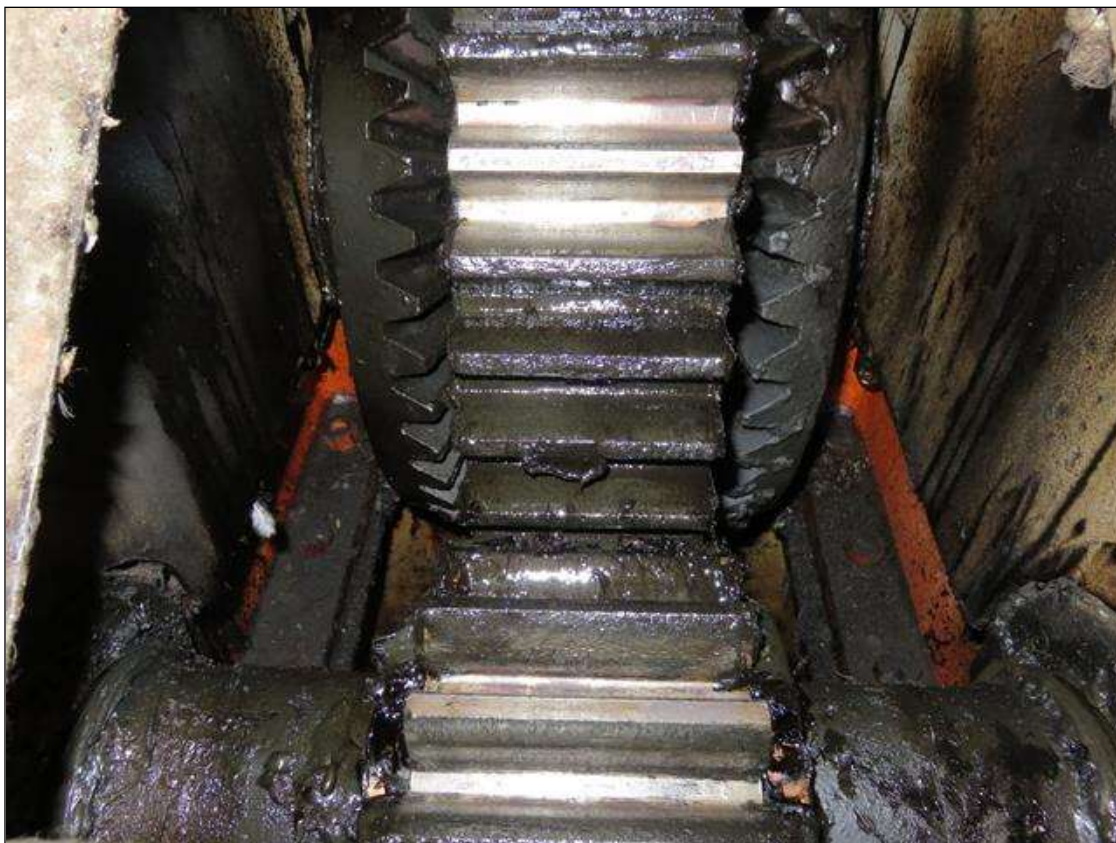
GEARS 278 & 357 IN NORTH EAST ROOM.

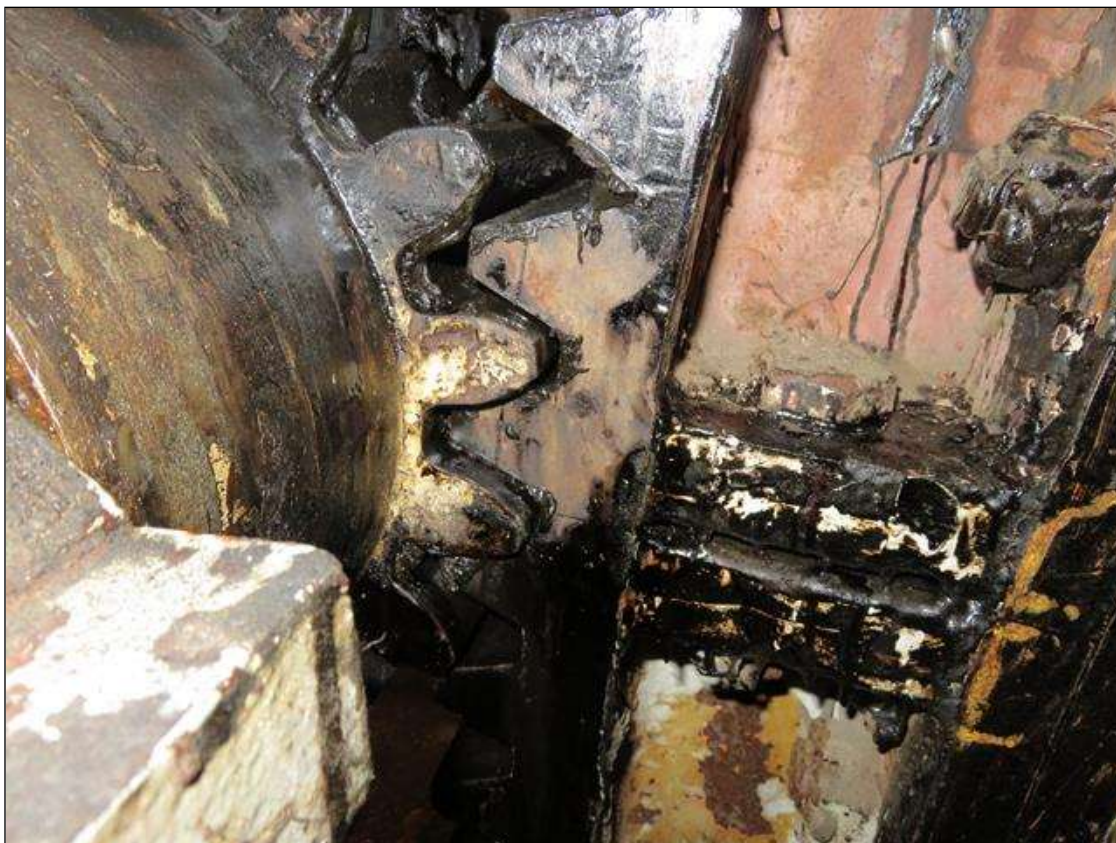
BACKLASH OF .099 WAS MEASURED FOR #271-2 & 278 GEARS IN NORTH EAST ROOM.

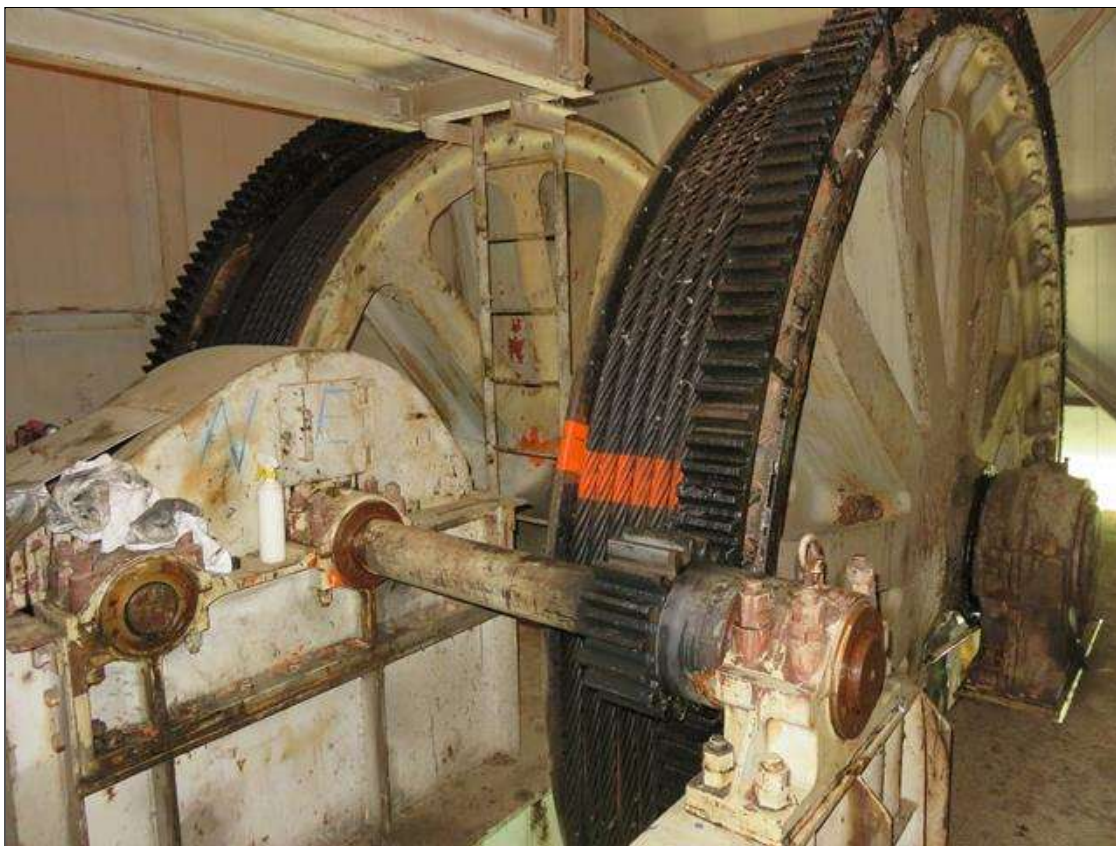
OPERATING MACHINERY NORTH EAST ROOM.

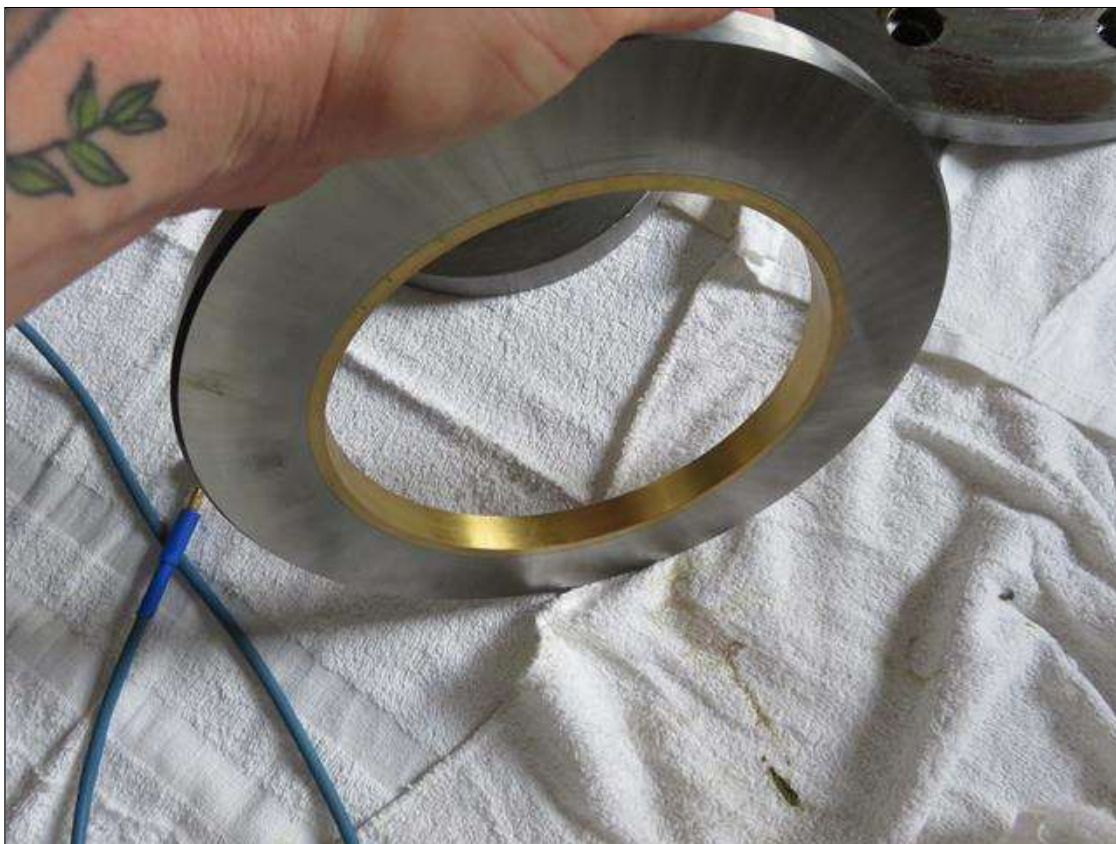
NEW BRONZE REPLACEMENT BUSHING FOR SOUTH WEST ROOM INNER SOUTH TRUNNION.

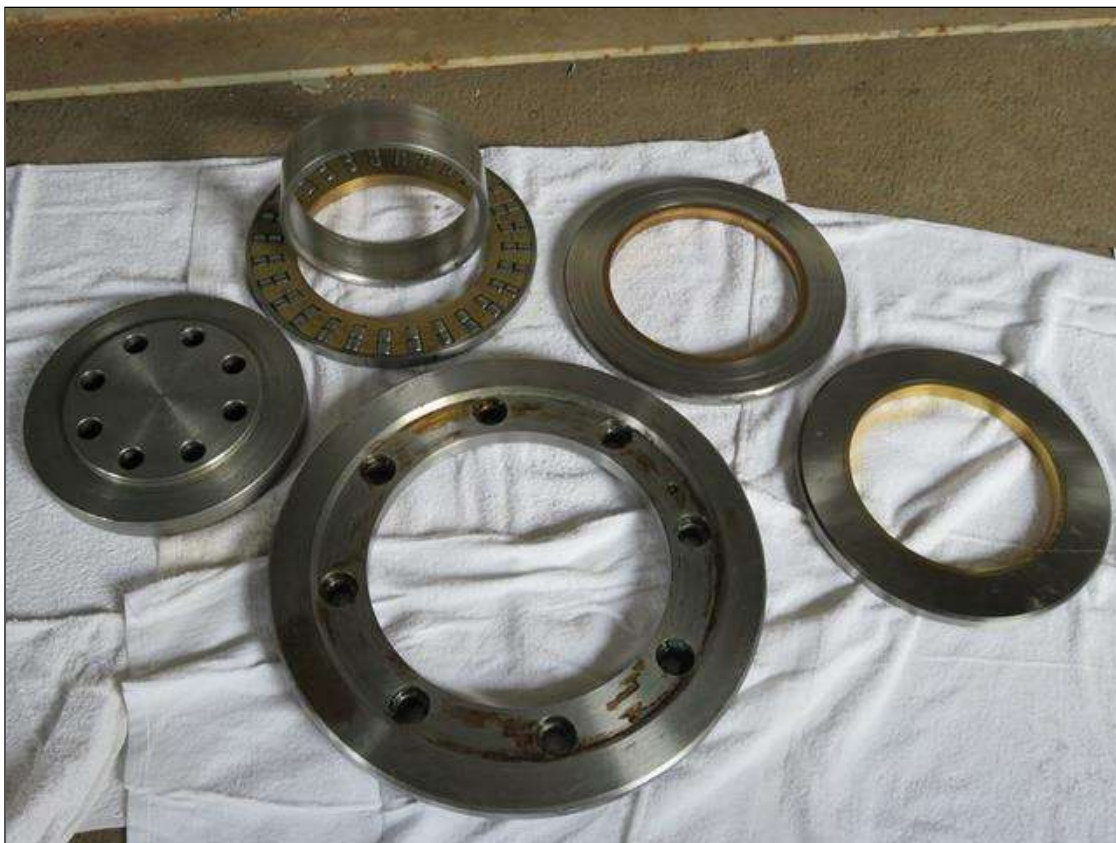
SOUTH WEST ROOM INNER TRUNNION PARTS. (GOOD)
