NC DEPARTMENT OF TRANSPORTATION
 DIVISION OF HIGHWAYS
 STRUCTURE MANAGEMENT UNIT

Structure Safety Report

Fracture Critical and Machinery Element Inspection

COUNTY: NEW HANOVER STRUCTURE NUMBER: 640013 FREQUENCY: 24 MONTHS

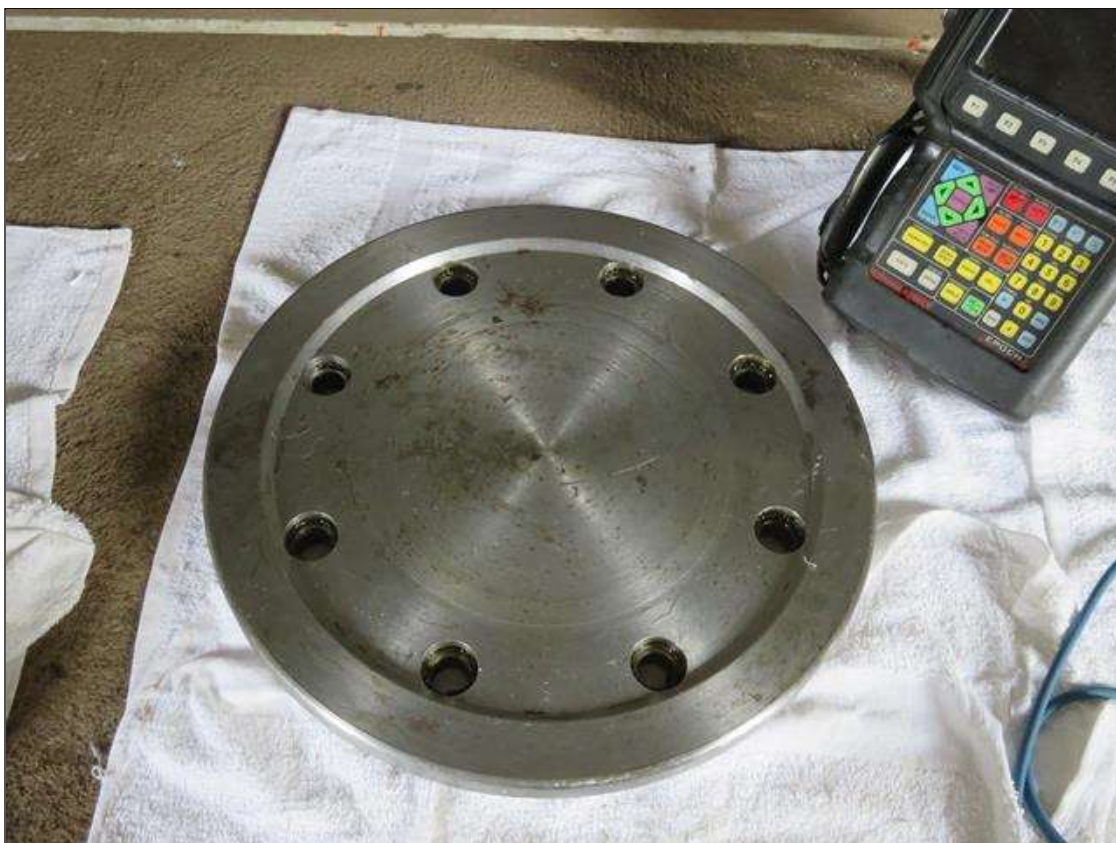
SOUTH WEST ROOM OUTSIDE SOUTH TRUNNION INNER PLATE. (GOOD NO PROBLEMS FOUND)

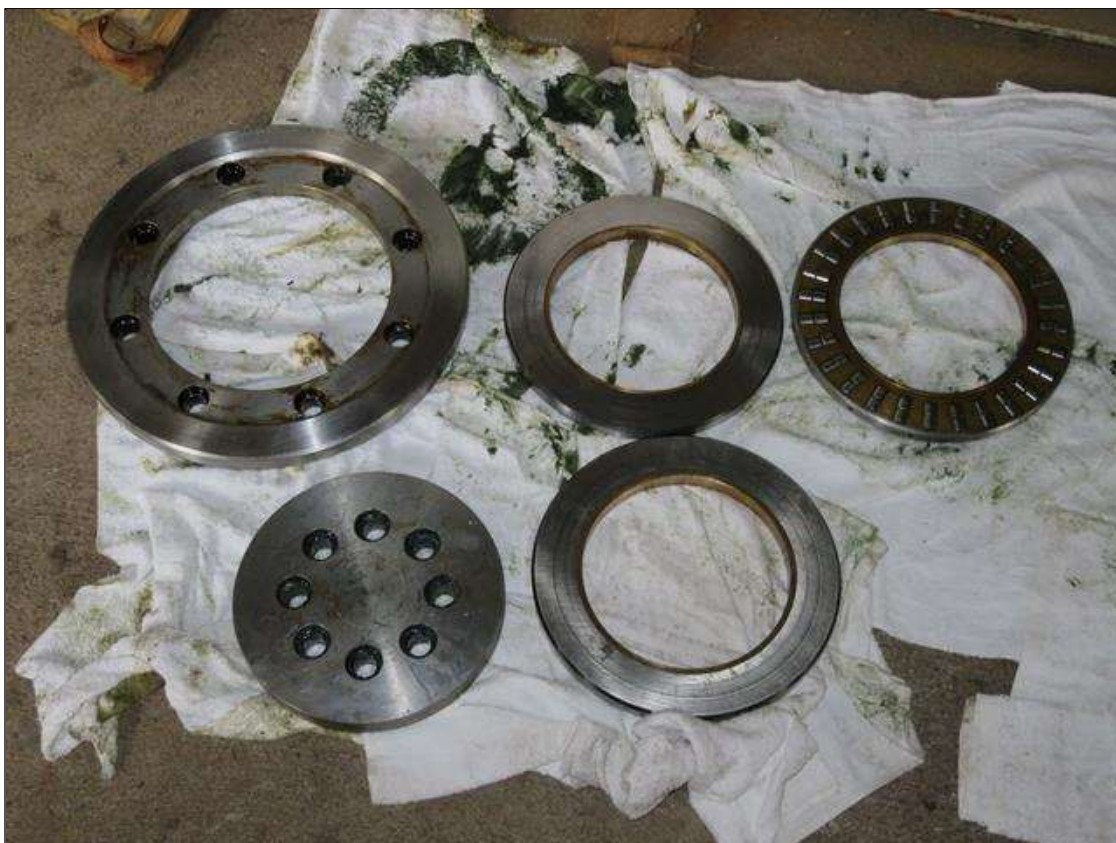
NORTH WEST ROOM INNER SOUTH TRUNNION PARTS AFTER BEING TESTED WITH ULTRA SONICS
MACHINE.

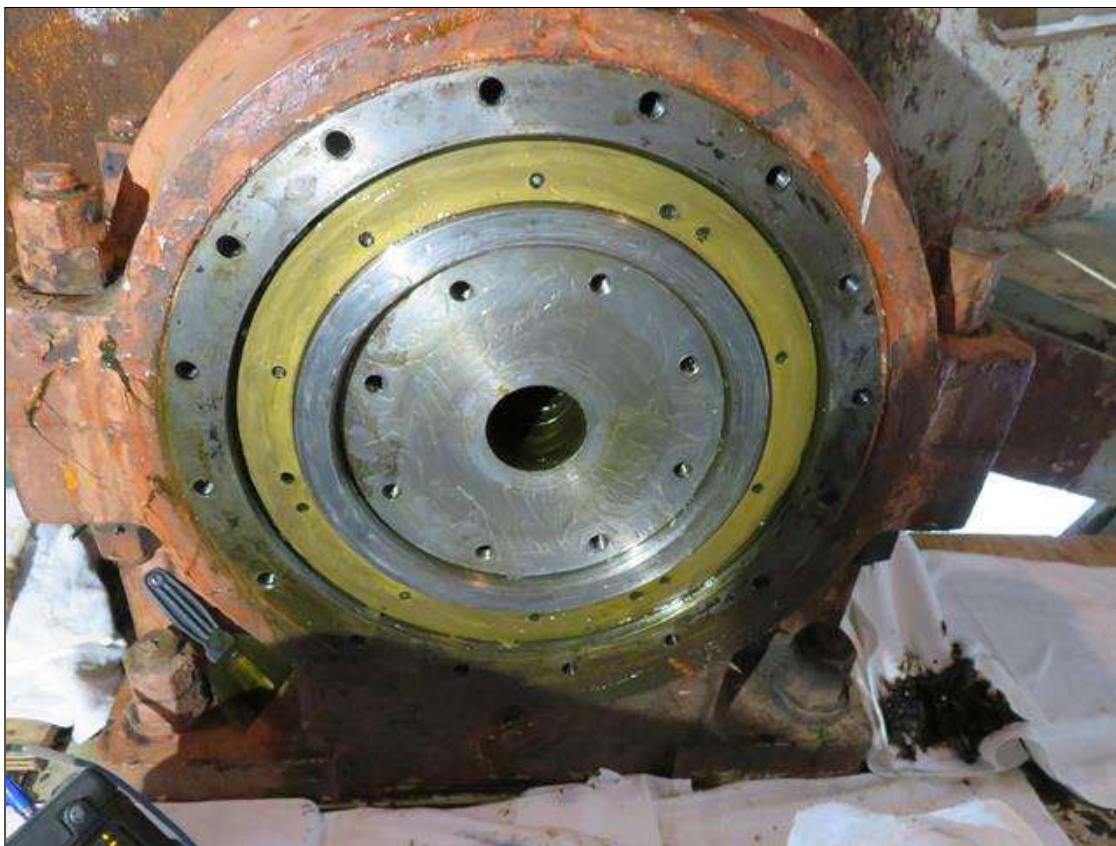
SOUTH WEST OUTSIDE TRUNNION AFTER TESTING WITH ULTRA SONICS MACHINE. (SOUTH SIDE)

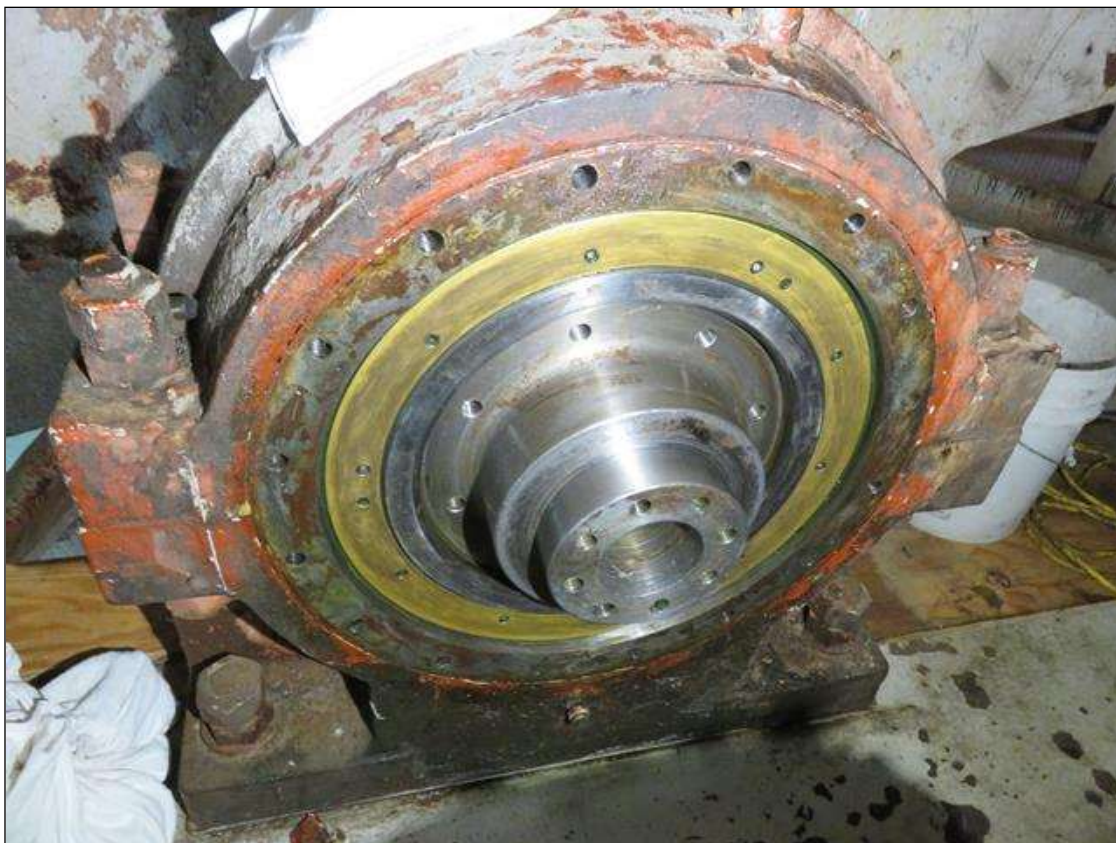
SOUTH WEST INNER TRUNNION DISASSEMBLED FOR ULTRA SONICS INSPECTION. (SOUTH SIDE)

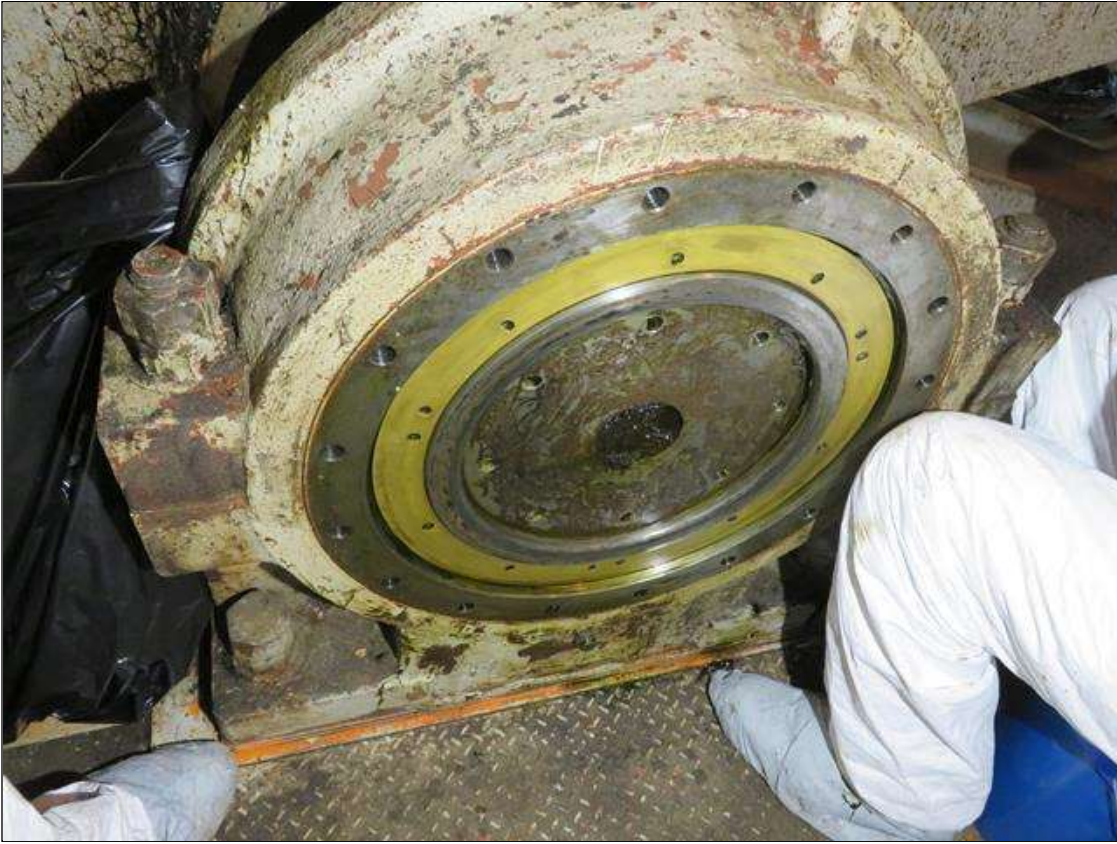
NORTH WEST ROOM OUTSIDE SOUTH TRUNNION DISASSEMBLED FOR ULTRA SONICS INSPECTION.

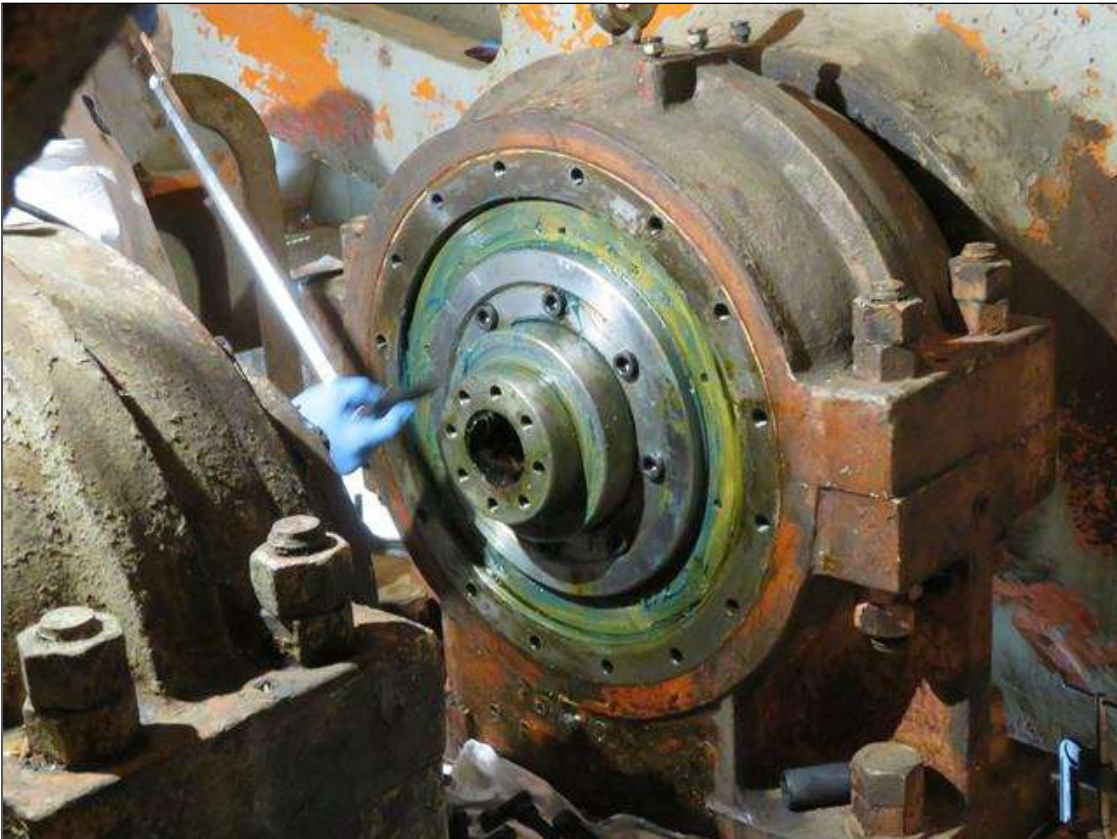
NORTH WEST ROOM INNER SOUTH TRUNNION BEING REASSEMBLED BY BRIDGE CREW.

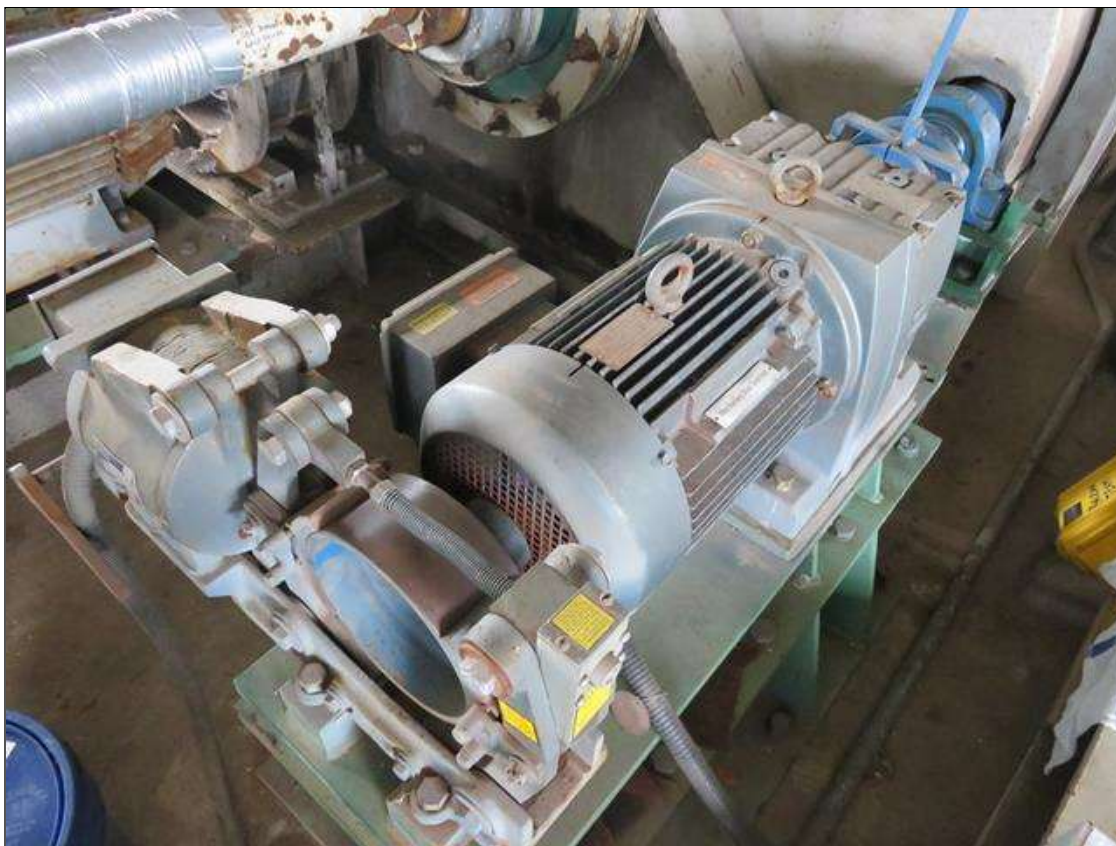
WEST AUXILIARY DRIVE GENERATOR AND BRAKE.

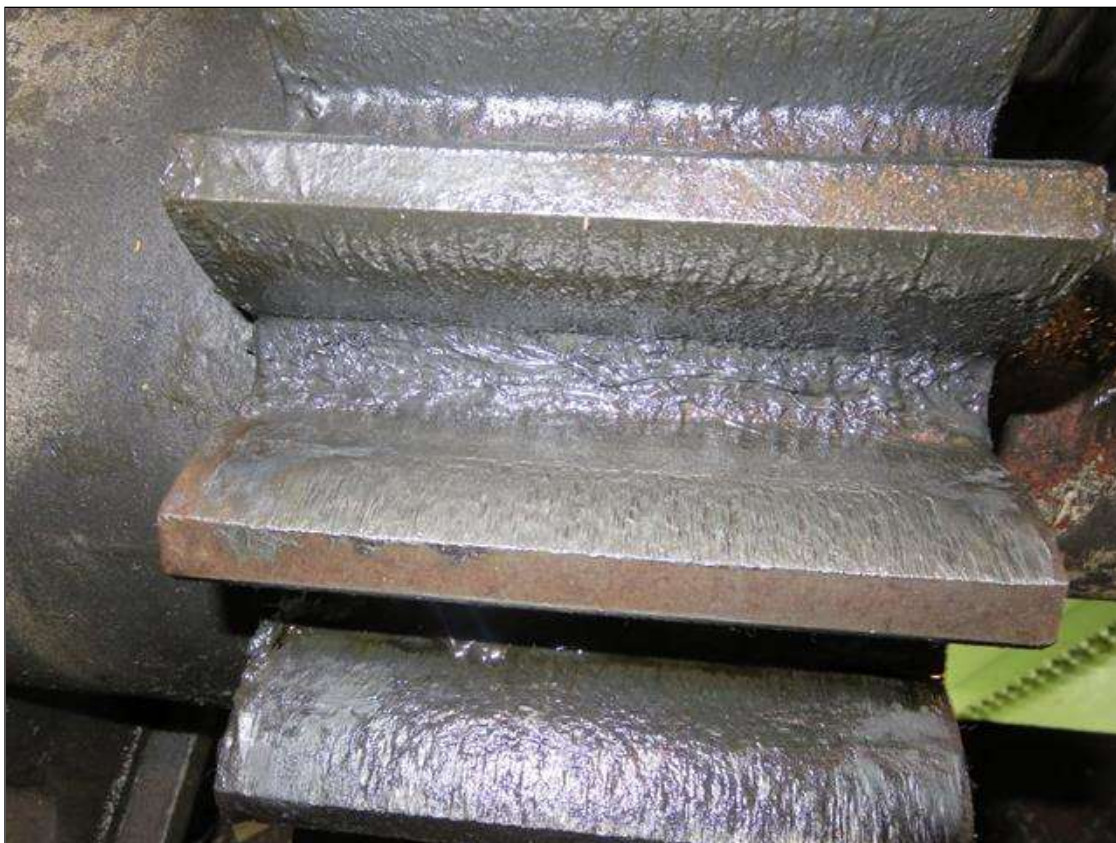
GEAR 276 HAS 1/32" GROOVES IN OPEN AND CLOSING SIDE OF TOOTH SOUTH WEST ROOM (WEST TOWER)

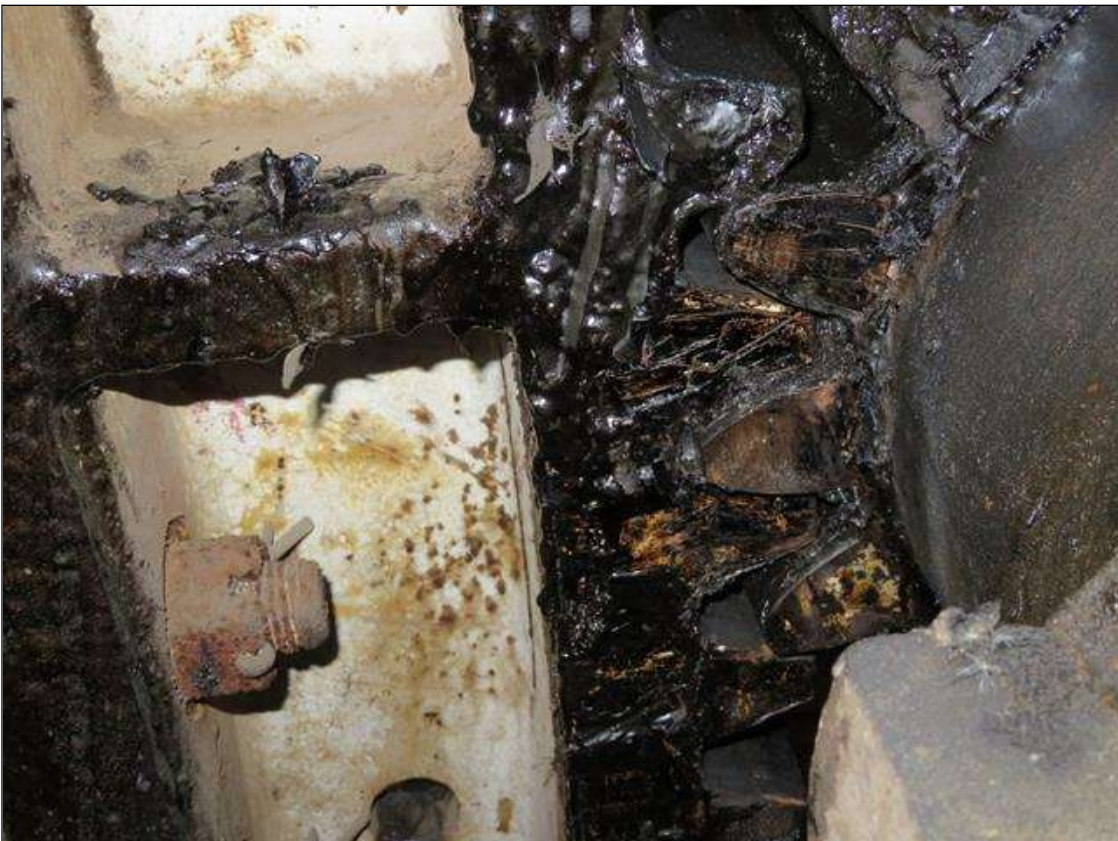
ROOT TO TIP WAS MEASURED .189 FOR GEARS 271-2 & 276 IN SOUTH WEST ROOM (WEST TOWER)

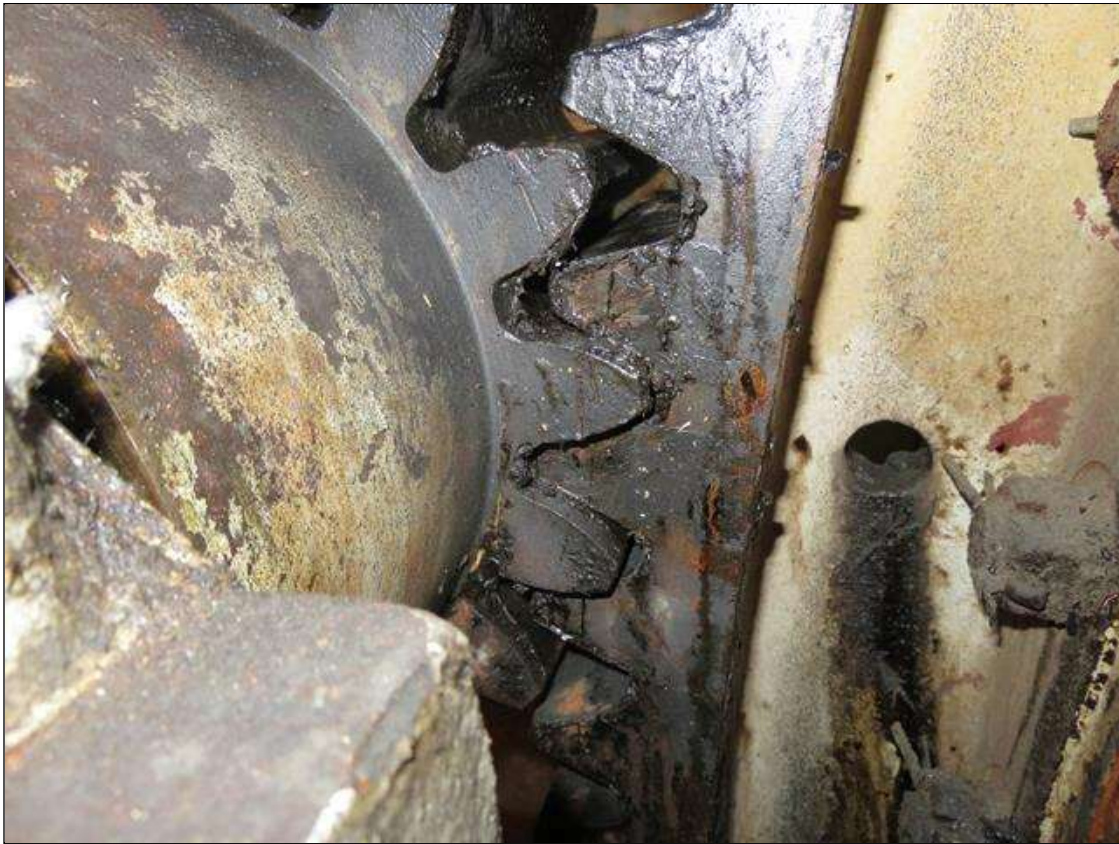
ROOT TO TIP WAS MEASURED .250 FOR GEARS 271-2 & 277 IN SOUTH WEST ROOM (WEST TOWER)

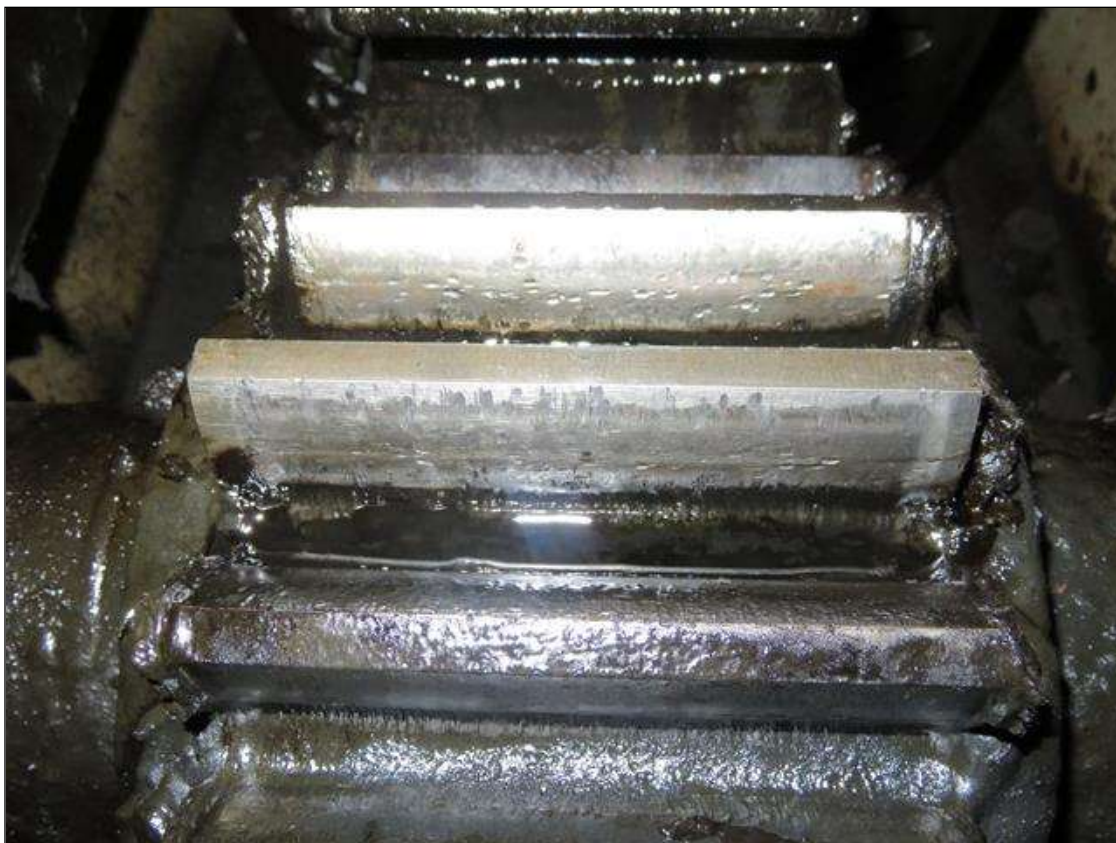
GEARS 278 HAVE SEVERAL SMALL 1/8" KNICKS AND GOUGES ON FACE OF TEETH NORTH WEST ROOM.

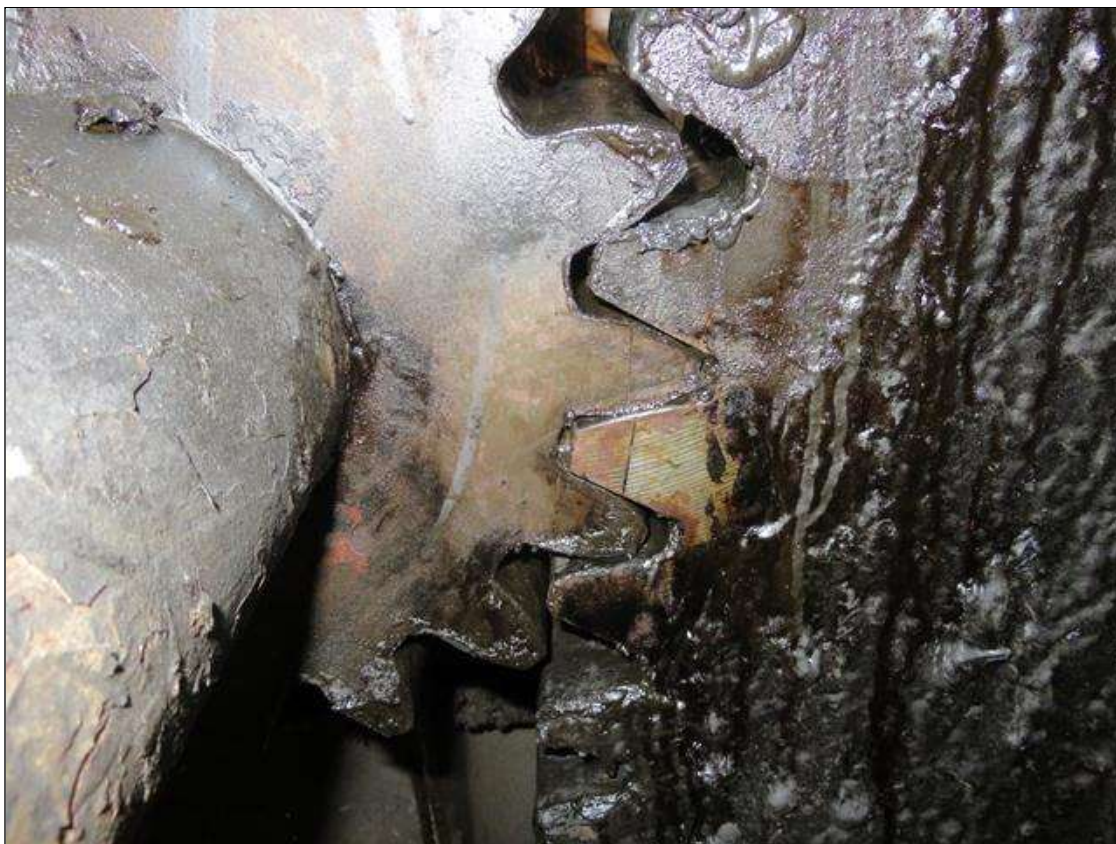
ROOT TO TIP MEASURED .147 FOR GEARS 271-1 & 276 NORTH WEST ROOM (WEST TOWER)

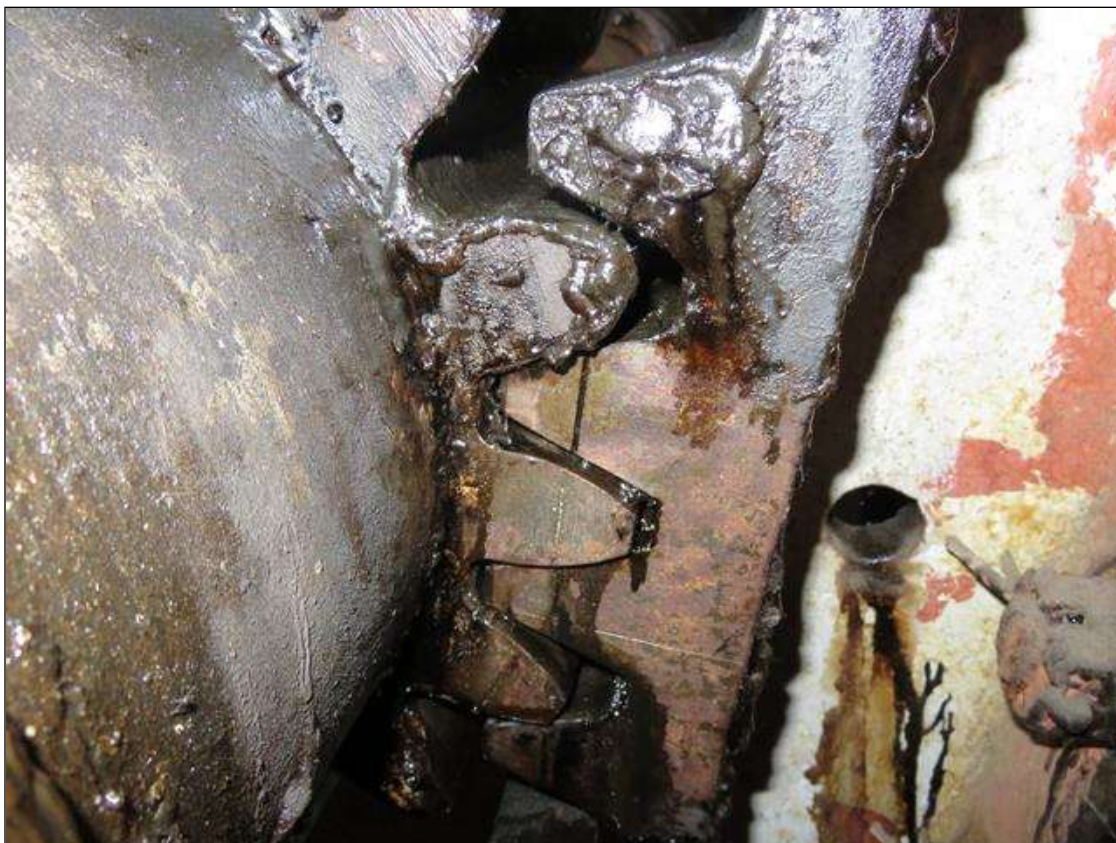
ROOT TO TIP MEASURED .180 FOR GEARS 271-2 & 277 NORTH WEST ROOM (WEST TOWER)

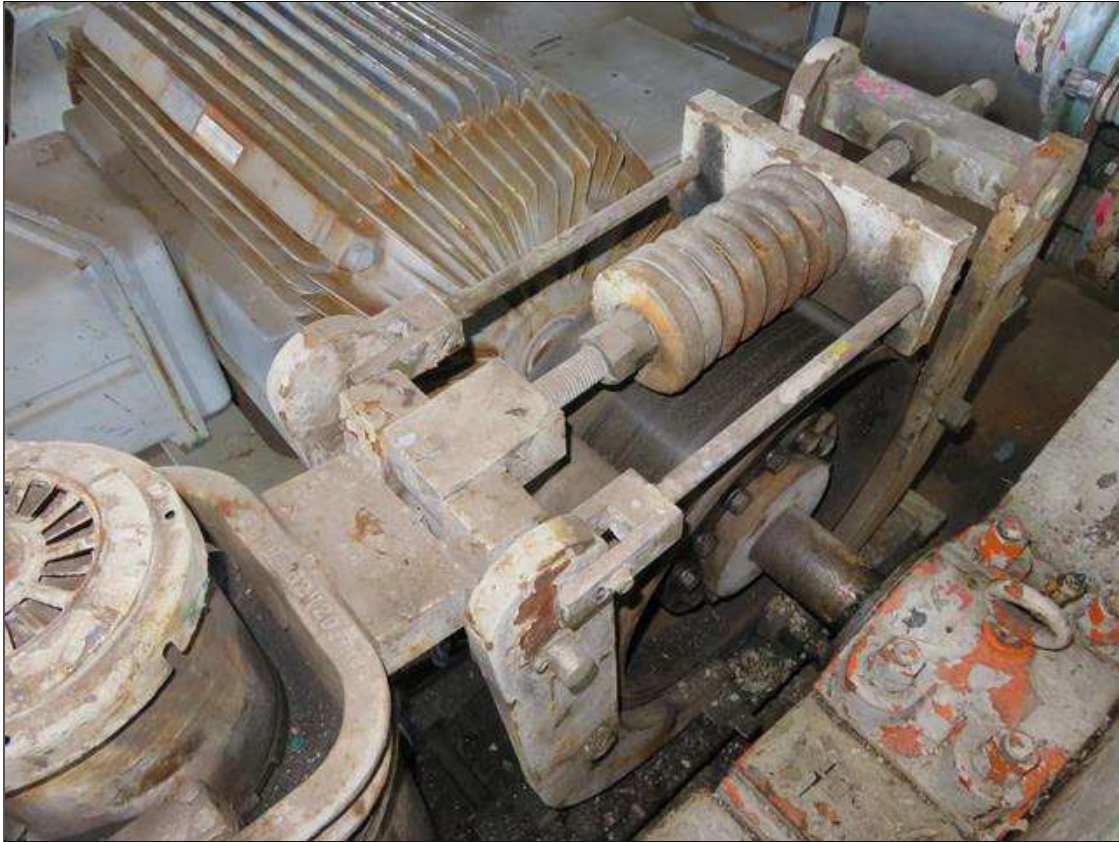
BRAKE #3 EAST OPERATING MACHINERY DRUM AND PADS GOOD.

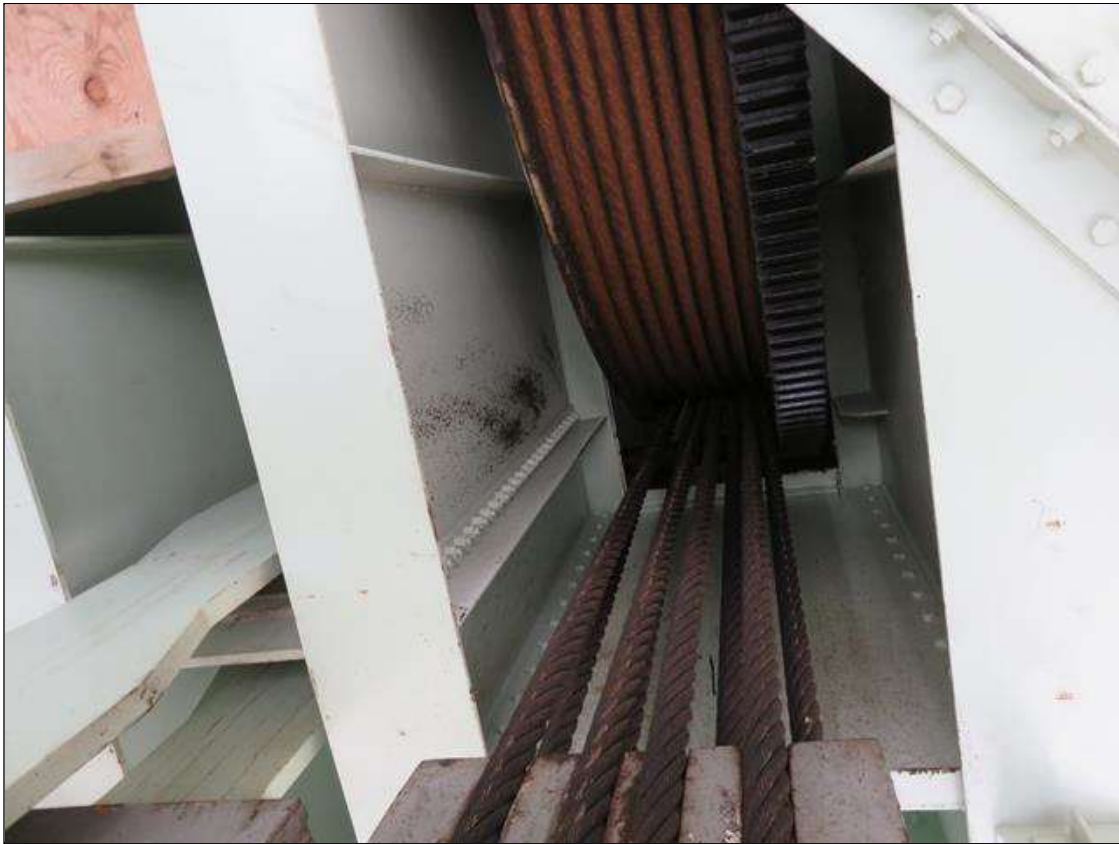
LOOKING UP AT CABLES AND GEARS (EAST TOWER)

ALL CABLES DRY. SURFACE RUST BEGINING TO FORM AT EXPOSED AREAS NEAR COUNTERWEIGHTS - WEST AND EAST TOWERS.

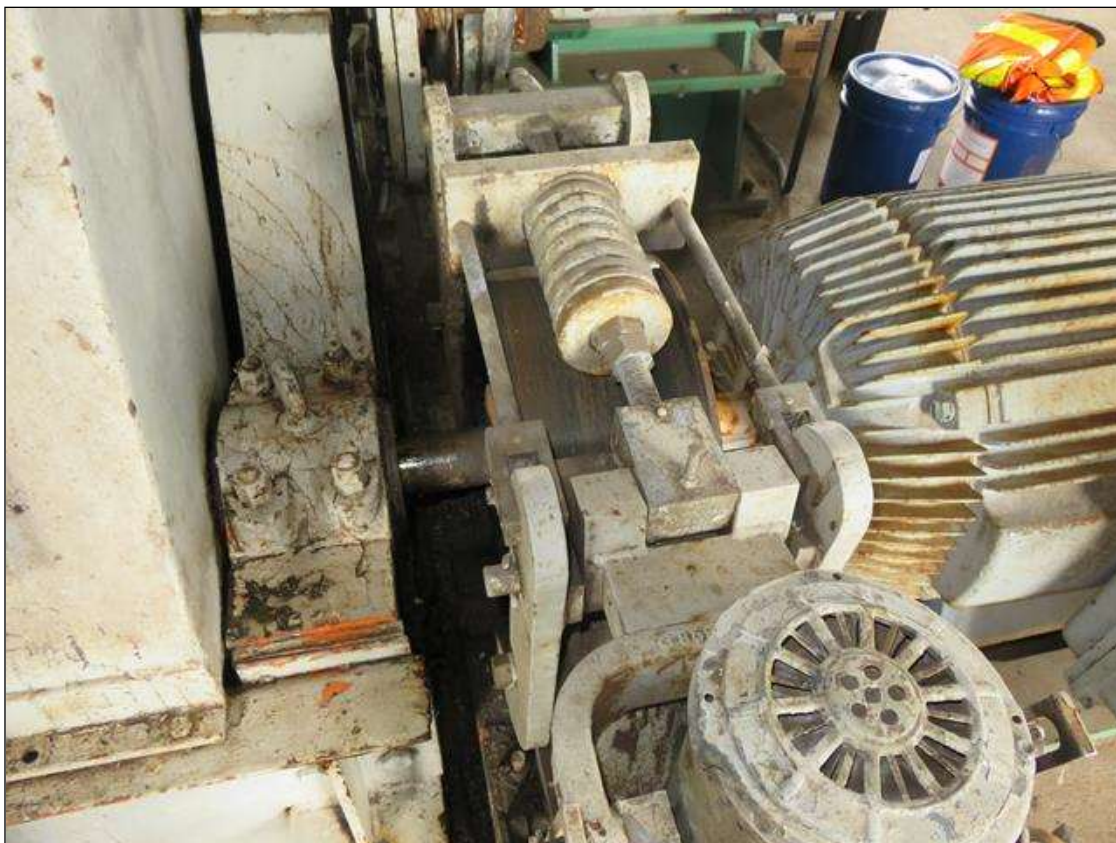
BRAKE #1 OPERATING MACHINE WEST TOWER. (FLUID LEVEL GOOD BUT DIRTY)
