PROJECT NO. 15BPR.15

NEW HANOVER COUNTY

APPROACH SPANS
STRUCTURAL STEEL

REPAIR DETAILS

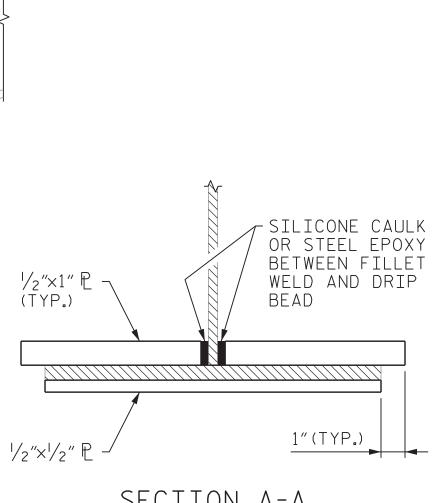
SECTION A-A

EXISTING BRACKET AT \
PARKING OVERHANG

CLOSE PARKING AREA TO TRAFFIC WHILE PERFORMING REPAIR (3).

REPAIR(3

REPAIR ONE BRACKET AT A TIME.

BEFORE PAINTING, APPLY SEALANT AROUND BENT PLATE.
