Green River Bridge NDT Survey
Peter Guice Memorial Bridge
Hendersonville, North Carolina
S&ME Project No. 6105-18-008
Phase 340

Reference: **Green River Bridge NDT Survey**
Peter Guice Memorial Bridge
Hendersonville, North Carolina
S&ME Project No. 6105-18-008 Phase 340

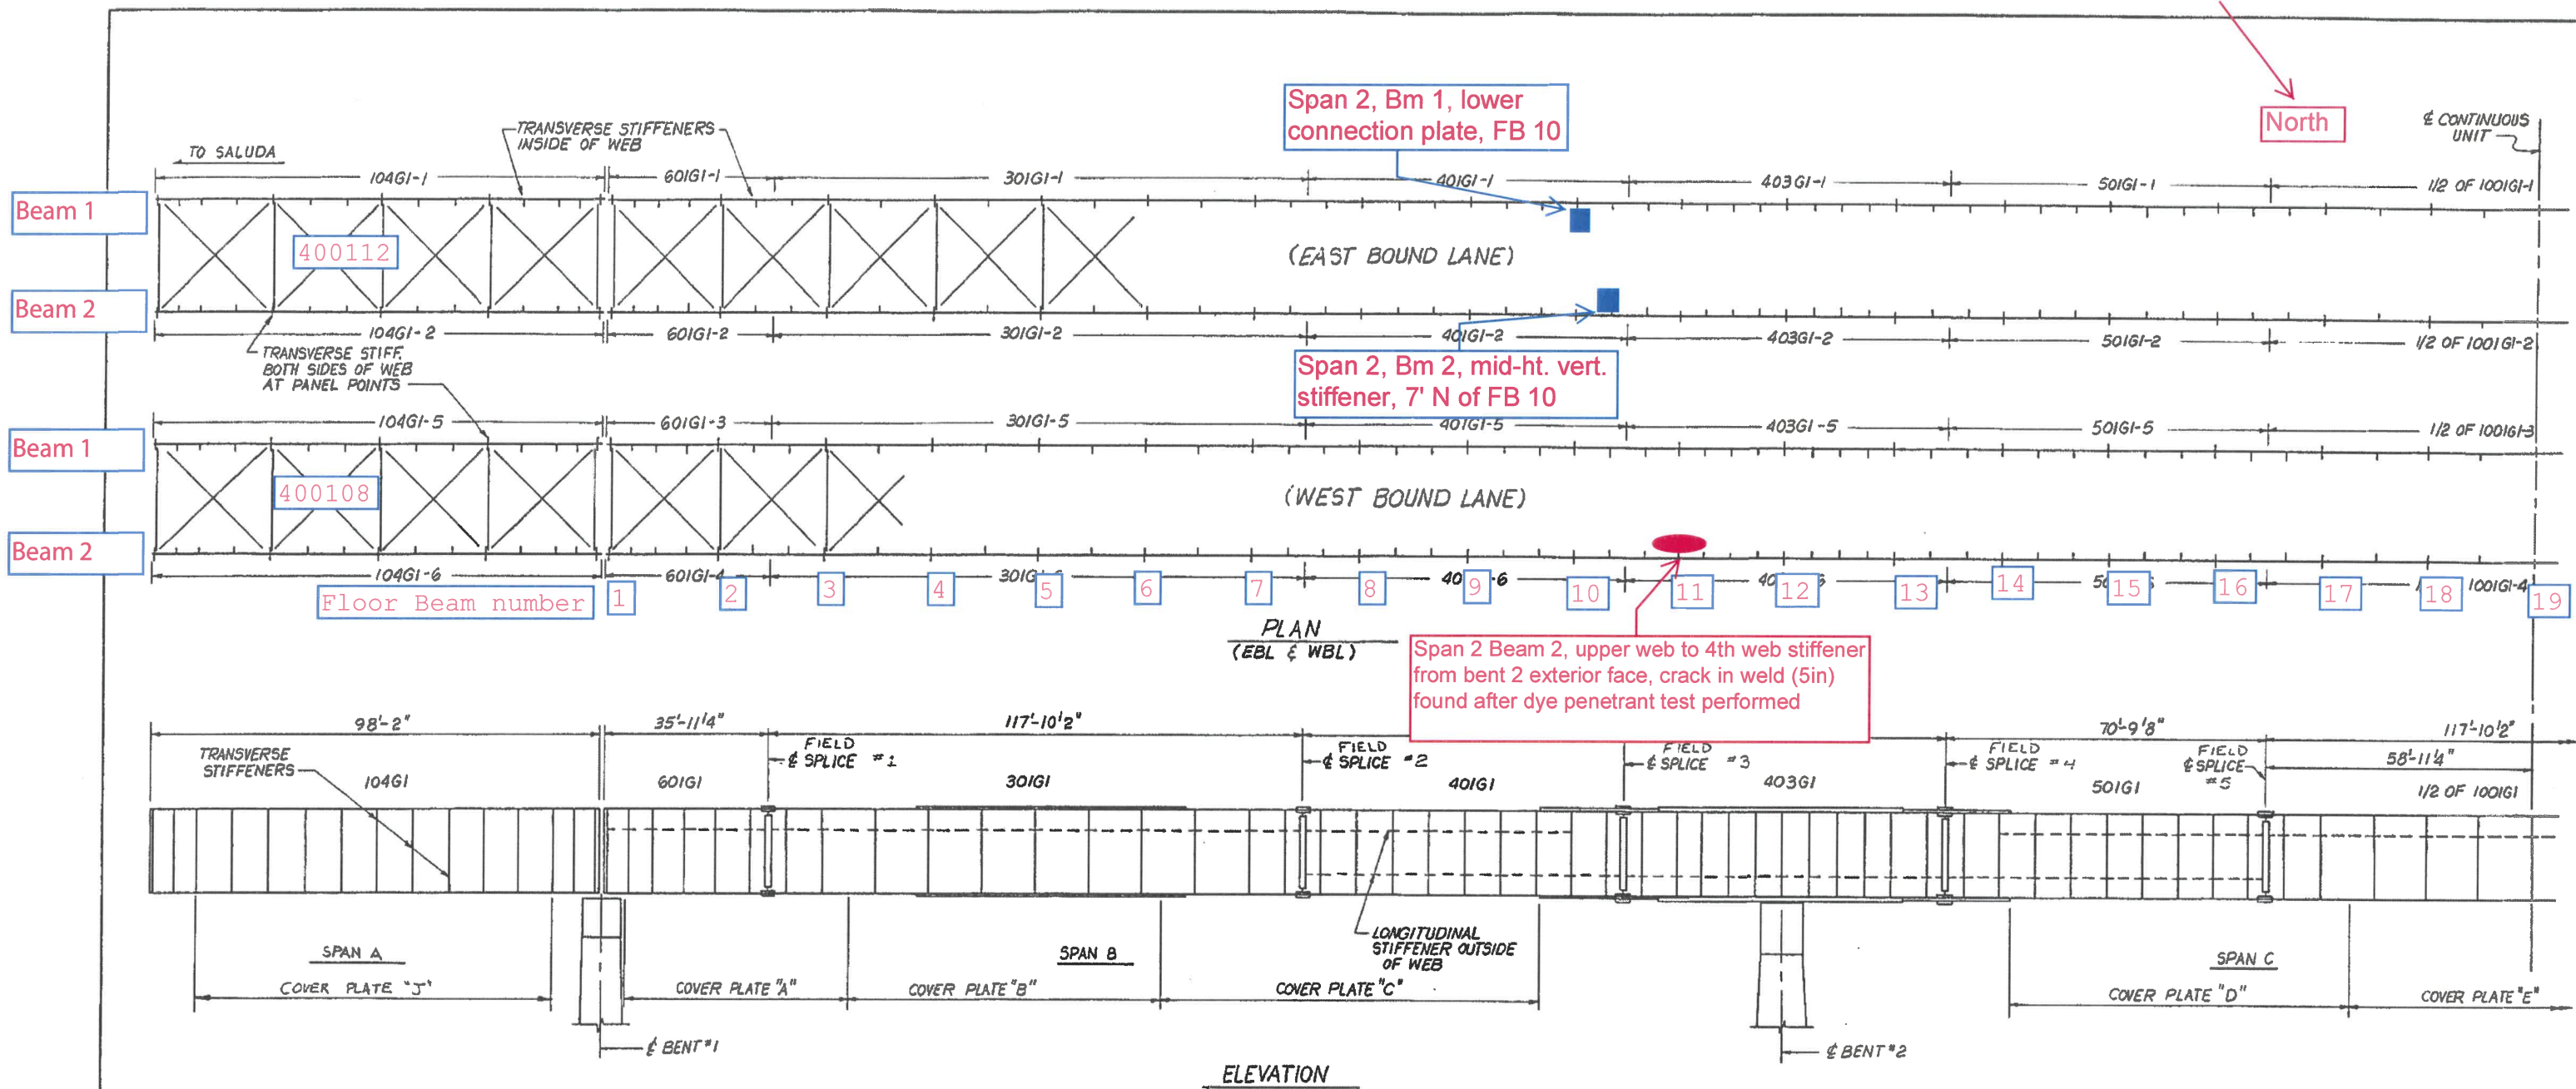
Span 2 Beam 2, upper web to 4th web stiffener from bent 2 exterior face, crack in weld (5in) found after dye penetrant test performed **13**

● **NDT Test Location** - Perform NDT to verify crack location, length, etc. and to determine if crack has propagated into web base metal.
