NC DEPARTMENT OF TRANSPORTATION
 DIVISION OF HIGHWAYS
 STRUCTURE MANAGEMENT UNIT

Structure Safety Report

Routine Element Inspection - Contract

DIVISION: 6 COUNTY: ROBESON STRUCTURE NUMBER: 770160 FREQUENCY: 24 MONTHS

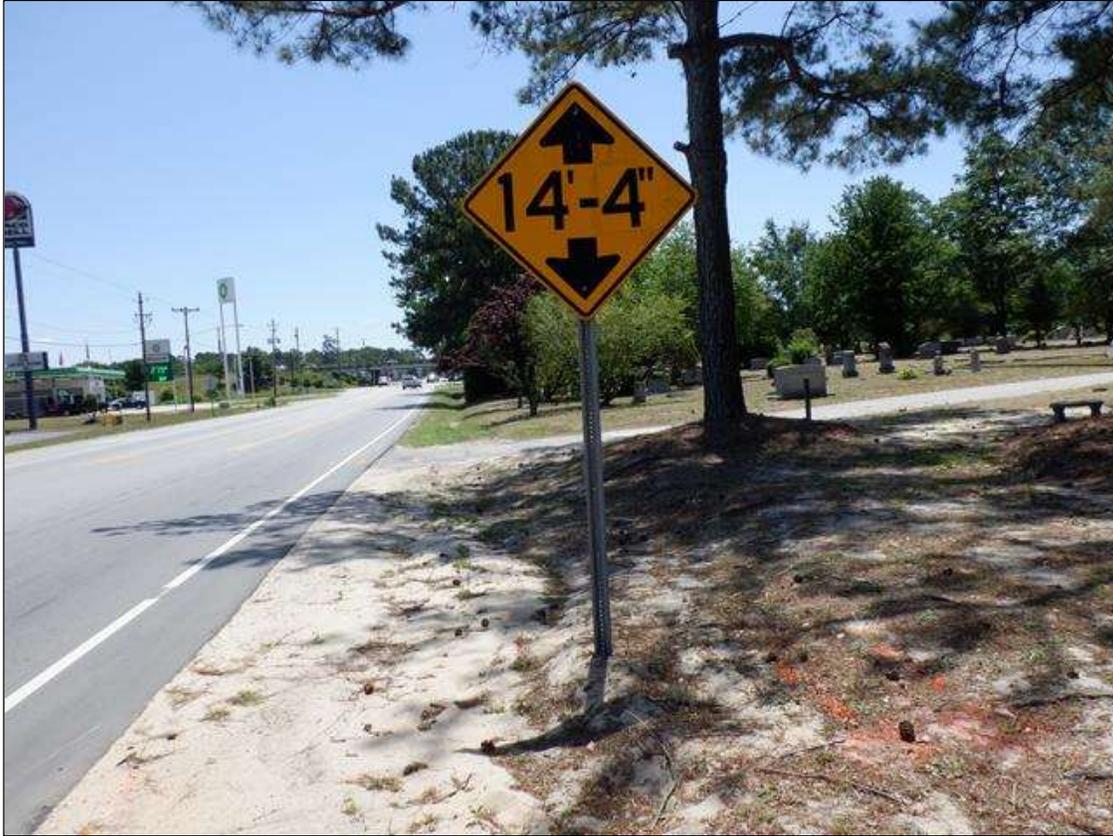
VERTICAL CLEARANCE SIGN 1000 FEET WEST OF BRIDGE STRUCTURE

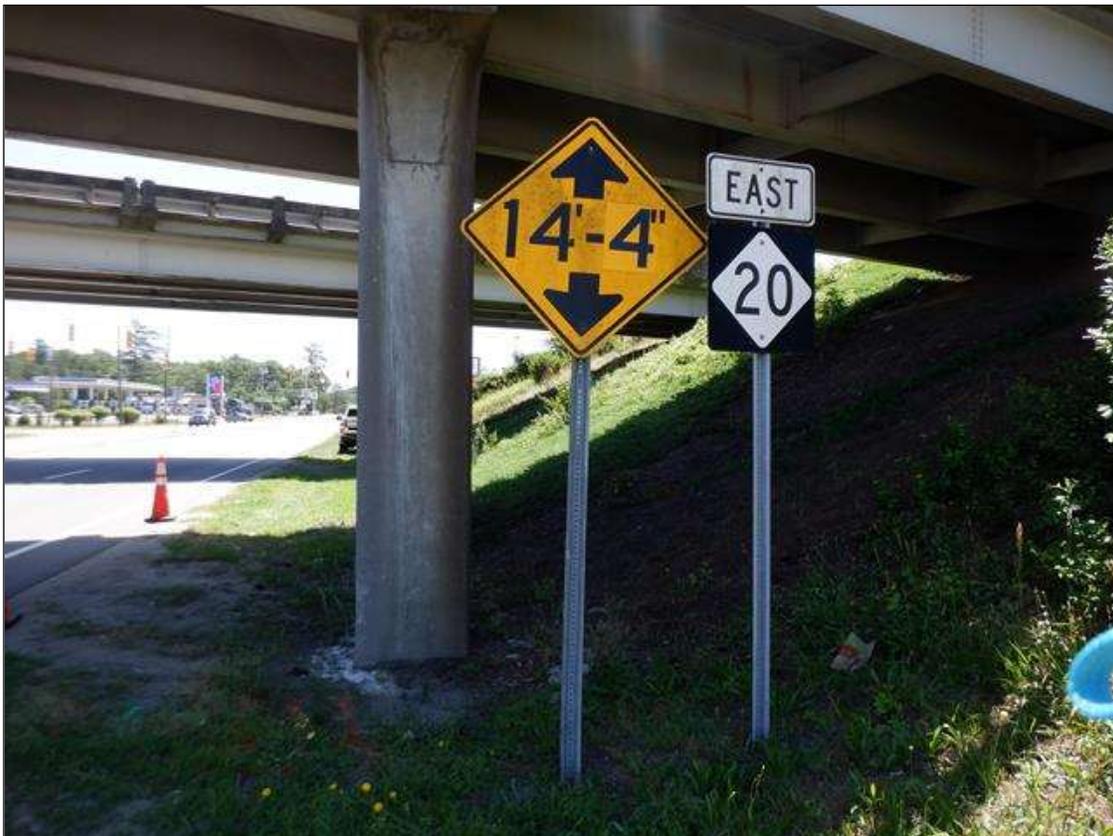
VERTICAL CLEARANCE SIGN ADJACENT TO BRIDGE STRUCTURE

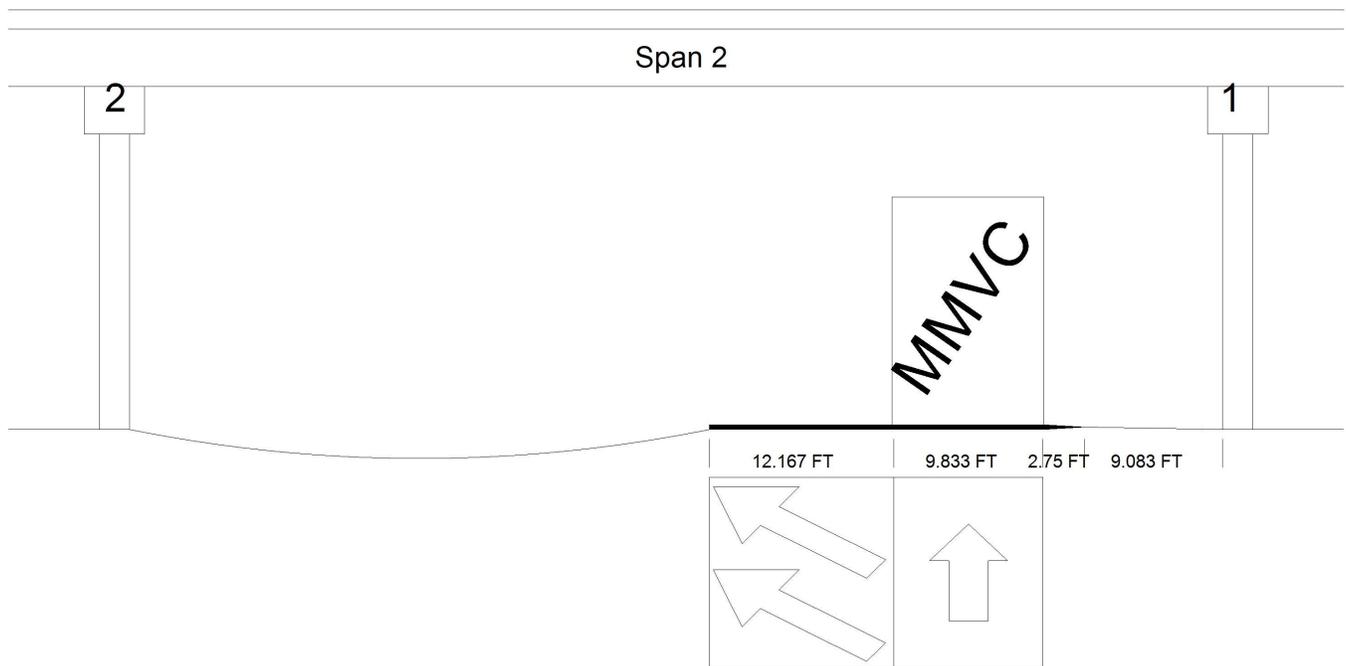
Roadway 1		Direction of Traffic	East
Distance to Left Rail		Distance to Right Rail	
Distance to Left Toe of Slope		Distance to Left Bent	50.417FT
Distance to Right Toe of Slope		Distance to Right Bent	11.833FT
MMVC	14.9 Ft at Beam 1, 10 FT from RIGHT EDGE OF PAVEMENT		
MVC	14.5 Ft at Beam 1, 0 FT from LEFT EDGE OF TRAVEL LANES

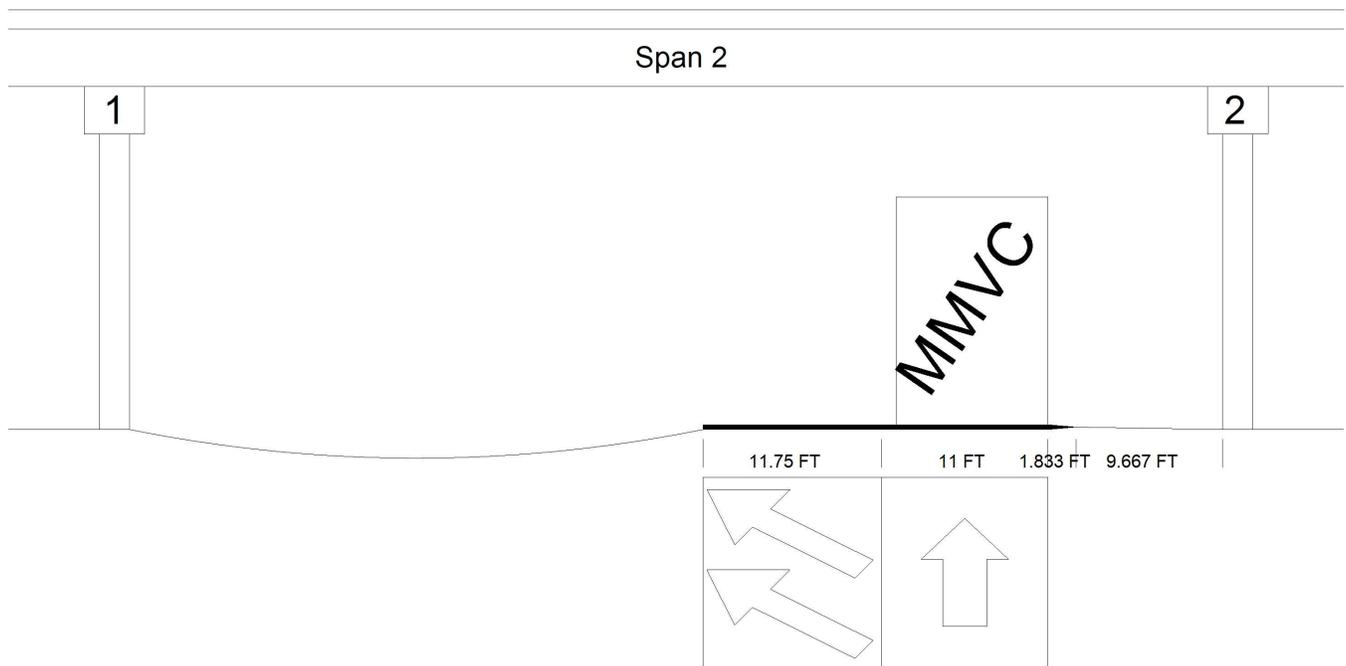
Roadway 1		Direction of Traffic	West
Distance to Left Rail		Distance to Right Rail	
Distance to Left Toe of Slope		Distance to Left Bent	49.583FT
Distance to Right Toe of Slope		Distance to Right Bent	11.5FT
MMVC	14.5 Ft at Beam 1, 10 FT from RIGHT EDGE OF PAVEMENT		
MVC	14.4 Ft at Beam 1, 0 FT from LEFT EDGE OF TRAVEL LANES
