AS-BUILT REPAIR QUANTITY TABLE

PROJECT NO. HB-0017  
DARE COUNTY  
 BRIDGE NO. 270009

STATE OF NORTH CAROLINA  
 DEPARTMENT OF TRANSPORTATION  
 RALEIGH

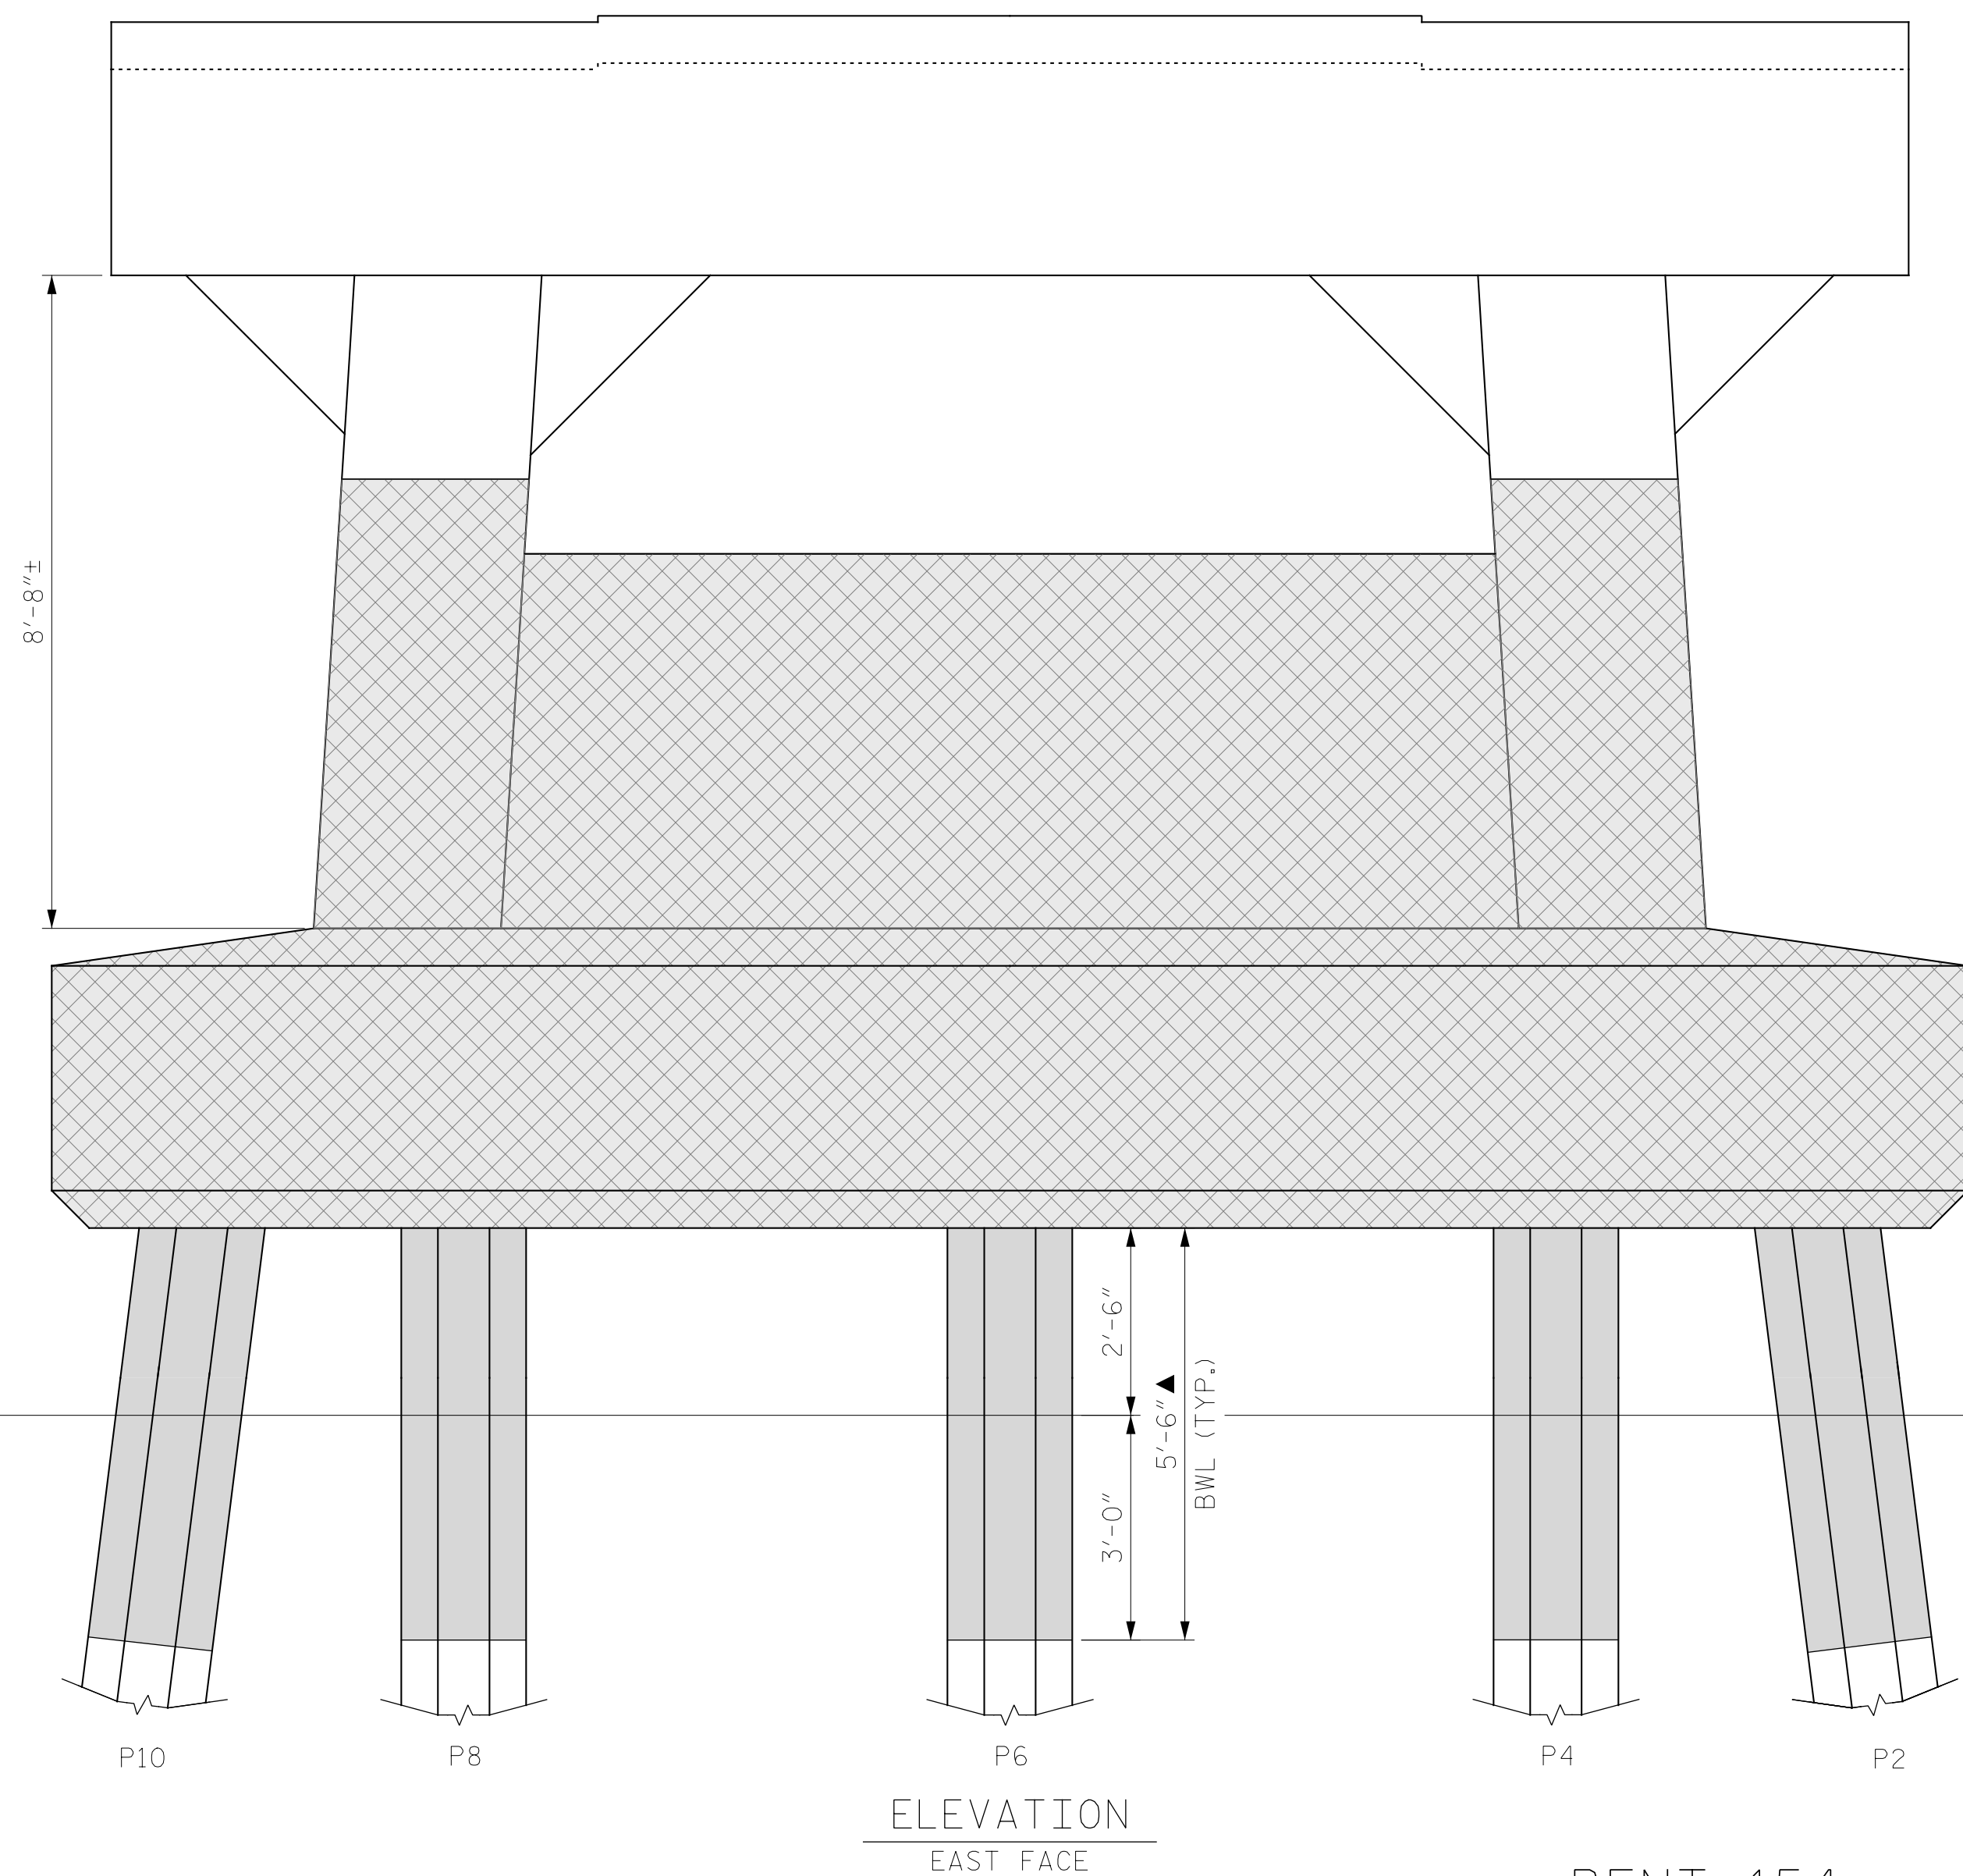
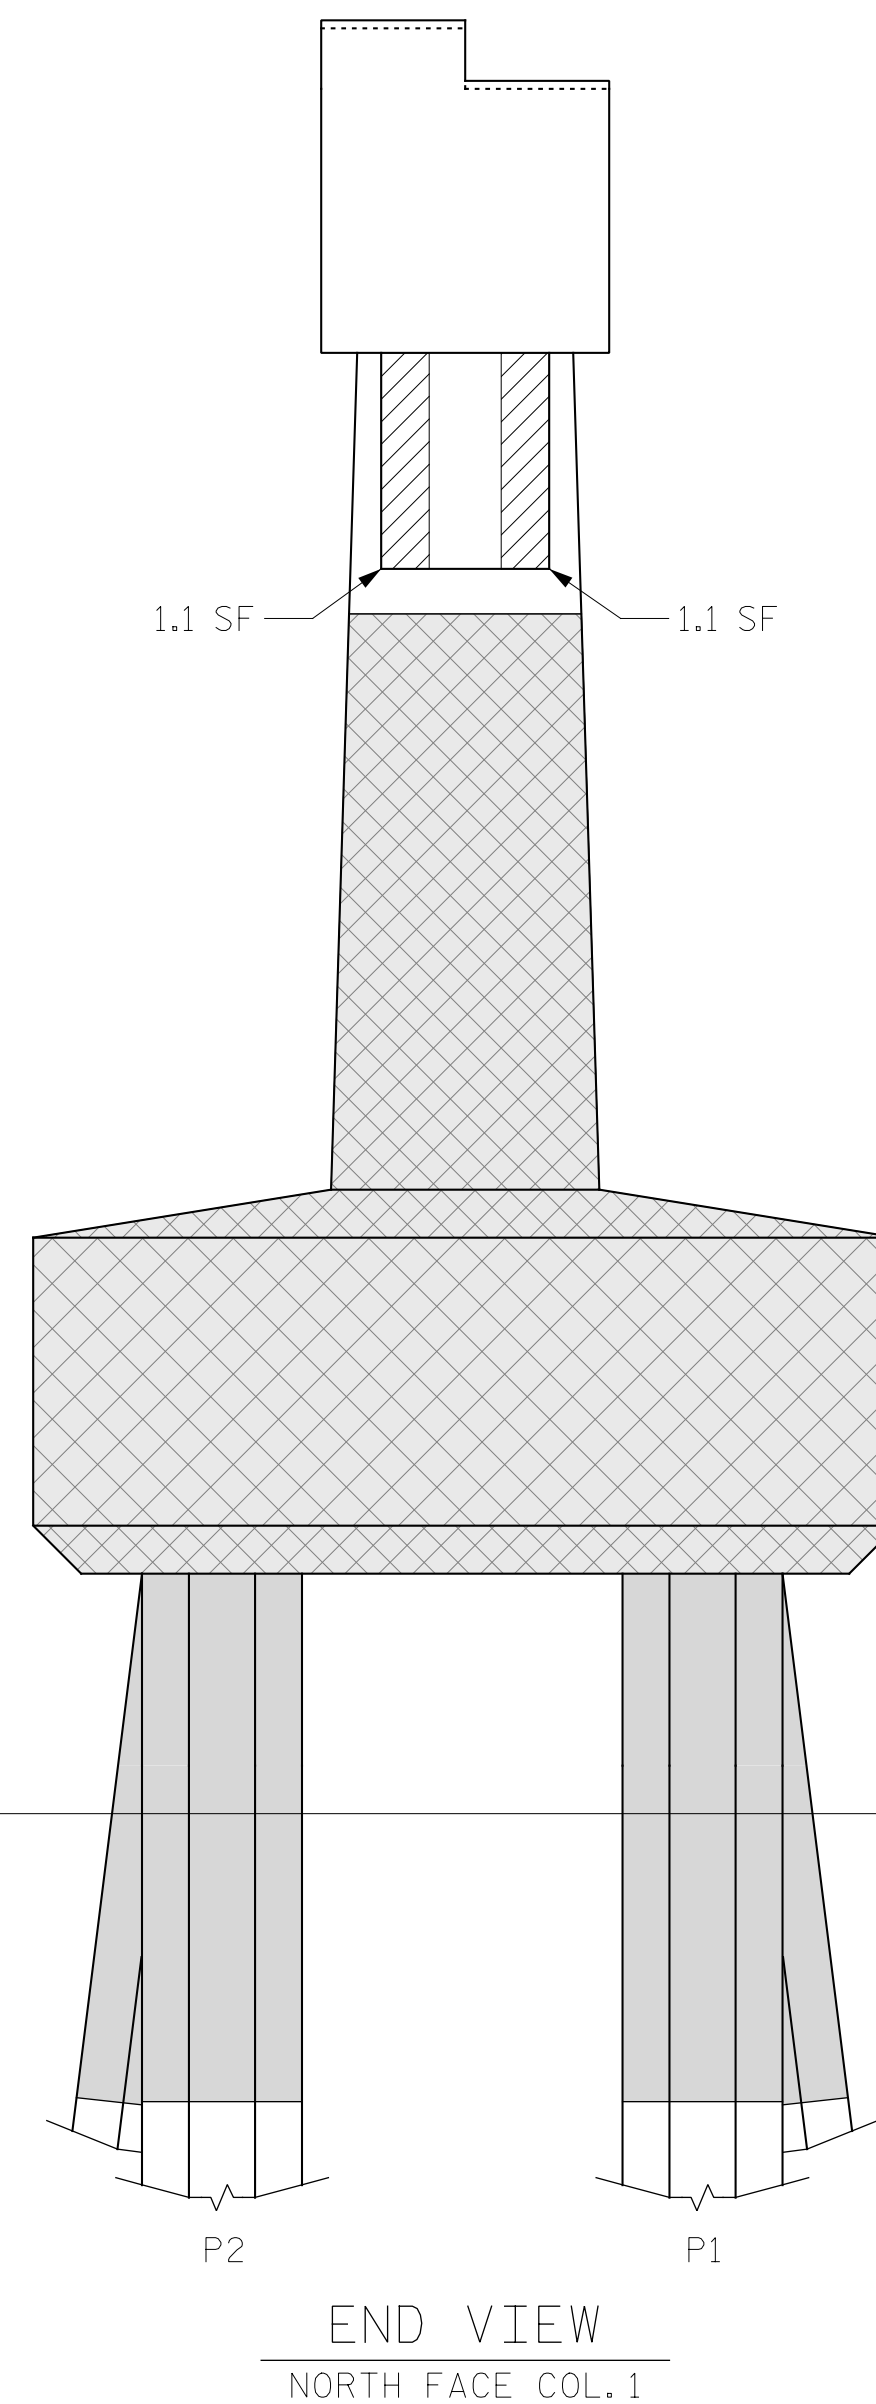
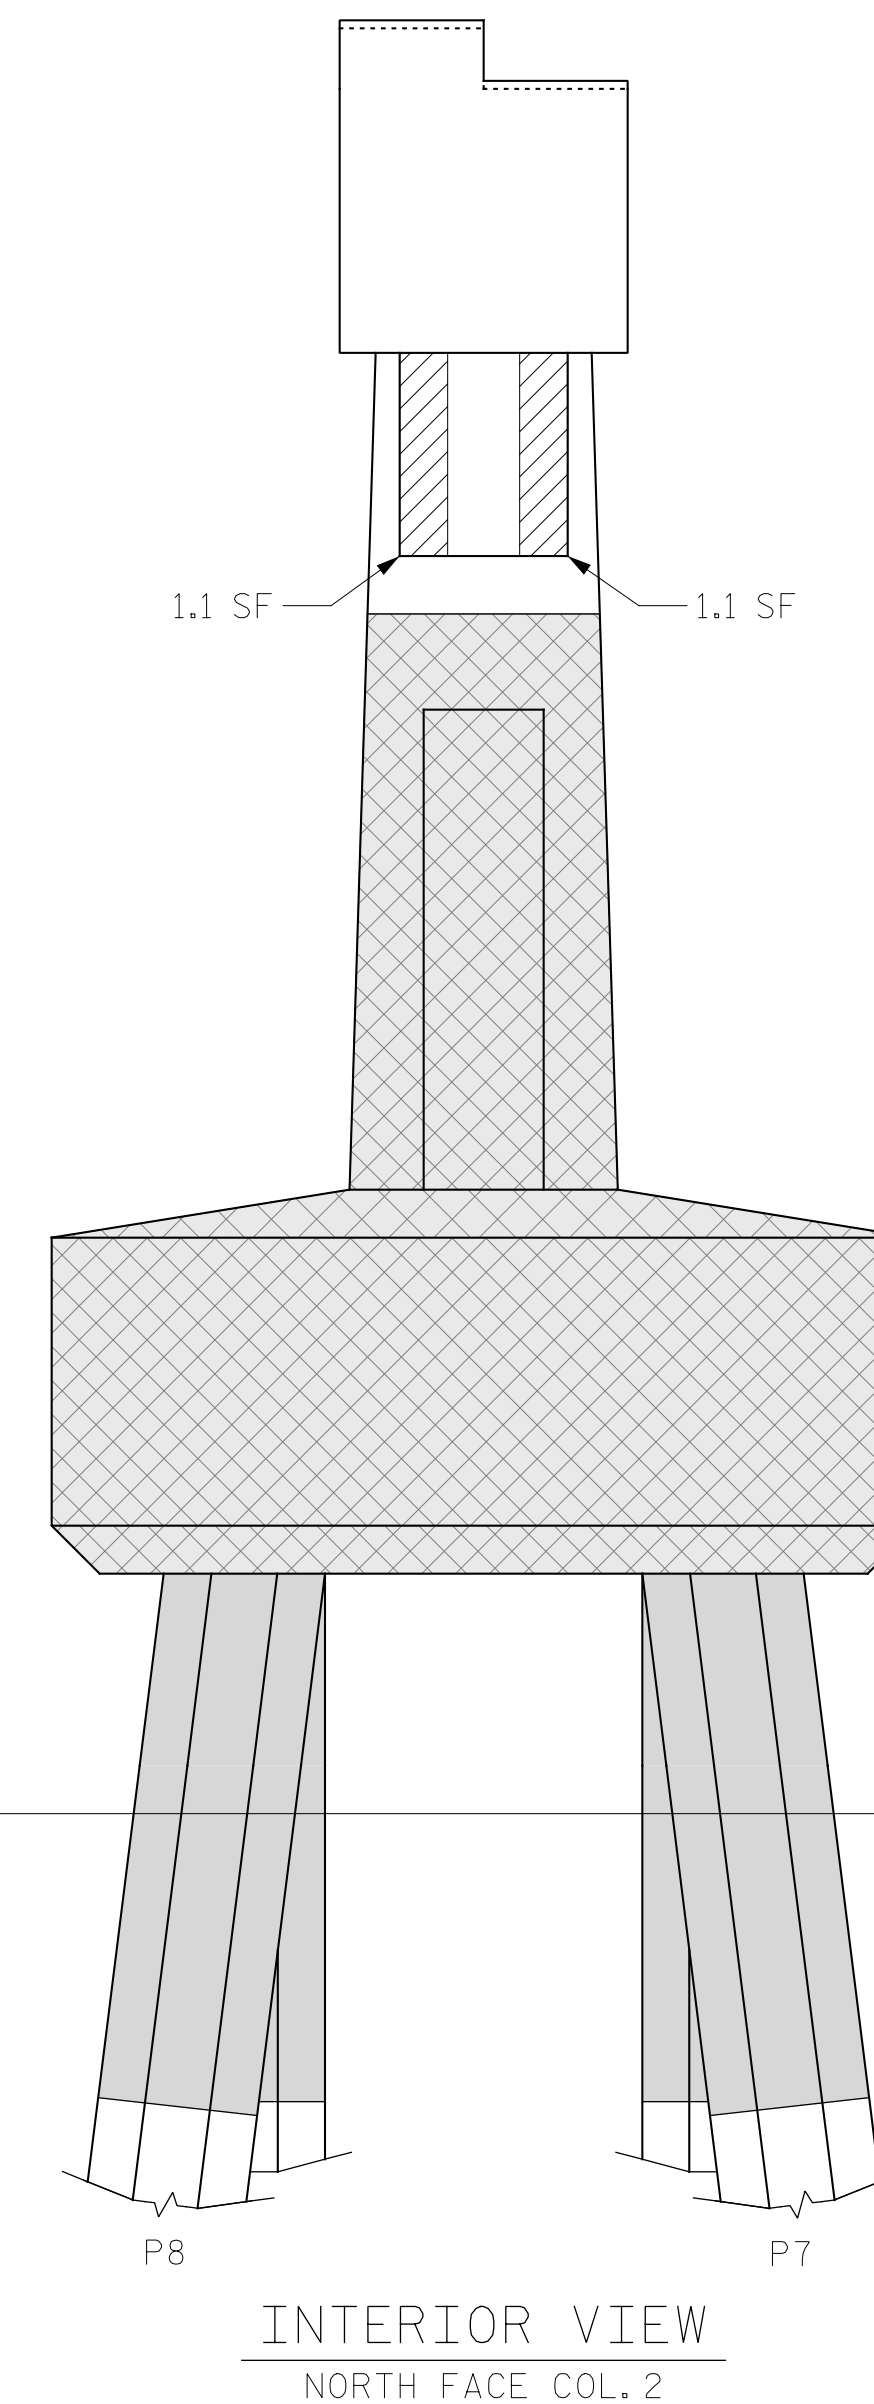
**BENT 154**

BENT 154				
CAP REPAIRS		ESTIMATE		ACTUAL
SHOTCRETE REPAIRS	- SF	- CF	SF	CF
EPOXY RESIN INJECTION	- LF		LF	
COLUMN REPAIRS		ESTIMATE		ACTUAL
SHOTCRETE REPAIRS	14.4 SF	7.2 CF	SF	CF
EPOXY RESIN INJECTION	- LF		LF	
PILE REPAIRS		ESTIMATE		ACTUAL
FRP PROTECTIVE SYSTEM AWL	- SF		SF	
FRP PROTECTIVE SYSTEM BWL	302.5 SF		SF

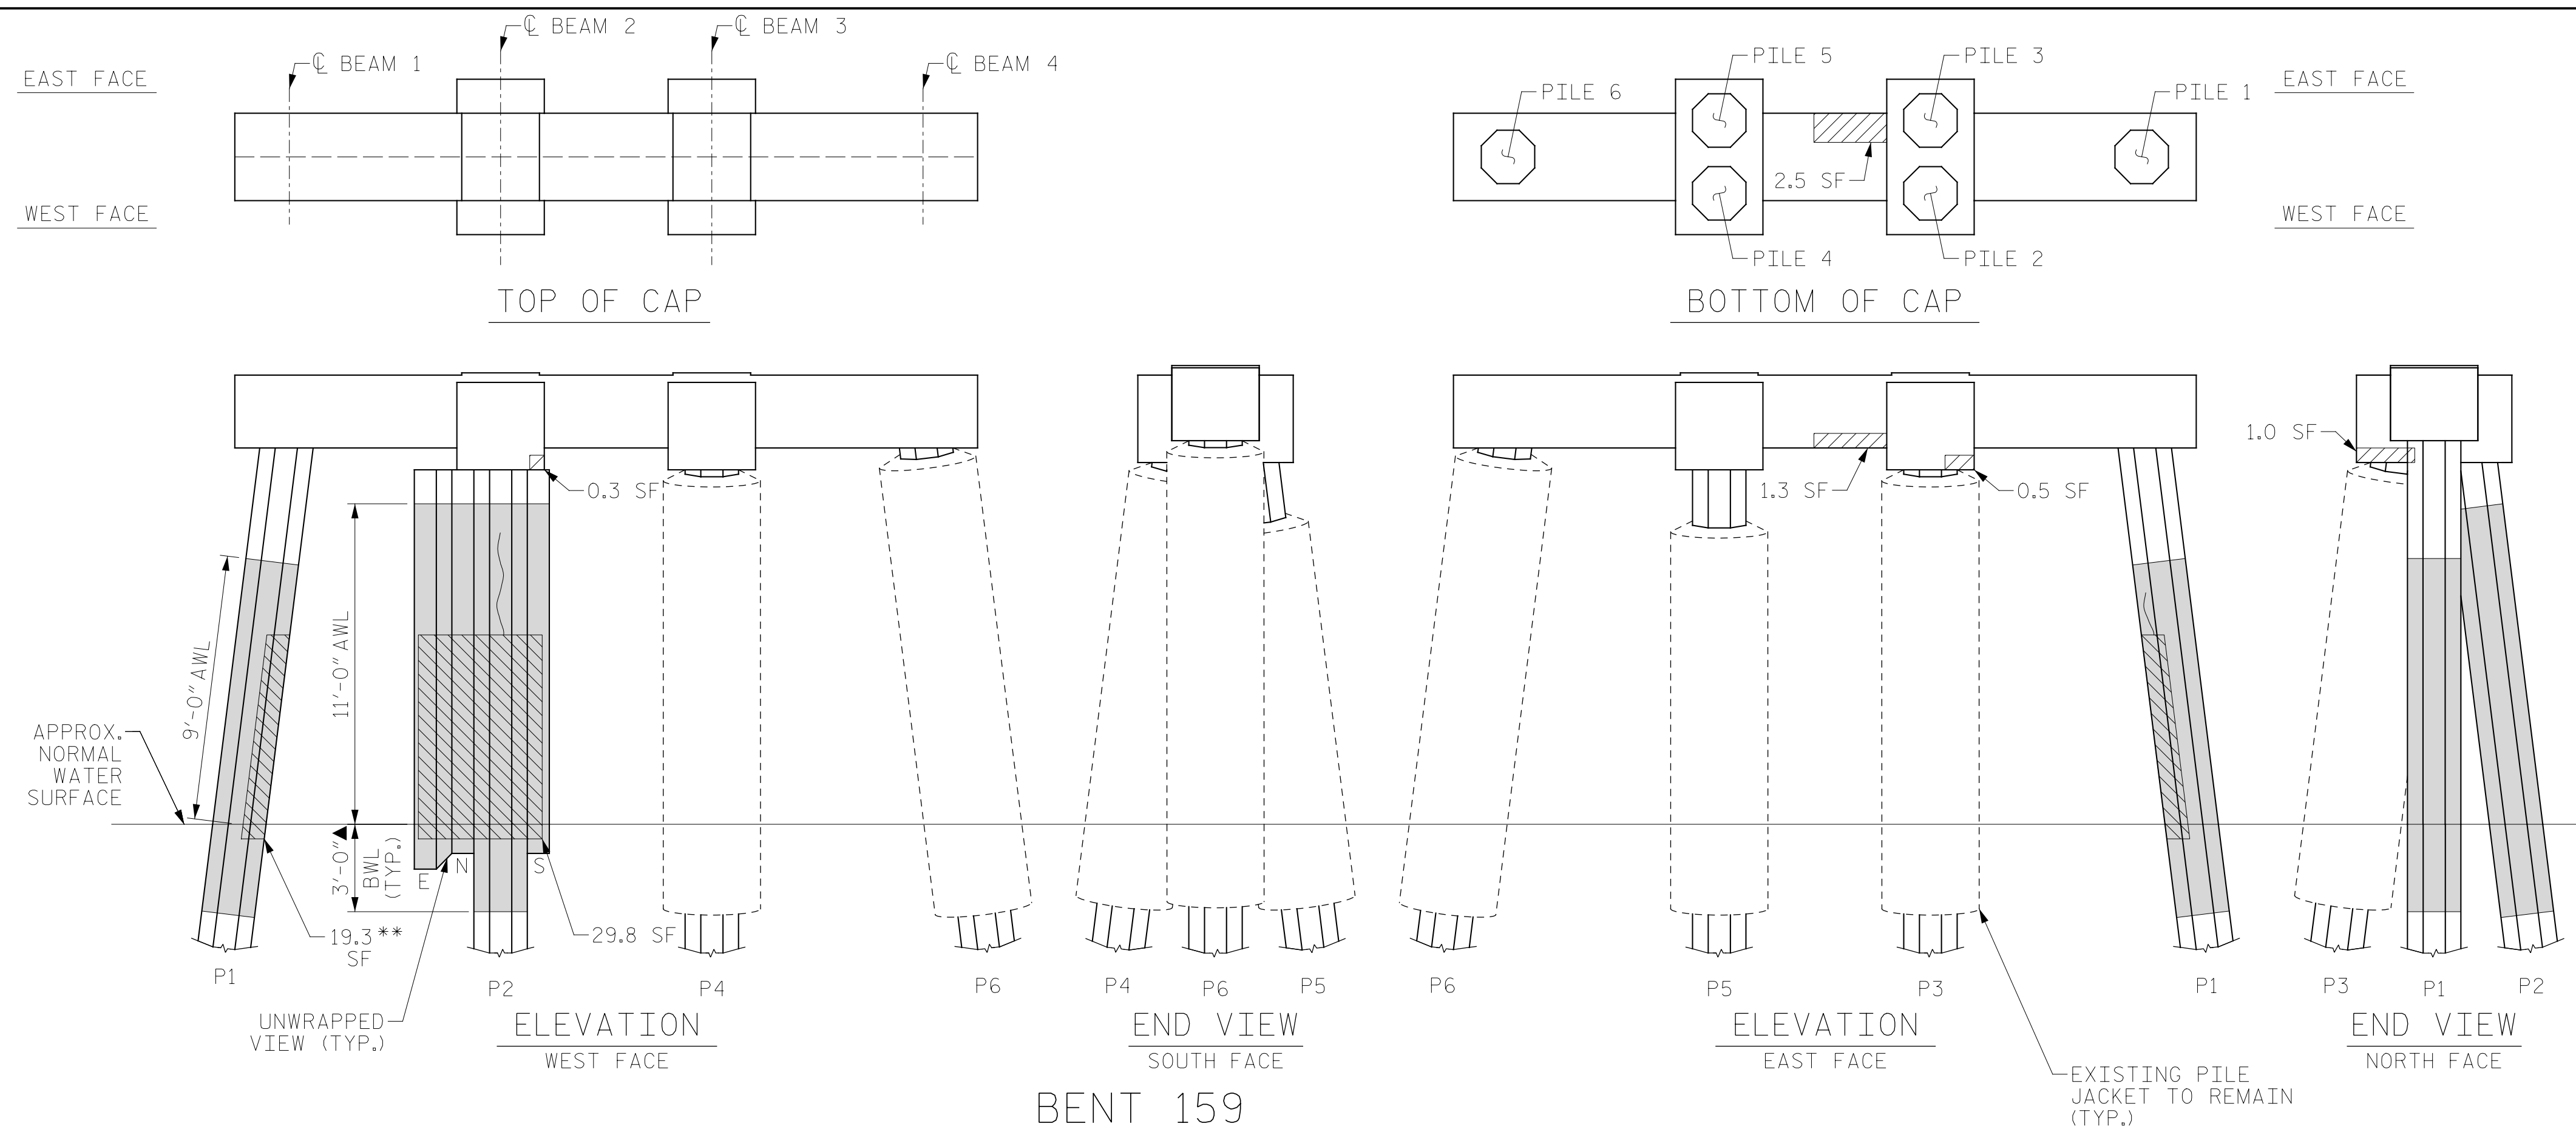
CAP REPAIRS			
SHOTCRETE REPAIRS	5.6 SF	2.5 CF	SF CF
EPOXY RESIN INJECTION	- LF		LF
PILE REPAIRS			
PILE CONCRETE RESTORATION	49.1 SF	18.8 CF	SF CF
FRP PROTECTIVE SYSTEM AWL	122.0 SF		
FRP PROTECTIVE SYSTEM BWL	36.6 SF

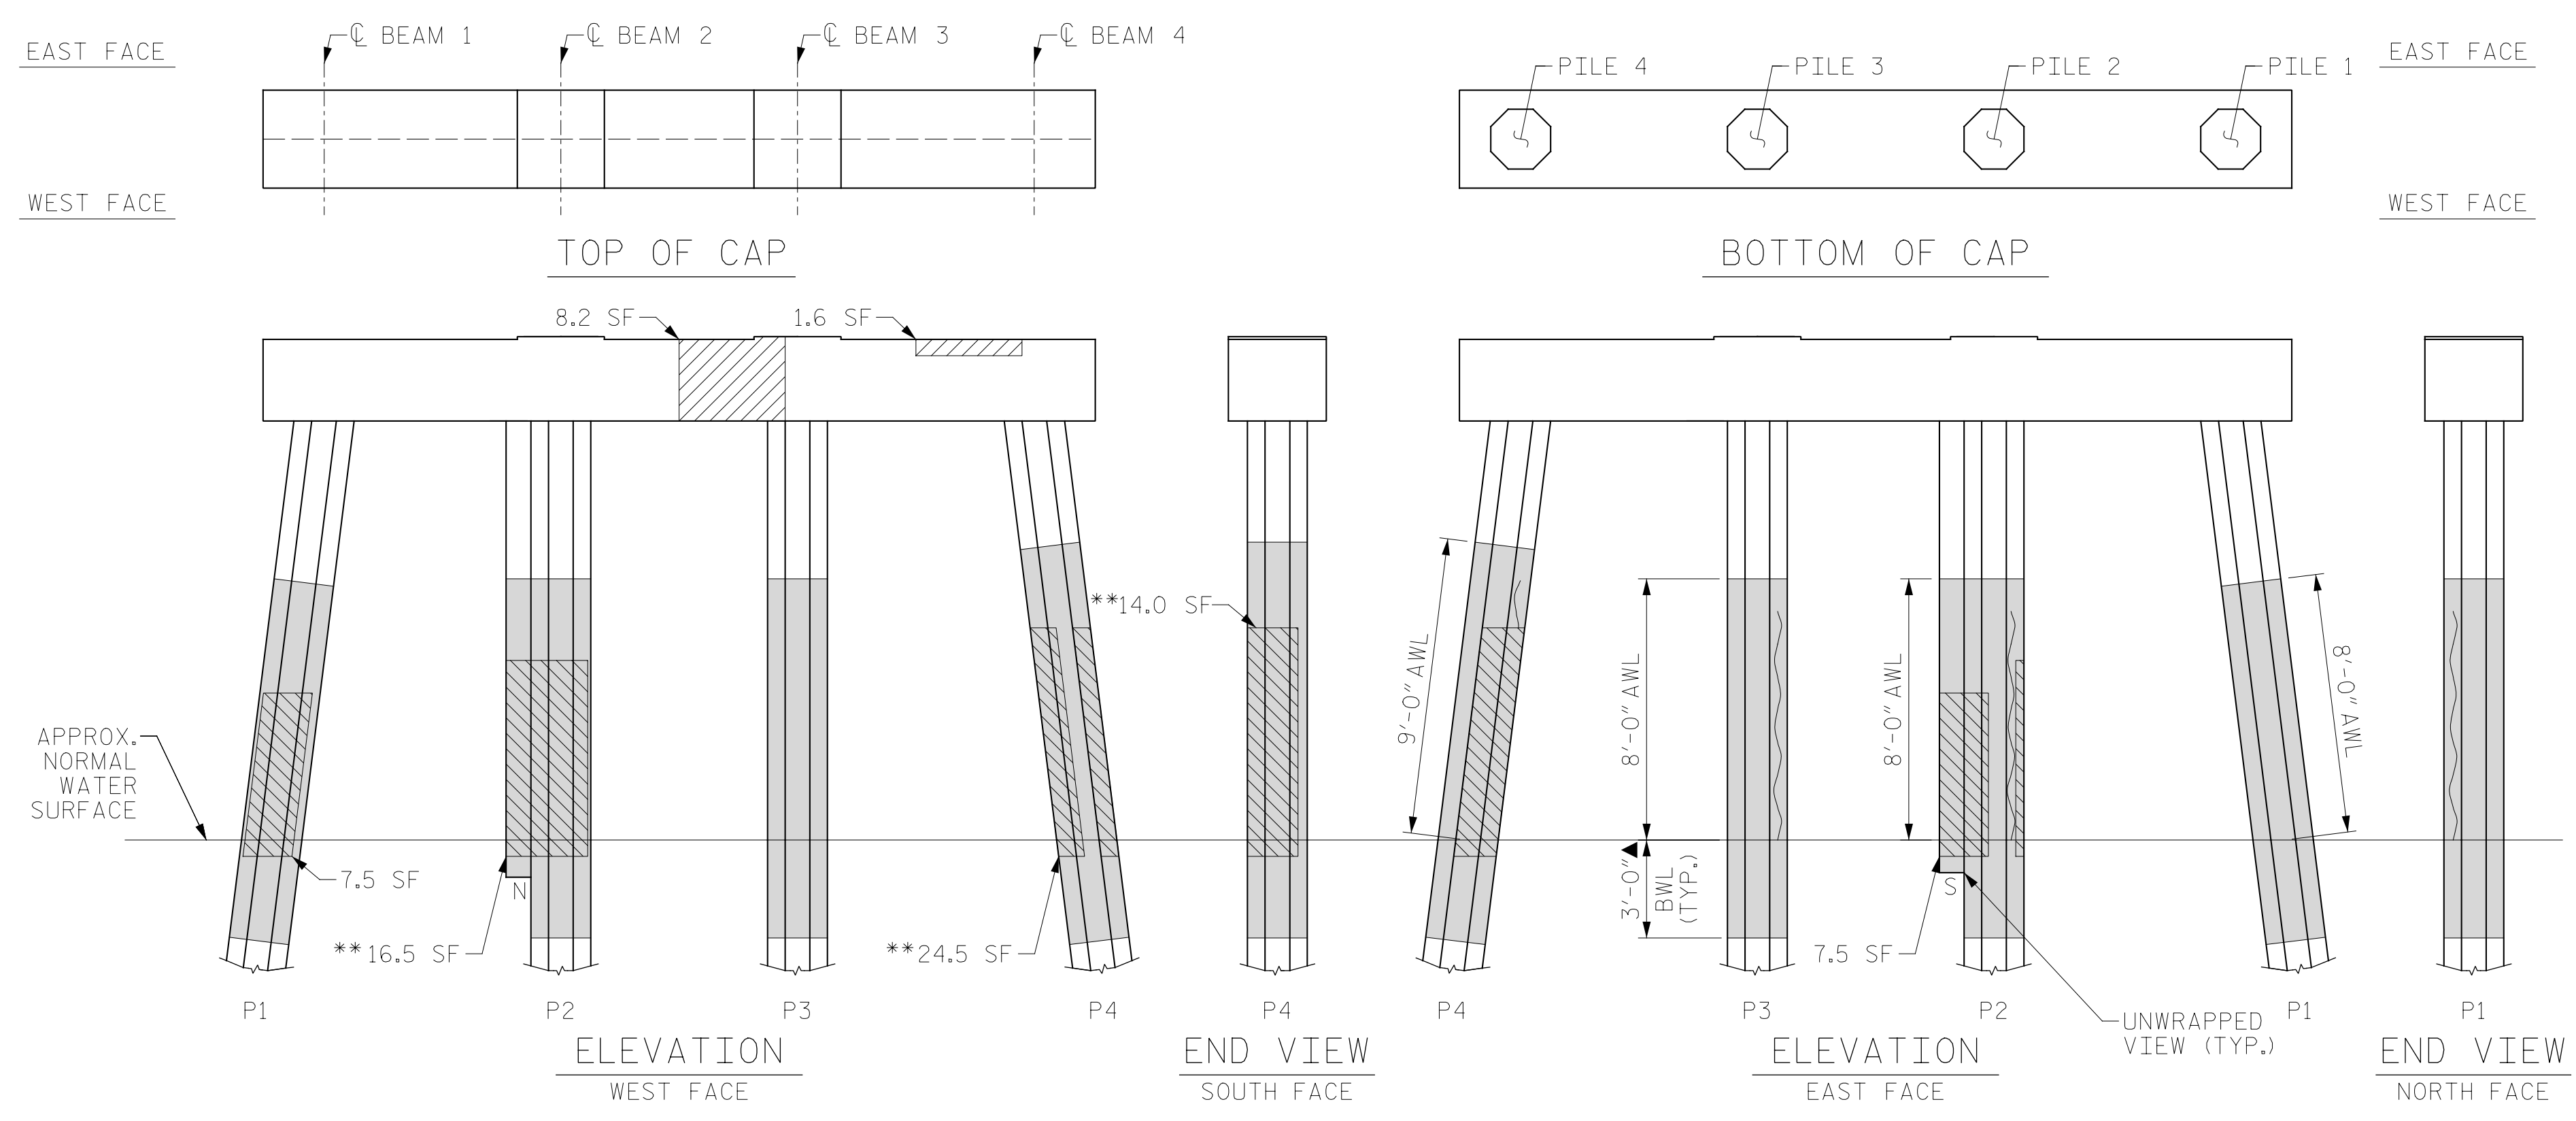
BENT 161

CAP REPAIRS			
SHOTCRETE REPAIRS	9.8 SF	4.9 CF	SF CF
EPOXY RESIN INJECTION	- LF		LF
PILE REPAIRS			
PILE CONCRETE RESTORATION	70.0 SF	27.6 CF	SF CF
FRP PROTECTIVE SYSTEM AWL	201.3 SF		
FRP PROTECTIVE SYSTEM BWL	73.2 SF

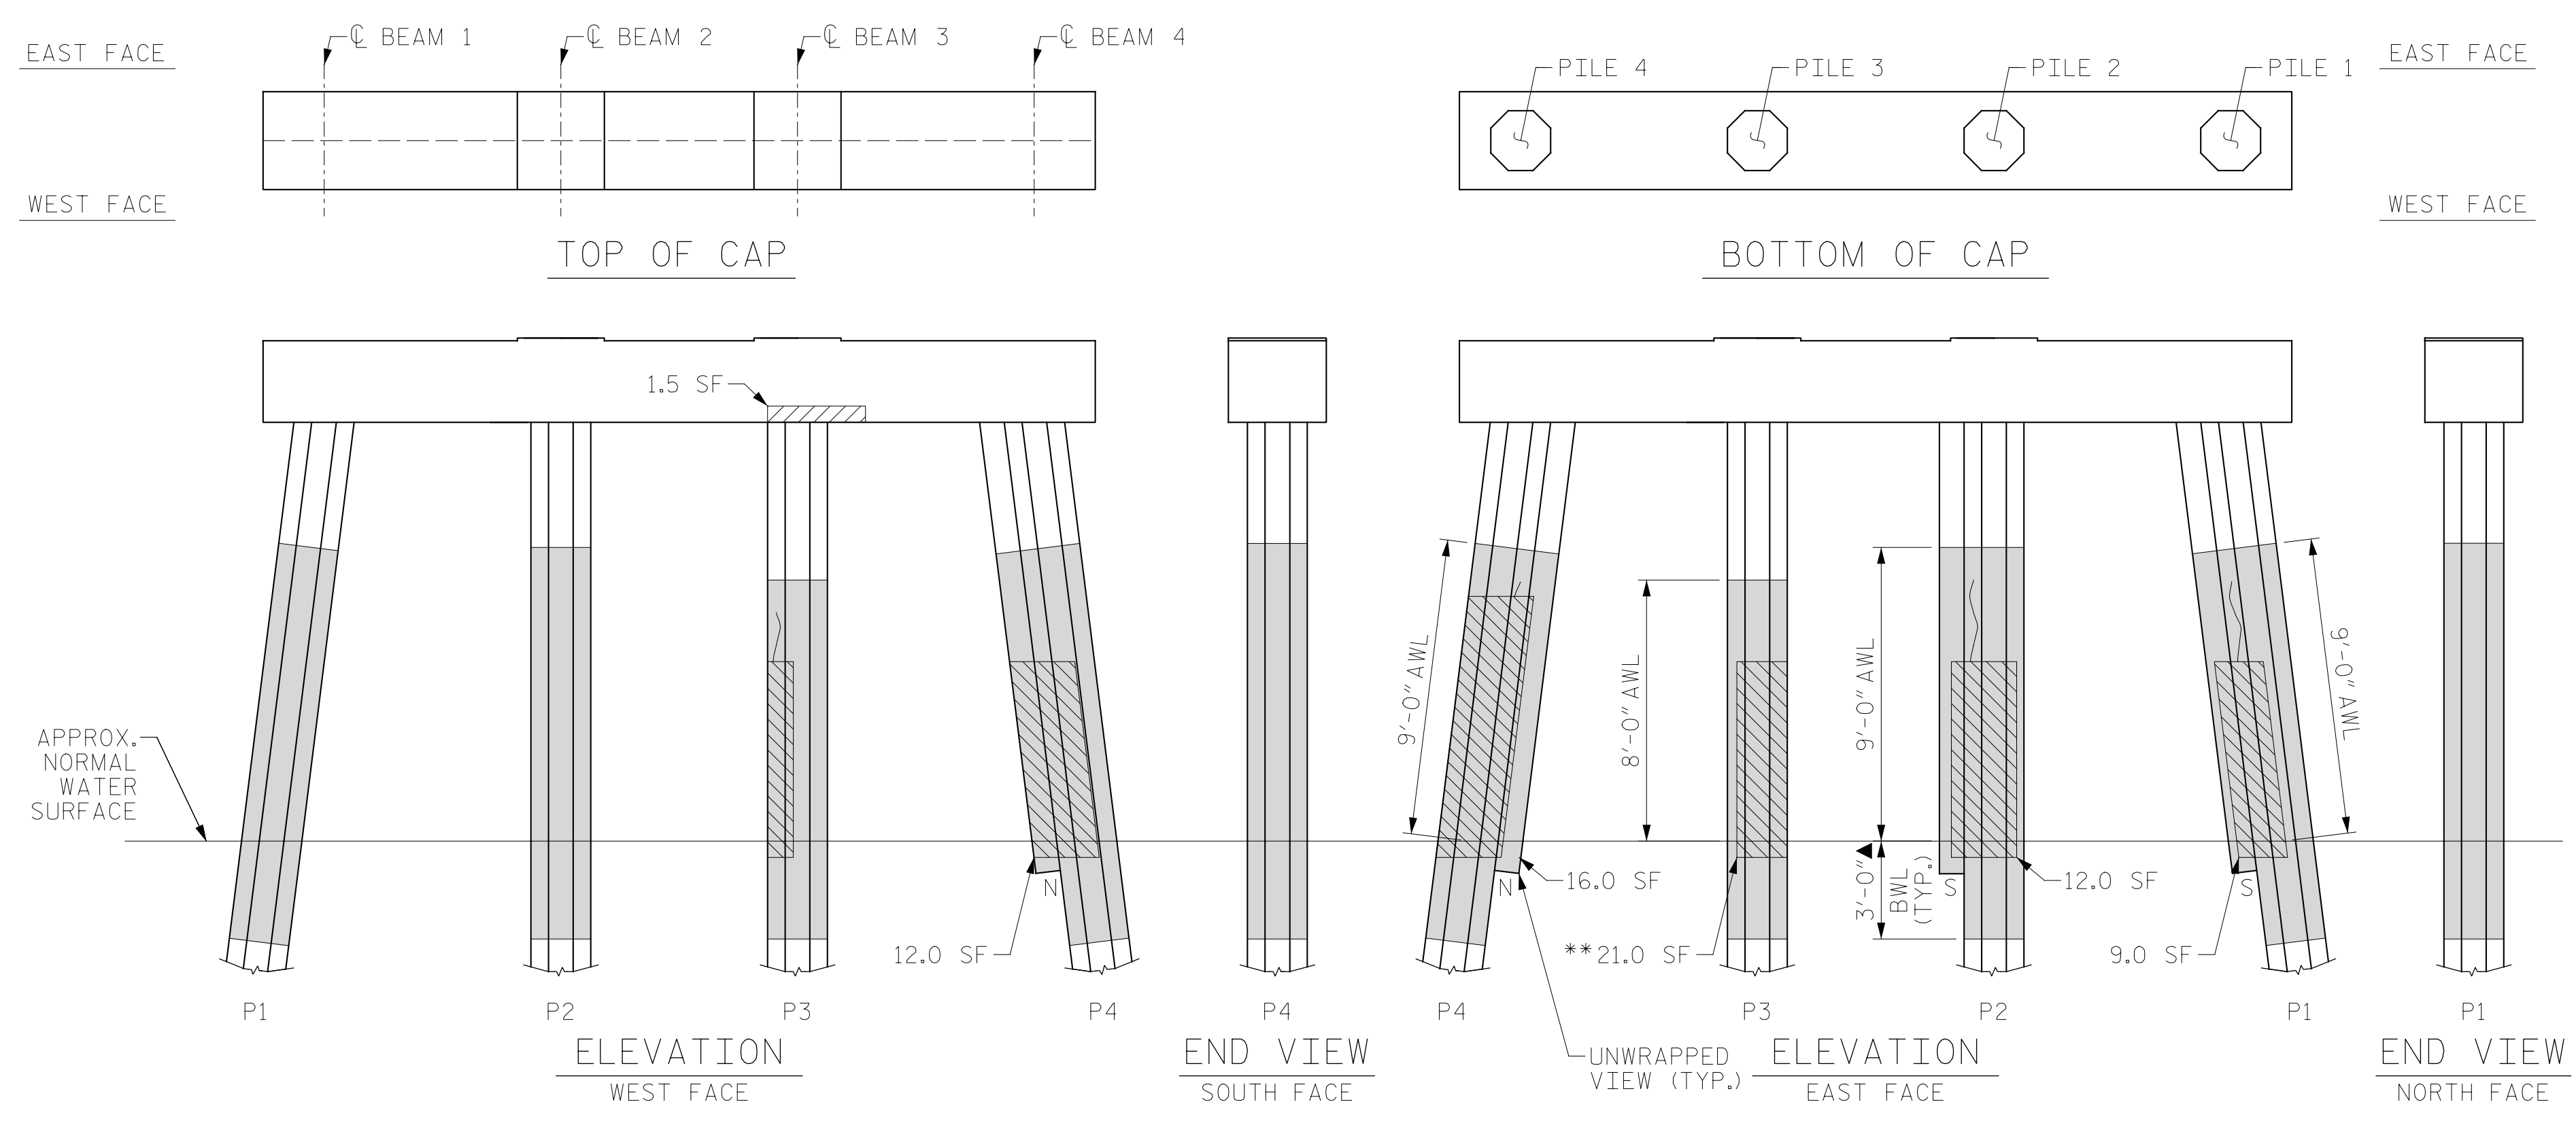
BENT 162

CAP REPAIRS			
SHOTCRETE REPAIRS	1.5 SF	0.8 CF	SF CF
EPOXY RESIN INJECTION	- LF		LF
PILE REPAIRS			
PILE CONCRETE RESTORATION	70.0 SF	27.5 CF	SF CF
FRP PROTECTIVE SYSTEM AWL	213.5 SF		
FRP PROTECTIVE SYSTEM BWL	73.2 SF

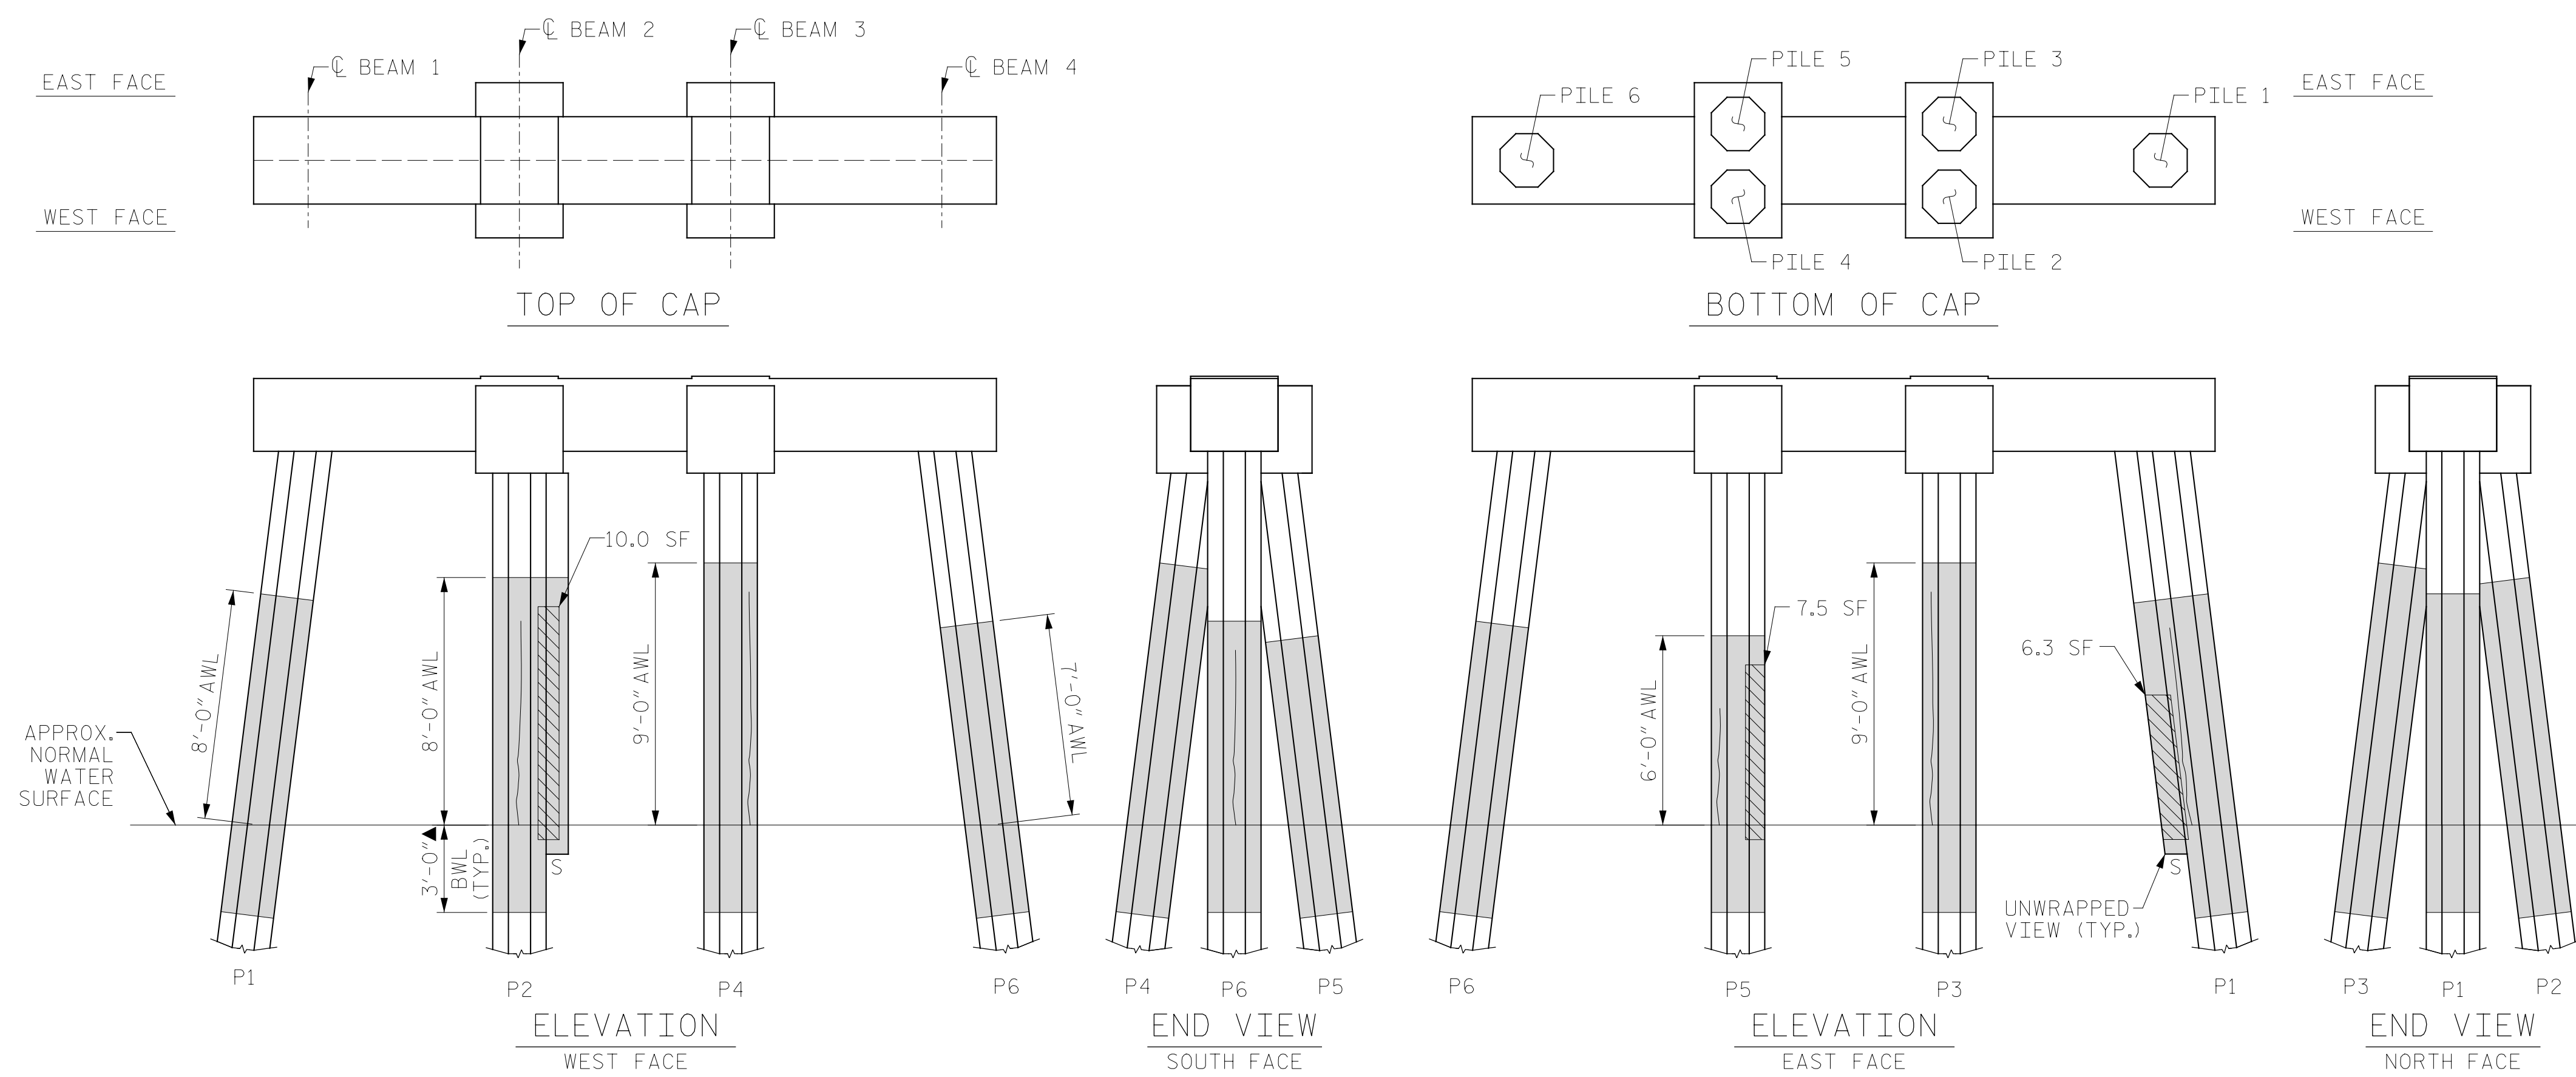
BENT 235

CAP REPAIRS			
SHOTCRETE REPAIRS	- SF	- CF	SF CF
EPOXY RESIN INJECTION	- LF		LF
PILE REPAIRS			
PILE CONCRETE RESTORATION	23.8 SF	10.1 CF	SF CF
FRP PROTECTIVE SYSTEM AWL	258.5 SF		
FRP PROTECTIVE SYSTEM BWL	99.0 SF

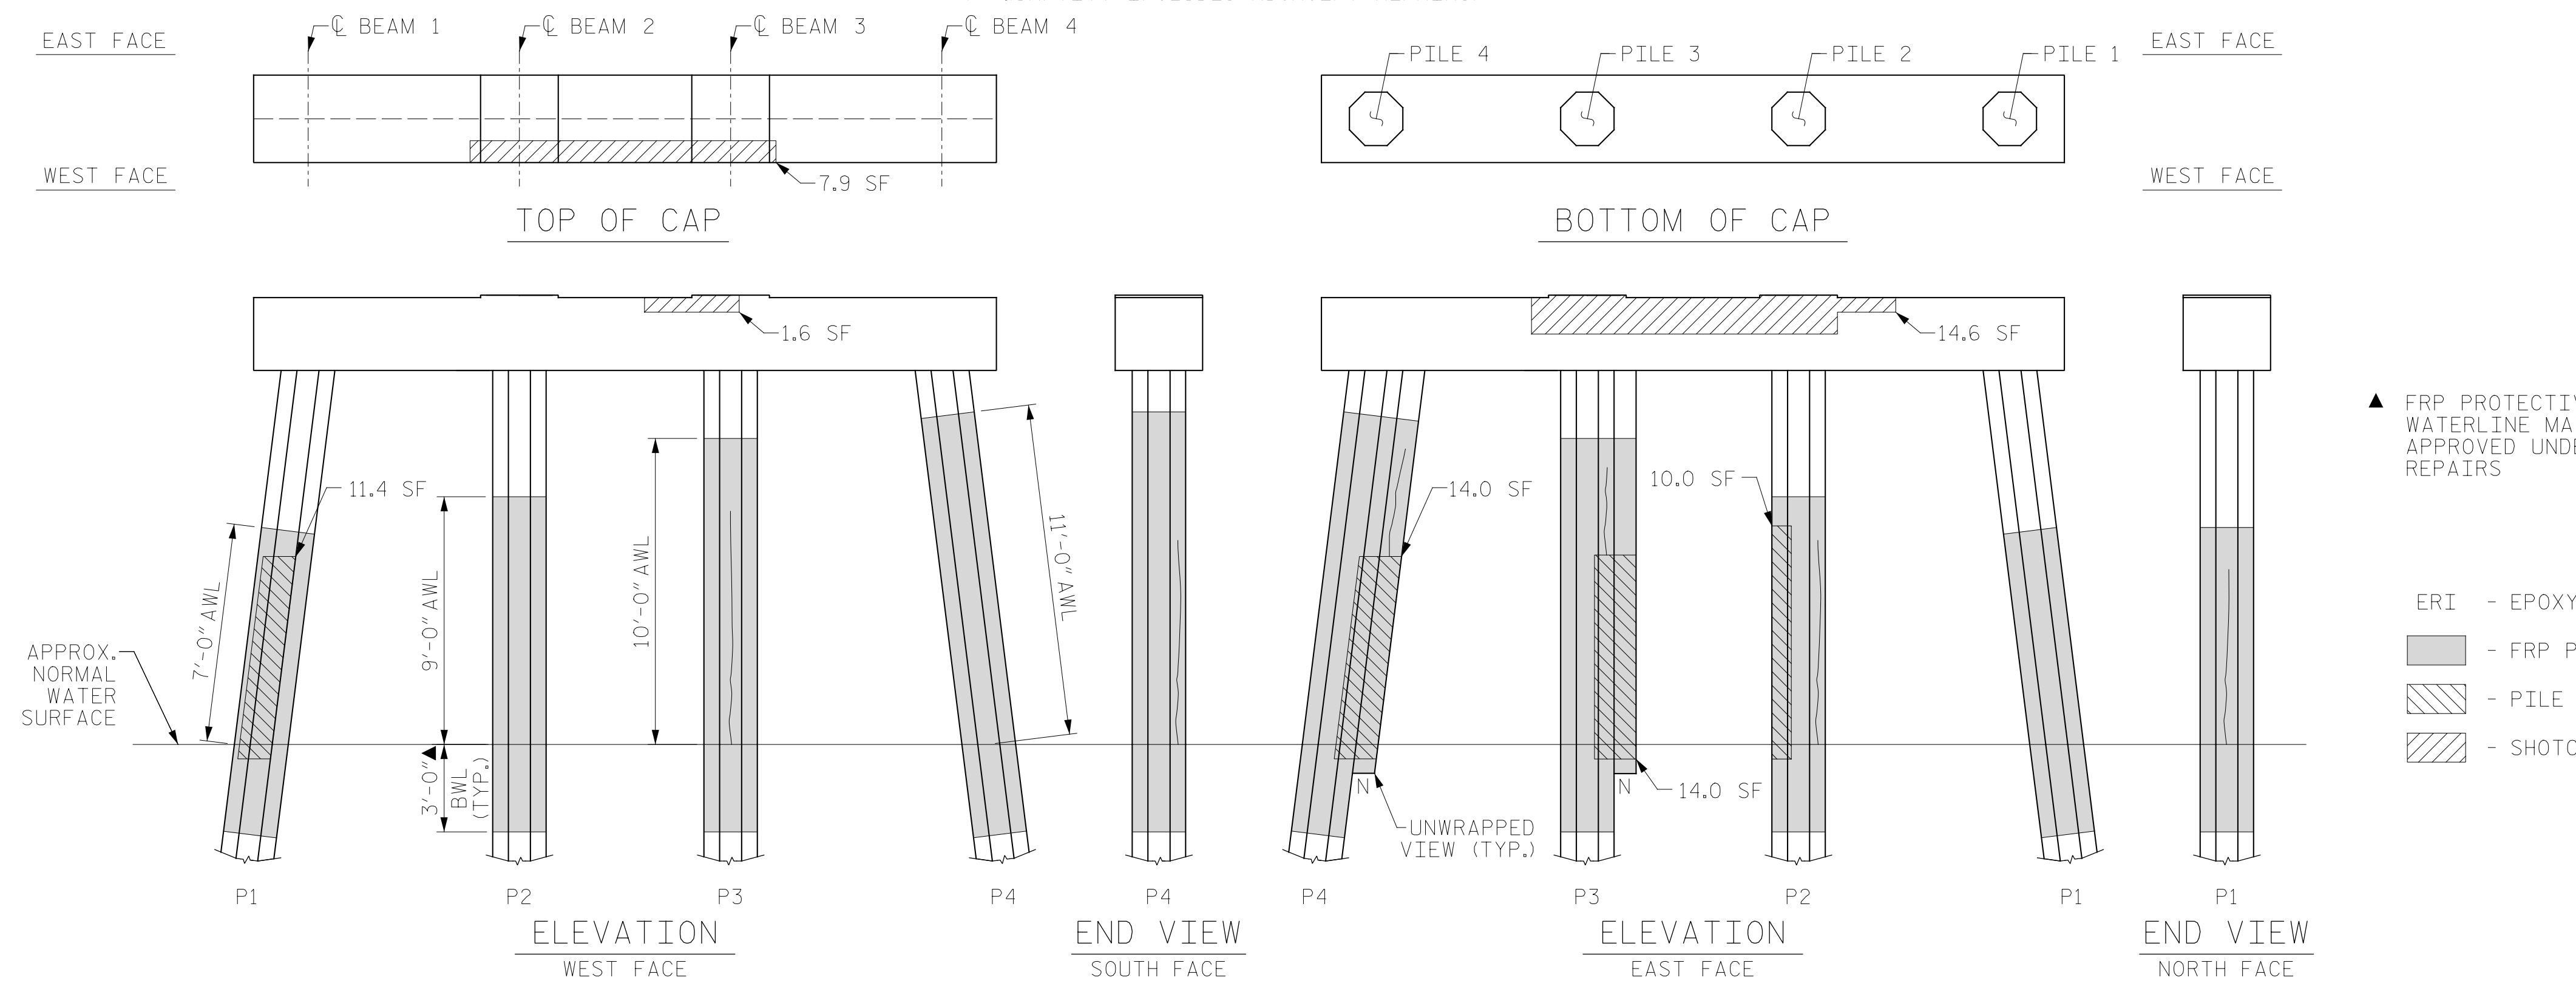
BENT 236

CAP REPAIRS			
SHOTCRETE REPAIRS	24.1 SF	12.1 CF	SF CF
EPOXY RESIN INJECTION	- LF		LF
PILE REPAIRS			
PILE CONCRETE RESTORATION	49.4 SF	20.4 CF	SF CF
FRP PROTECTIVE SYSTEM AWL	203.5 SF		
FRP PROTECTIVE SYSTEM BWL	66.0 SF
