AS-BUILT REPAIR QUANTITY TABLE

PROJECT NO. HB-0017  
DARE COUNTY  
 BRIDGE NO. 270009

STATE OF NORTH CAROLINA  
 DEPARTMENT OF TRANSPORTATION  
 RALEIGH

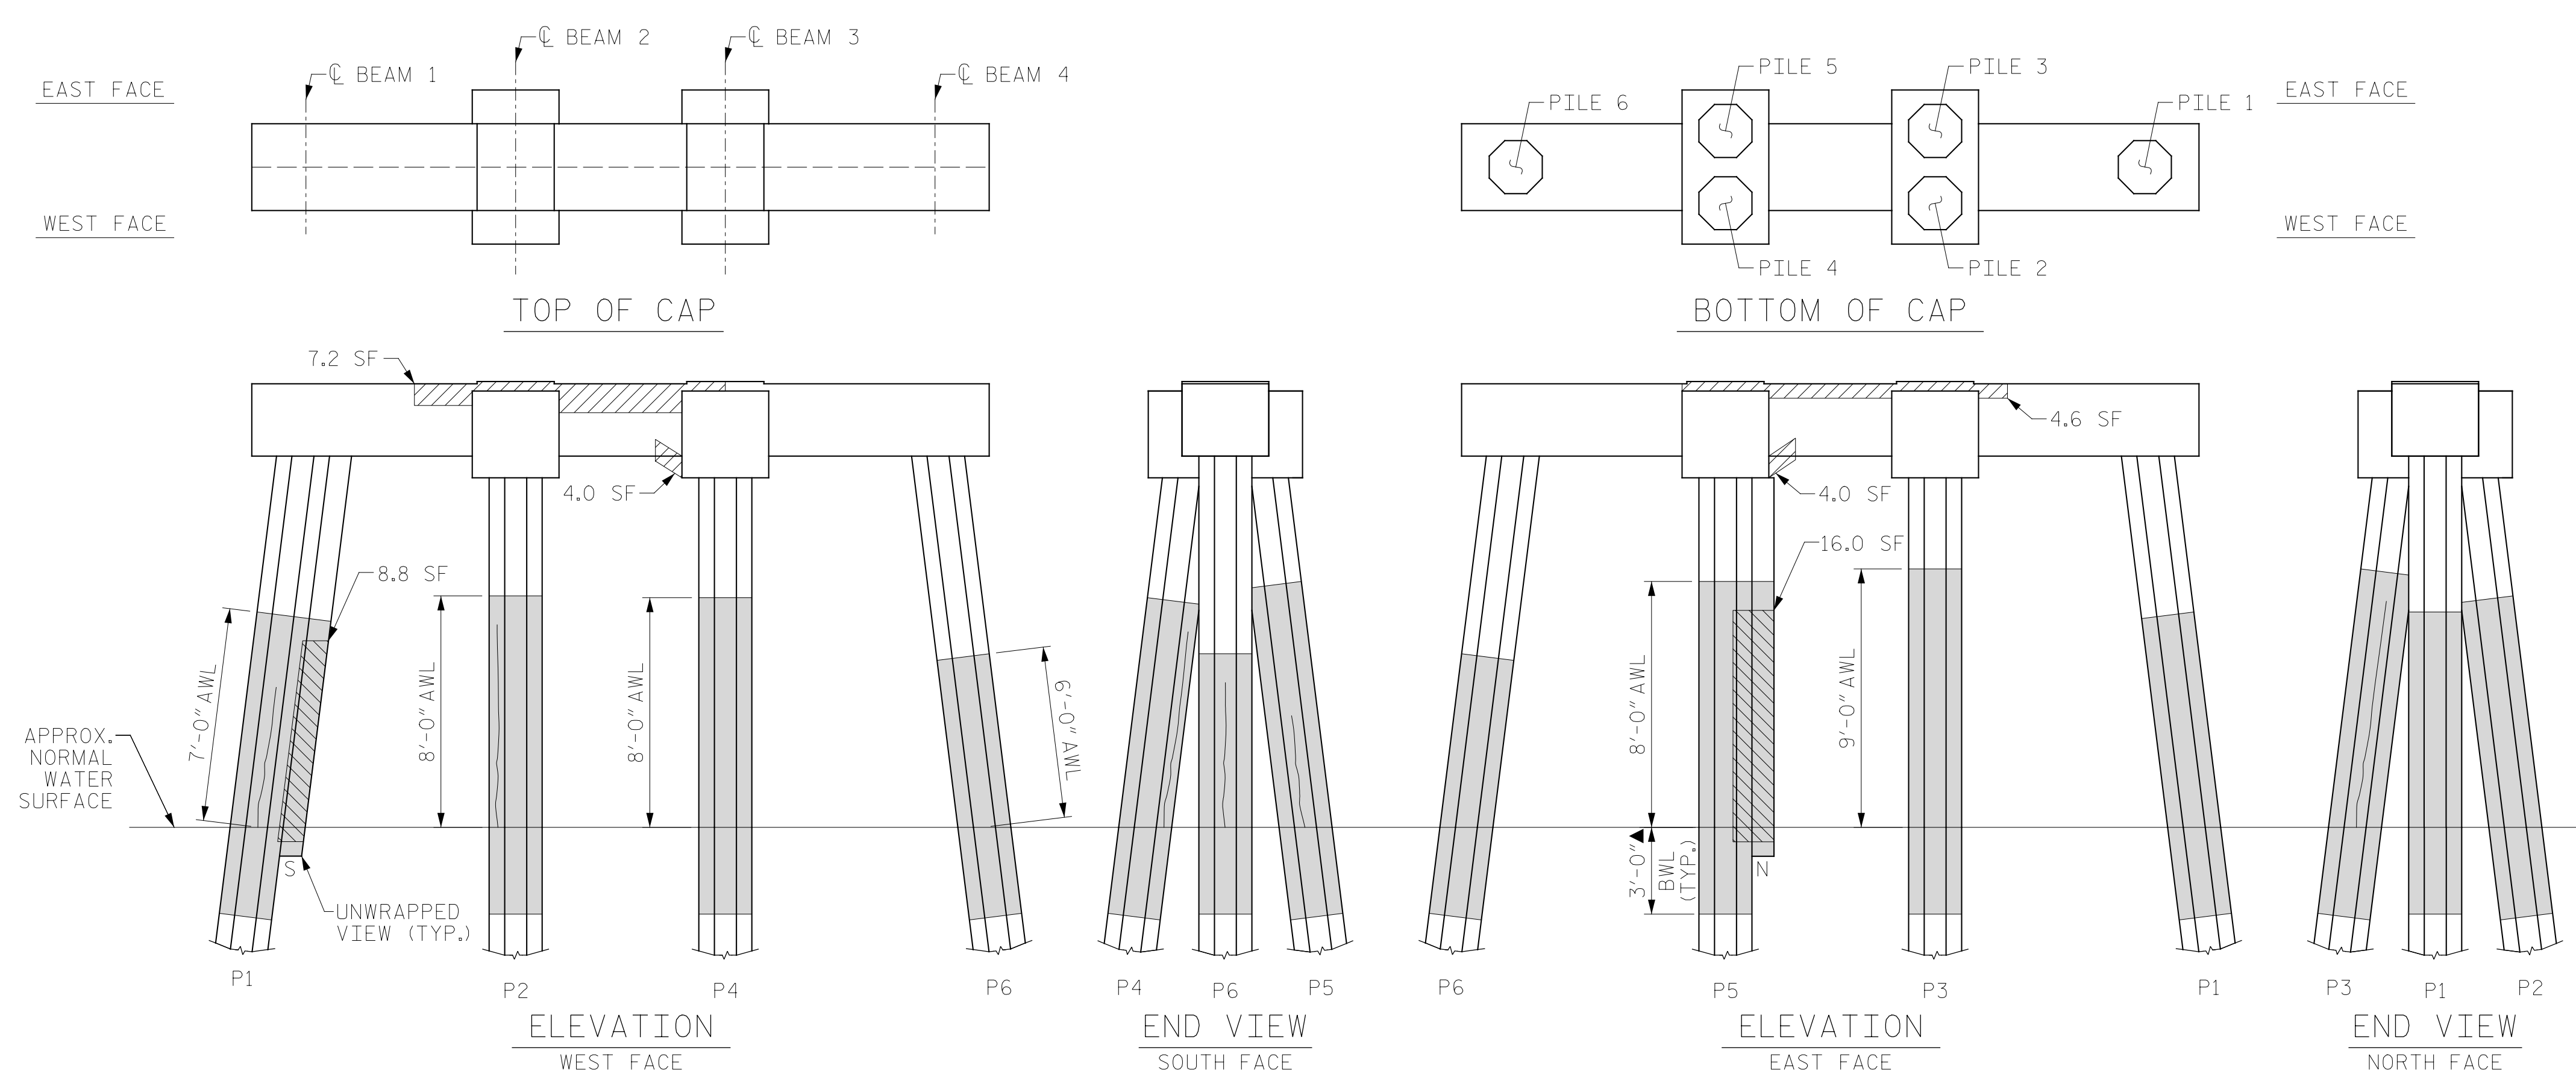
BENT 237

CAP REPAIRS			
SHOTCRETE REPAIRS	13.4 SF	6.7 CF	
EPOXY RESIN INJECTION	- LF		
PILE REPAIRS			
PILE CONCRETE RESTORATION	8.8 SF	3.7 CF	
FRP PROTECTIVE SYSTEM AWL	126.5 SF		
FRP PROTECTIVE SYSTEM BWL	66.0 SF

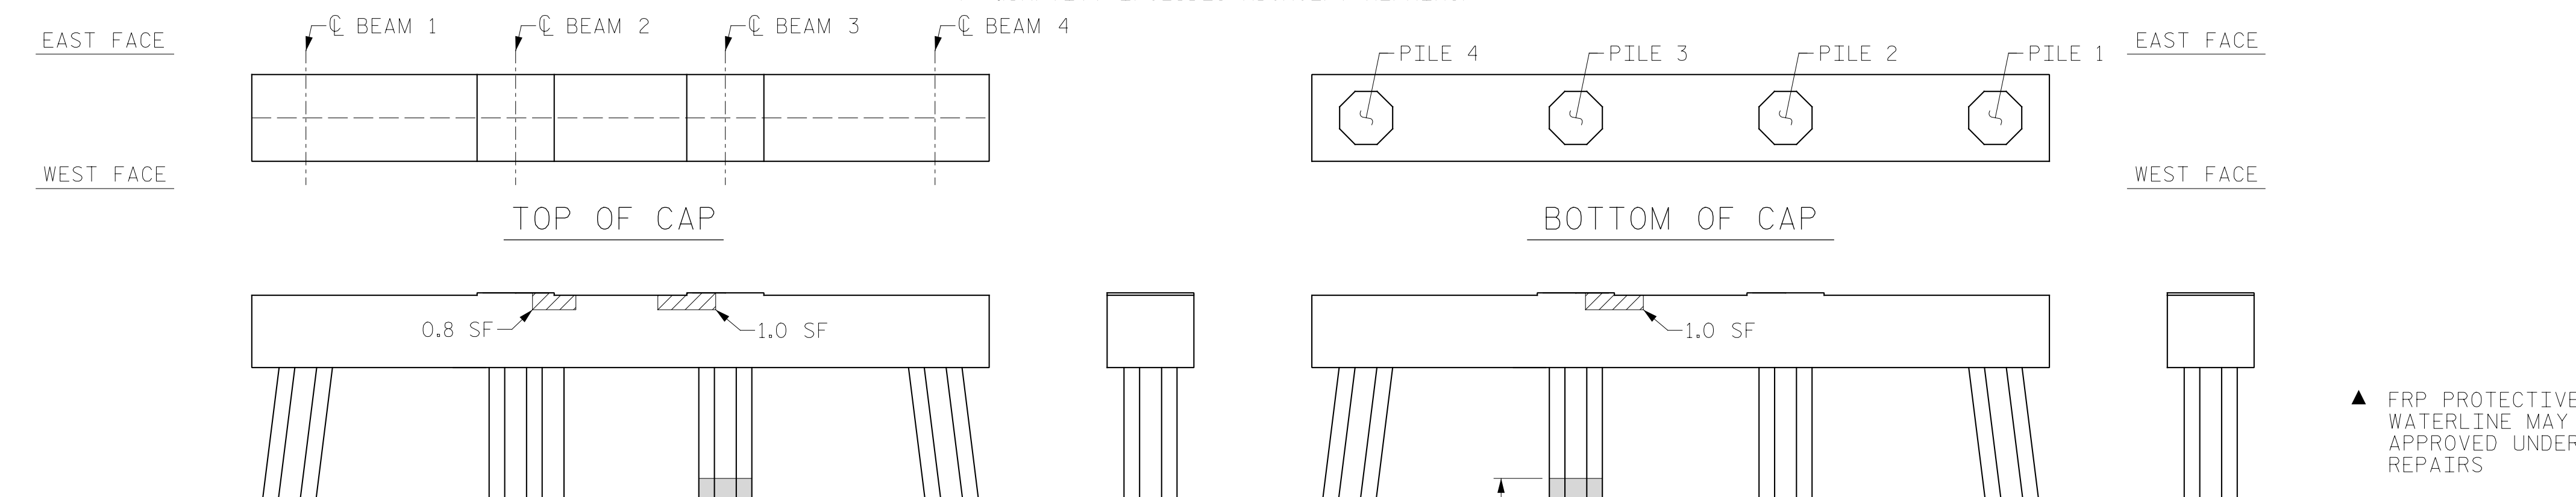
BENT 238

CAP REPAIRS			
SHOTCRETE REPAIRS	- SF	- CF	
EPOXY RESIN INJECTION	- LF		
PILE REPAIRS			
PILE CONCRETE RESTORATION	30.1 SF	12.3 CF	
FRP PROTECTIVE SYSTEM AWL	159.5 SF		
FRP PROTECTIVE SYSTEM BWL	66.0 SF

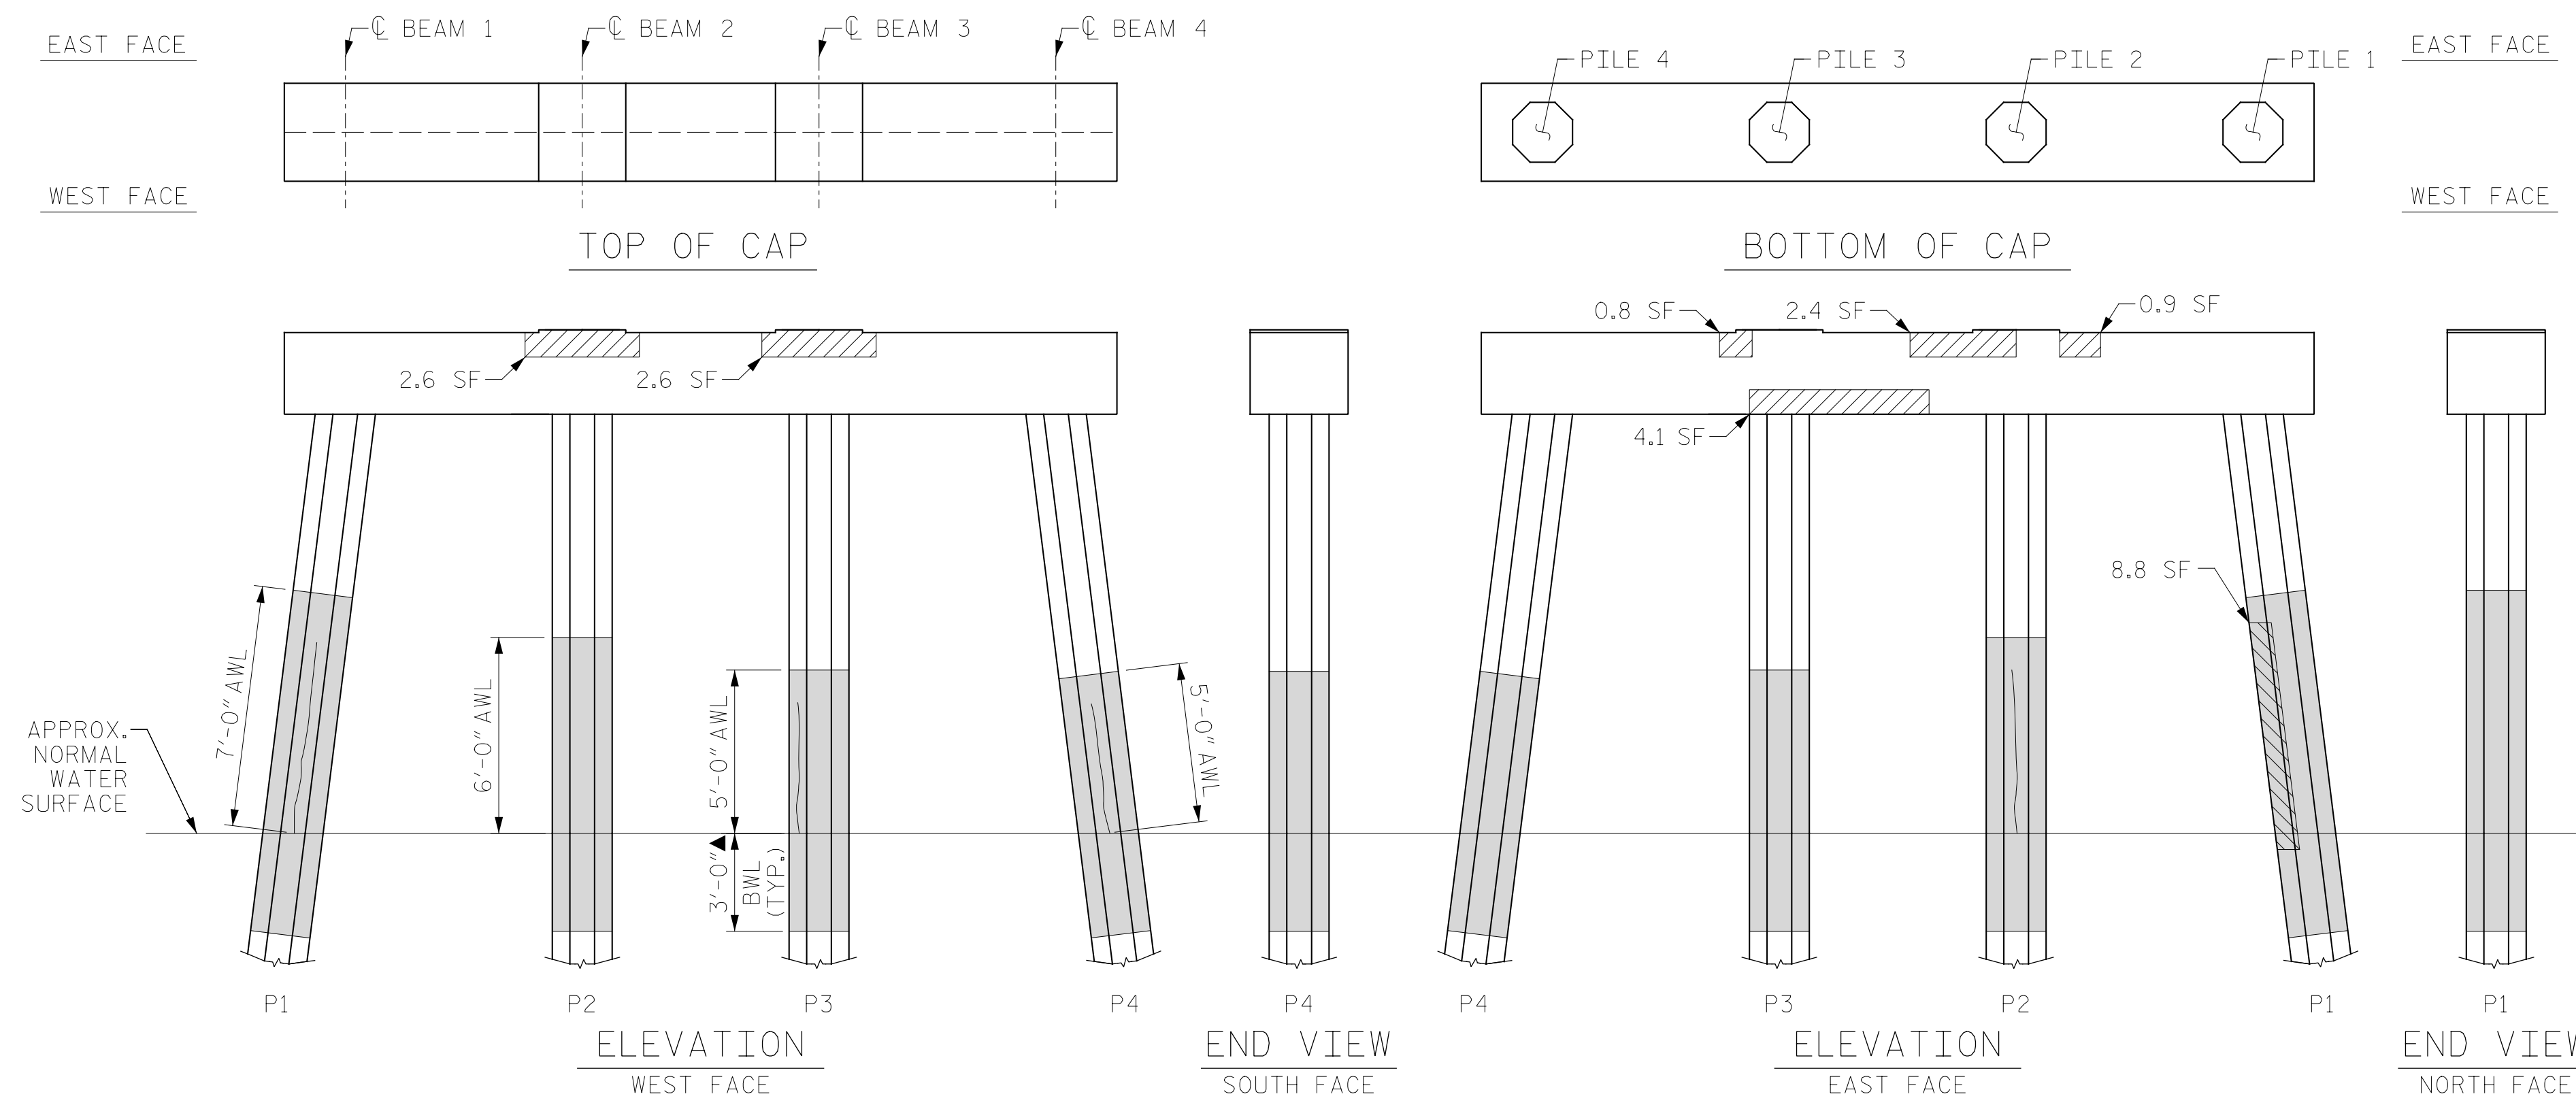
BENT 239

CAP REPAIRS			
SHOTCRETE REPAIRS	2.8 SF	1.4 CF	SF CF
EPOXY RESIN INJECTION	- LF		LF
PILE REPAIRS			
PILE CONCRETE RESTORATION	26.3 SF	10.9 CF	SF CF
FRP PROTECTIVE SYSTEM AWL	137.5 SF		
FRP PROTECTIVE SYSTEM BWL	66.0 SF

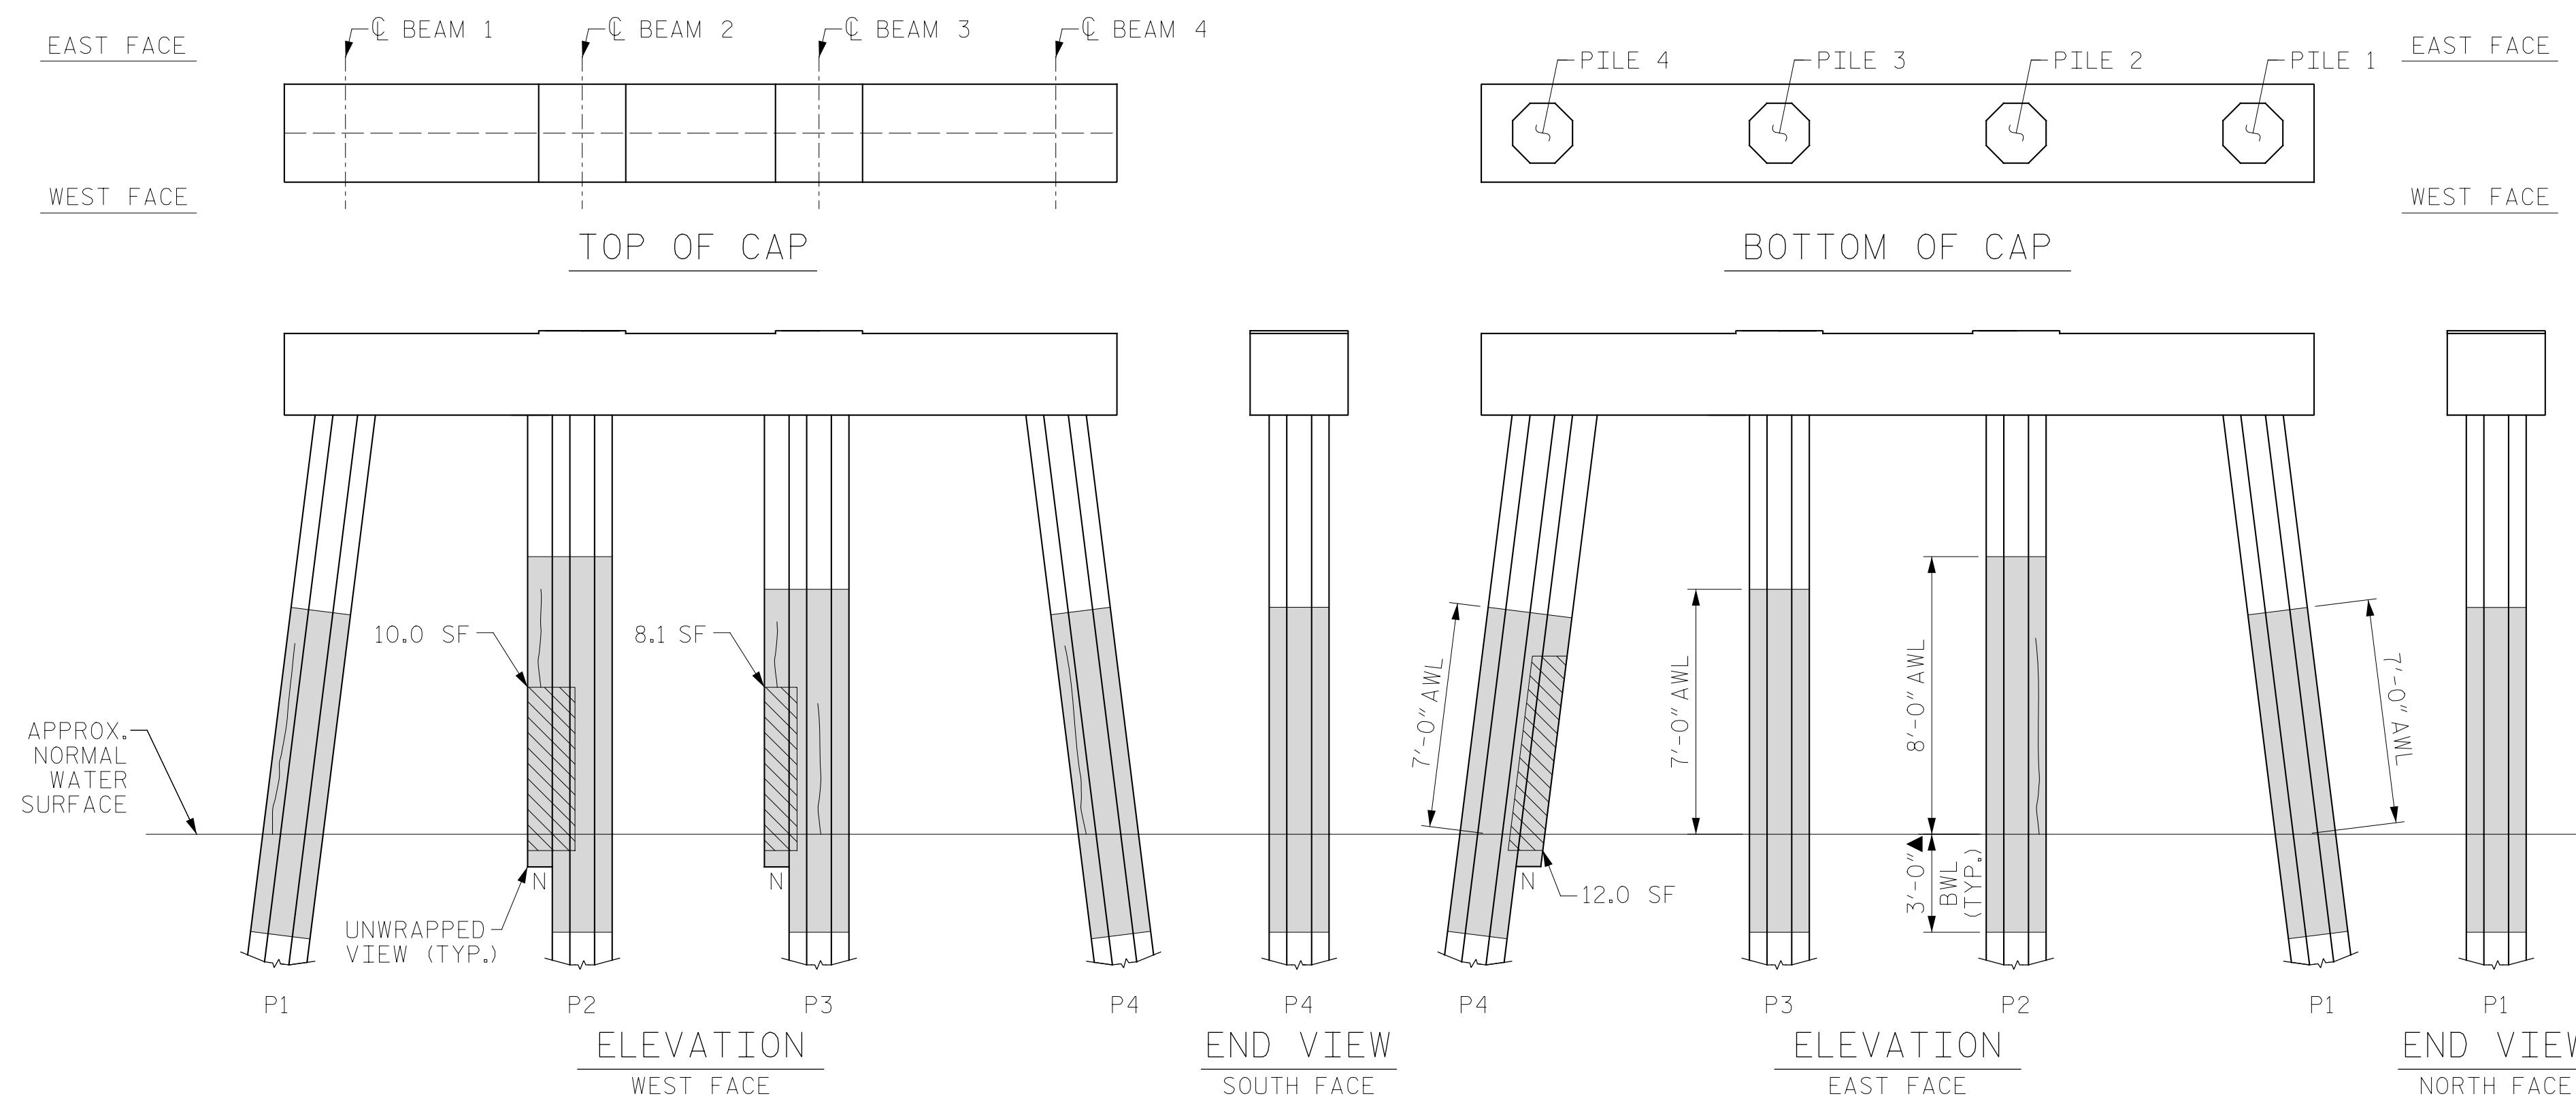
BENT 240

CAP REPAIRS			
SHOTCRETE REPAIRS	3.8 SF	1.9 CF	SF CF
EPOXY RESIN INJECTION	- LF		LF
PILE REPAIRS			
PILE CONCRETE RESTORATION	16.5 SF	6.6 CF	SF CF
FRP PROTECTIVE SYSTEM AWL	197.1 SF		
FRP PROTECTIVE SYSTEM BWL	66.0 SF

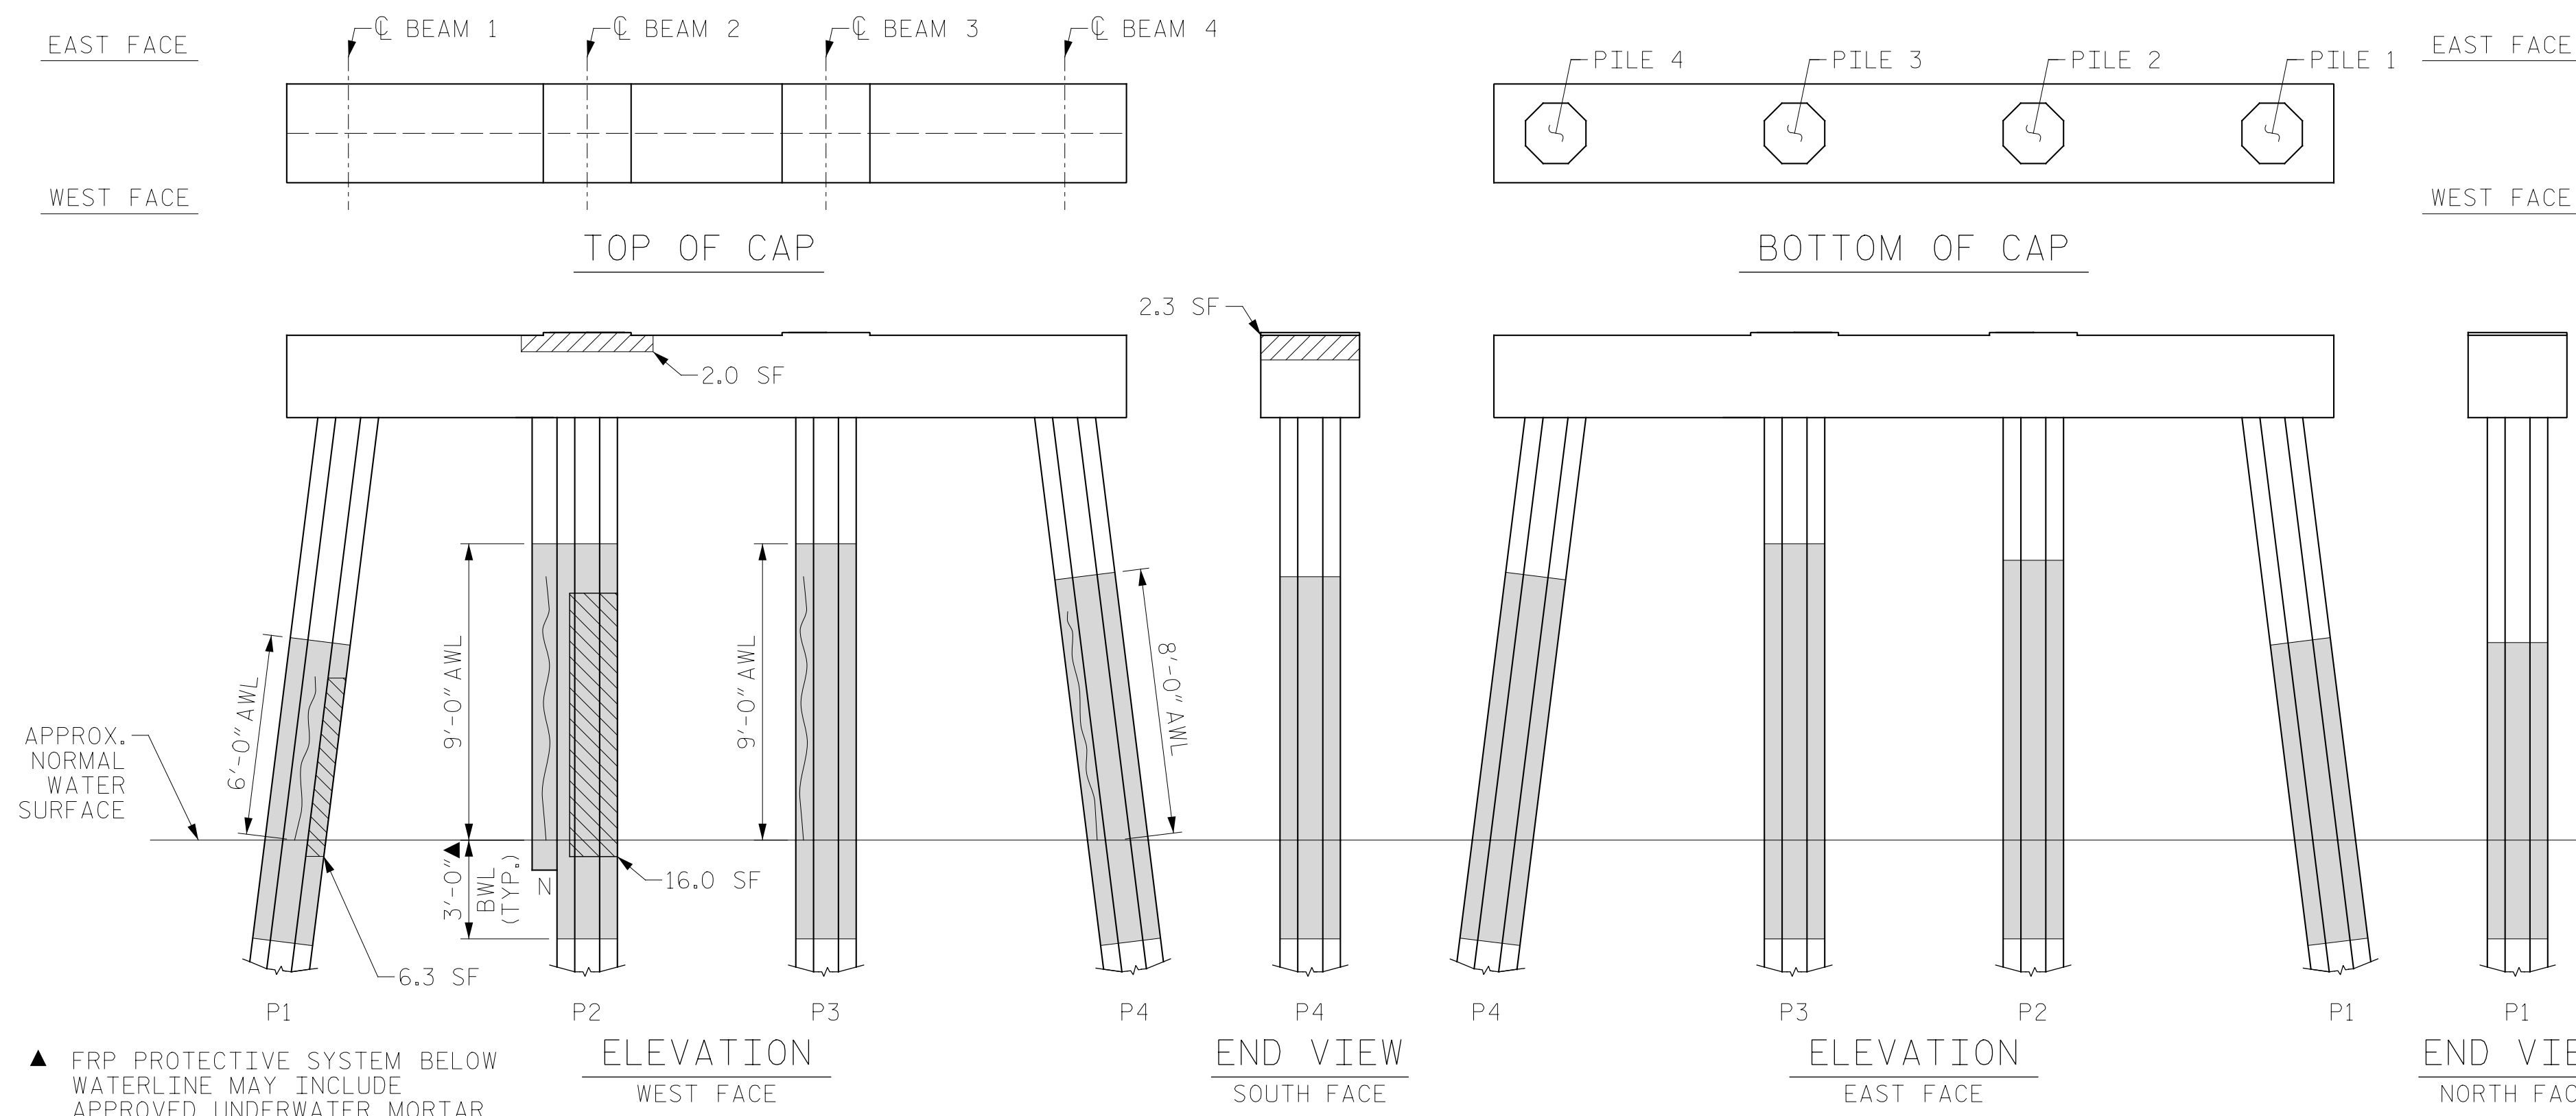
BENT 243

BENT	PILE	DIRECTION							
		NW	W	SW	S	SE	E	NE	N
243	PILE 1	3	5	-	-	5	4	-	-
	PILE 2	-	-	-	3	3	-	7	8
	PILE 3	8	6	4	3	-	-	-	-
	PILE 4	6	3	4	-	-	4	-	7
244	PILE 1	6	-	-	-	7	-	-	7
	PILE 2	-	-	5	2	-	-	-	-
	PILE 3	-	4	-	-	4	-	7	7
	PILE 4	-	-	4	-	4	-	-	4
	PILE 5	3	12	3	6	-	-	-	-
	PILE 6	-	9	-	-	4	-	-	12

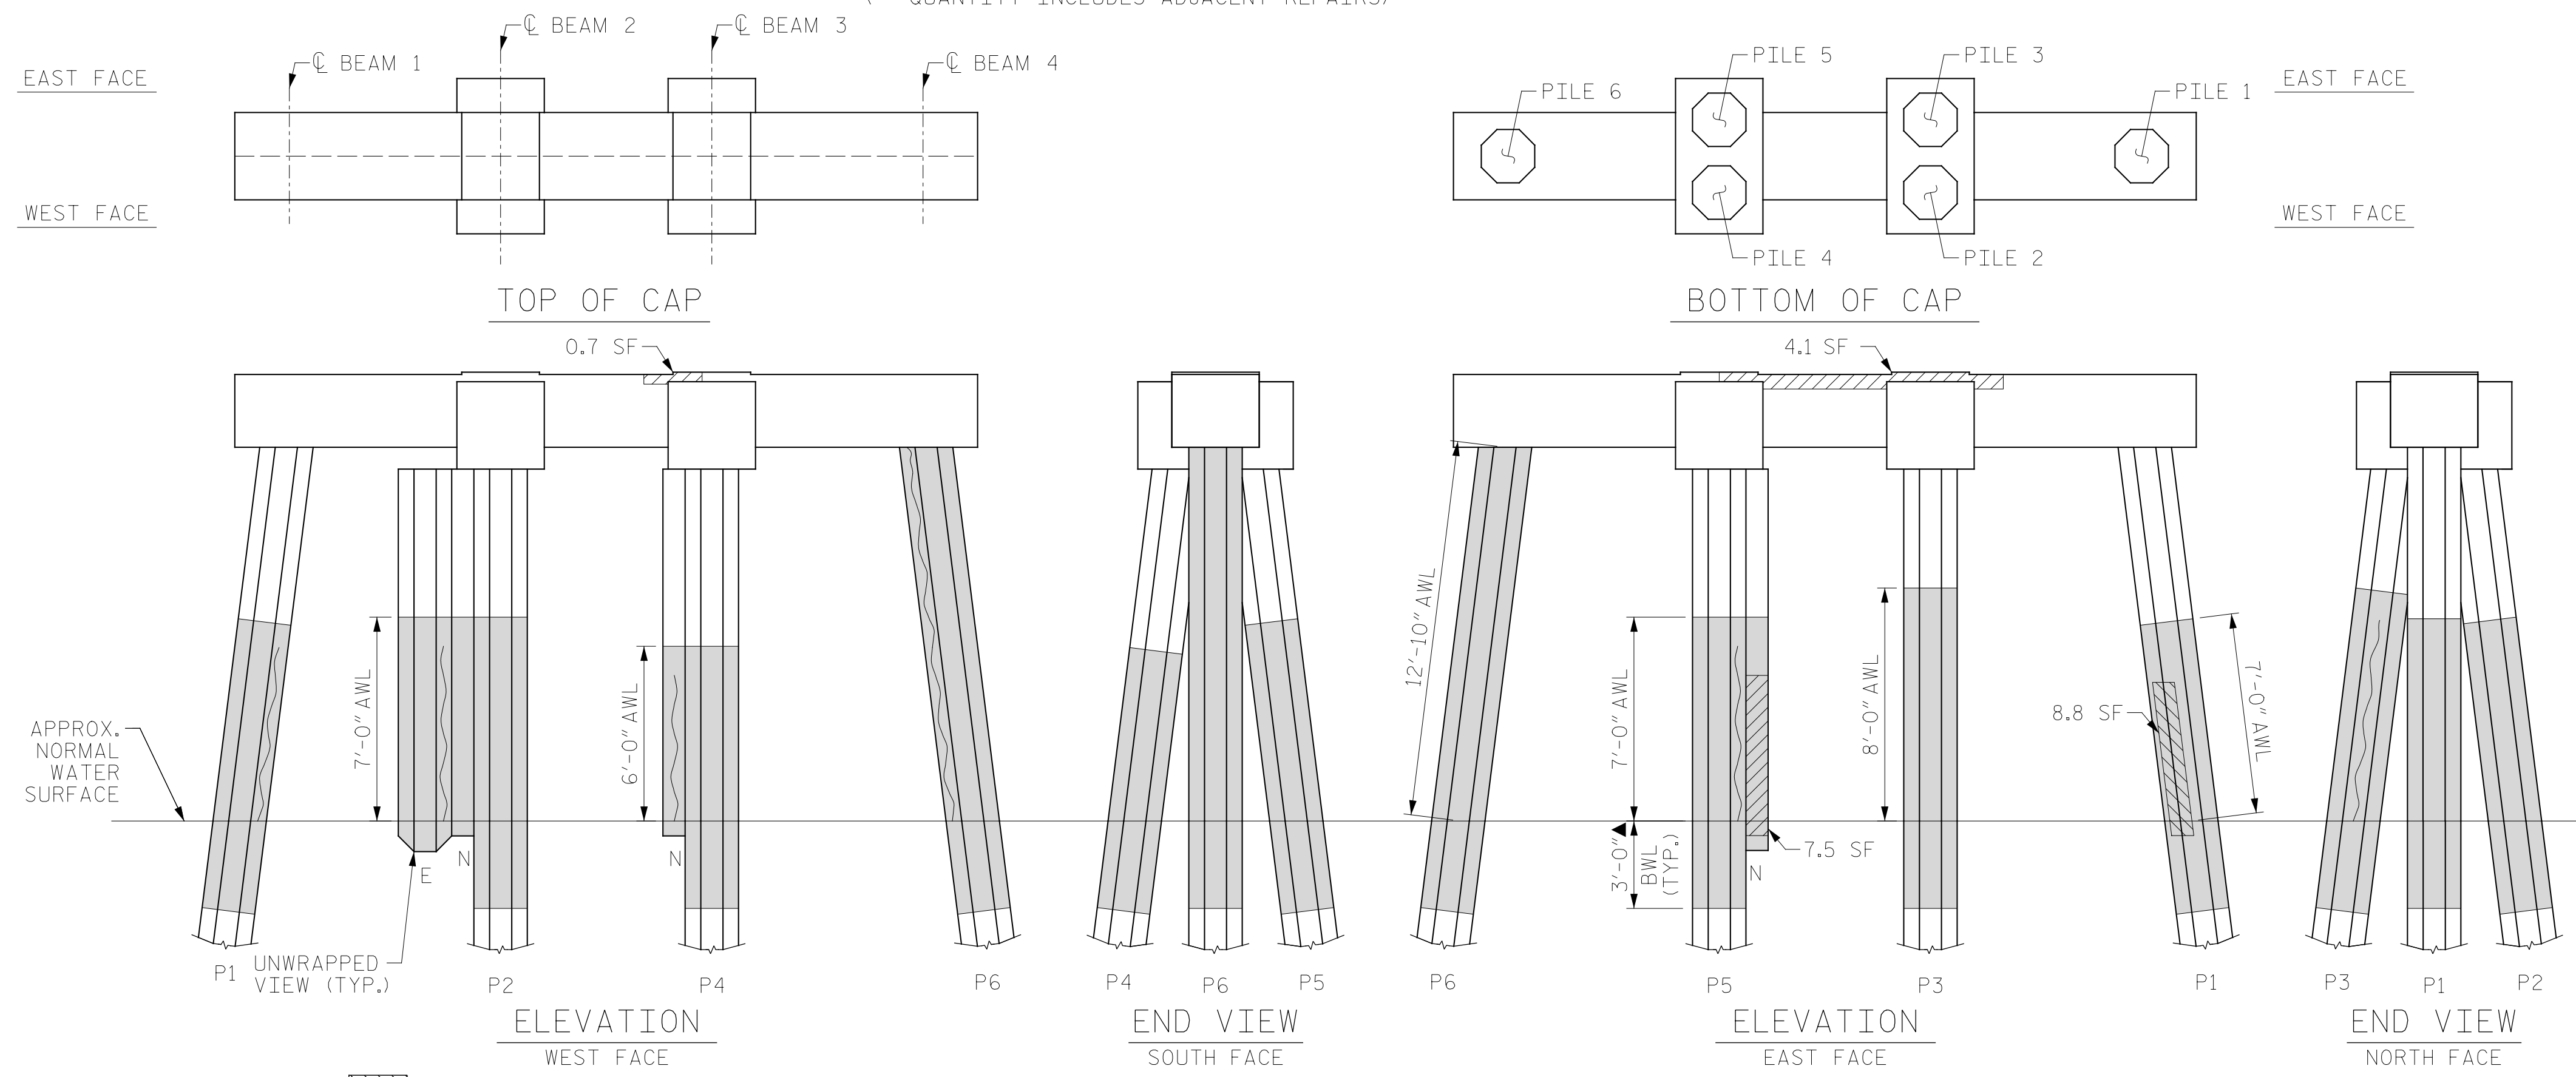
NW	W	SW	S	SE	E	NE	N
BENT 259	PILE 1	-	4	-	6	6	-	-	-
	PILE 2	-	6	-	3	3	6	-	-
	PILE 3	-	6	3	-	-	4	6	-
	PILE 4	-	4	4	-	4	4	-	-
BENT 260	PILE 1	-	-	6	6	-	-	-	-
	PILE 2	2	-	4	5	-	4	6	5
	PILE 3	-	6	6	-	-	-	-	7
	PILE 4	3	-	-	3	3	5	5	-
	PILE 5	6	-	5	4	-	5	6	-
	PILE 6	13	4	5	-	5	6	13	-

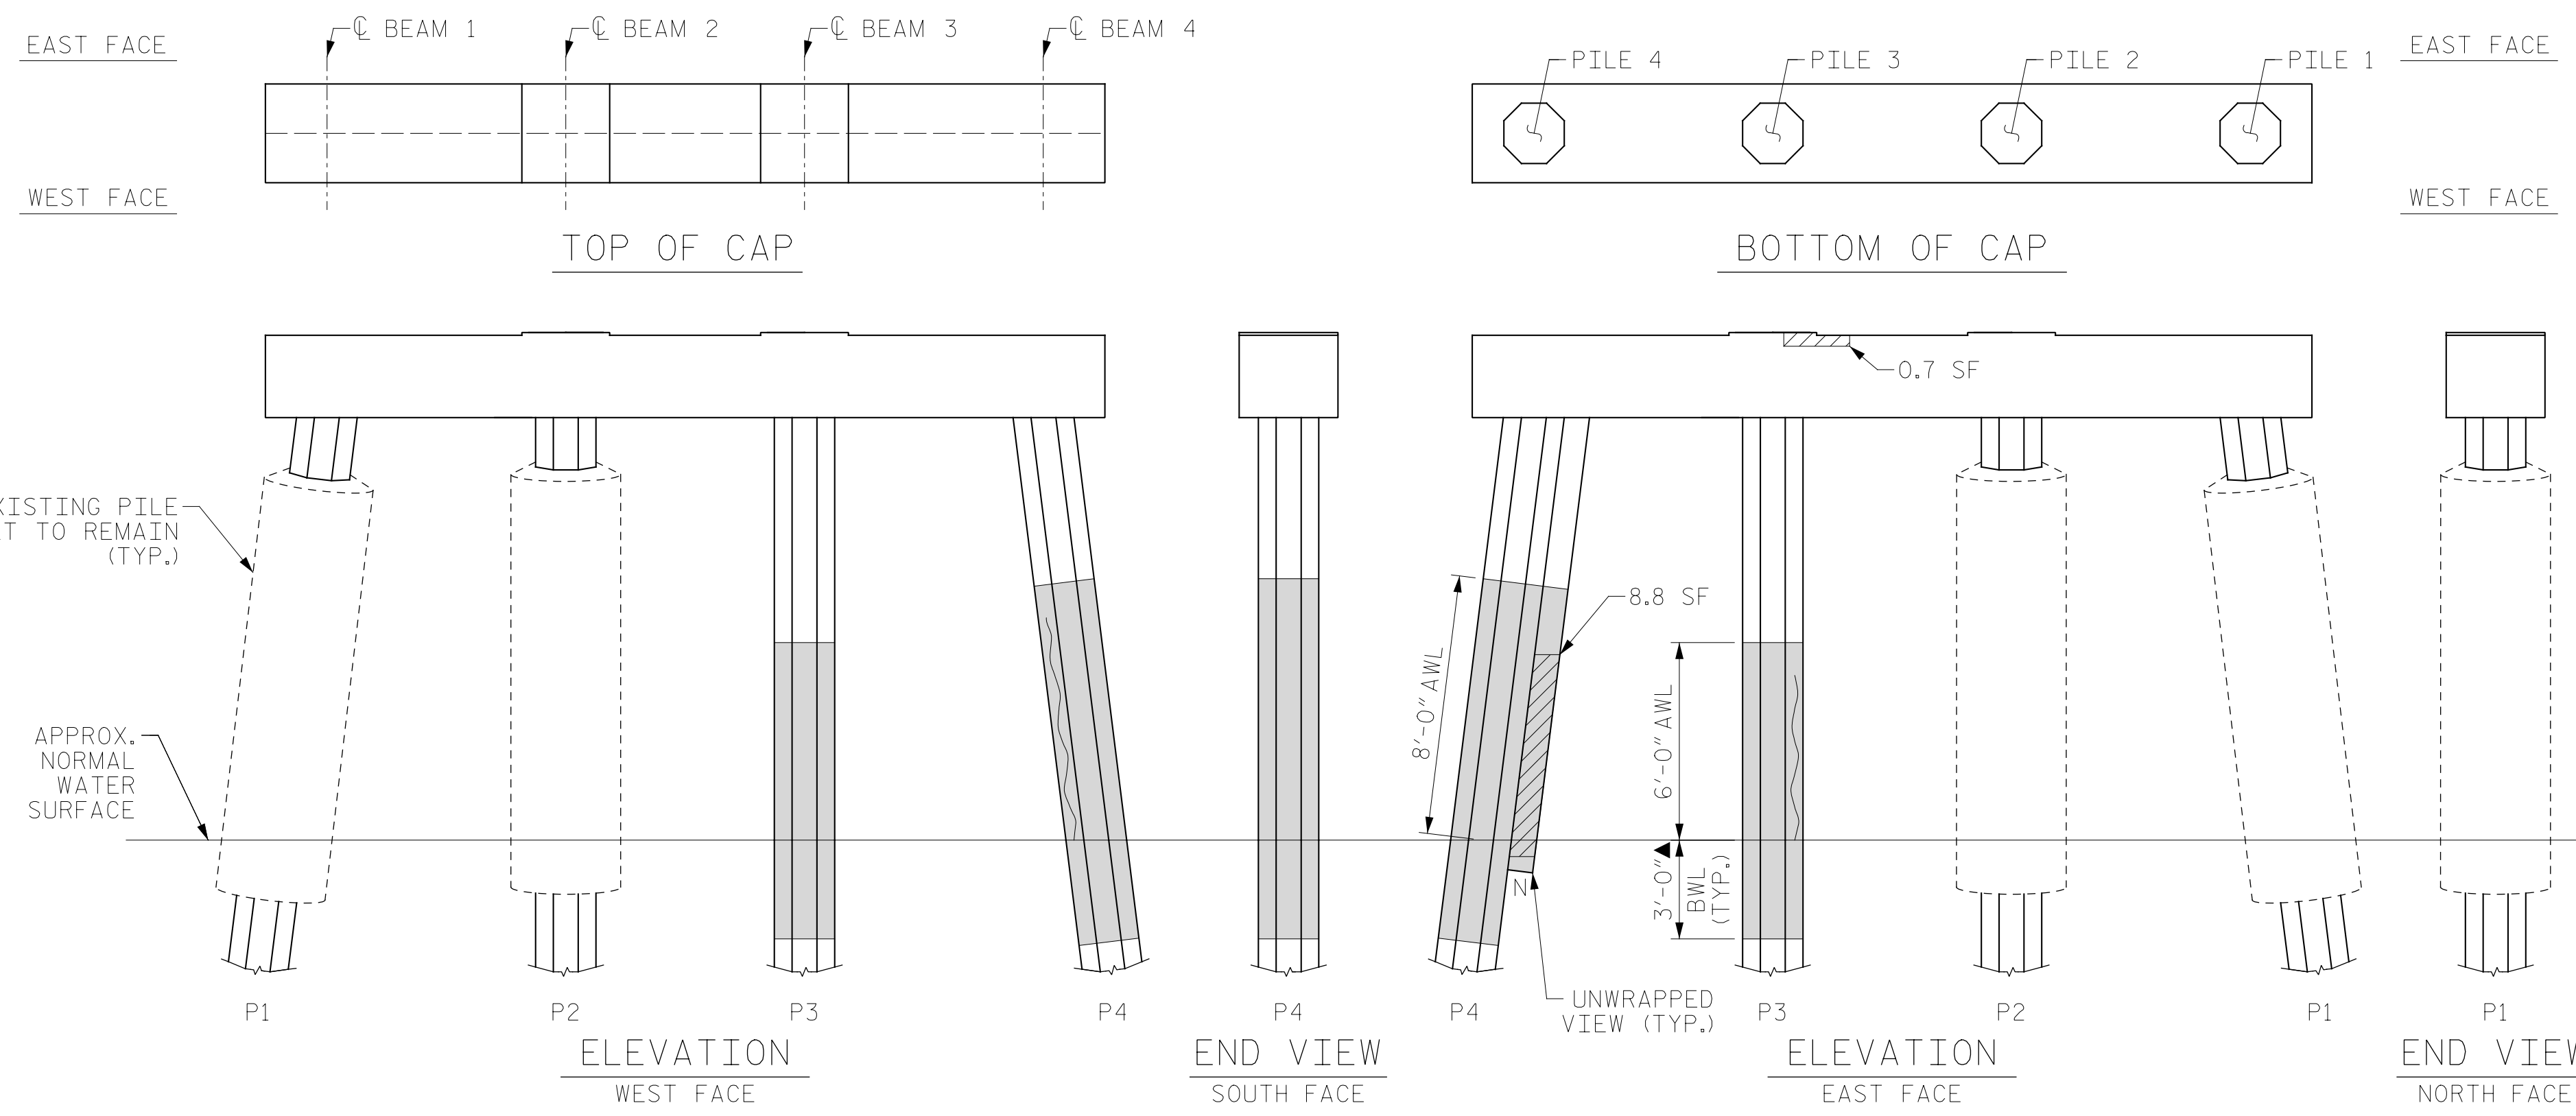
BENT 263

CAP REPAIRS		ESTIMATE			
SHOTCRETE REPAIRS	2.3 SF	1.2 CF	SF	CF	
EPOXY RESIN INJECTION	- LF				LF
PILE REPAIRS		ESTIMATE			
PILE CONCRETE RESTORATION	7.3 SF	3.2 CF	SF	CF	
FRP PROTECTIVE SYSTEM AWL	126.5 SF				
FRP PROTECTIVE SYSTEM BWL	49.5 SF

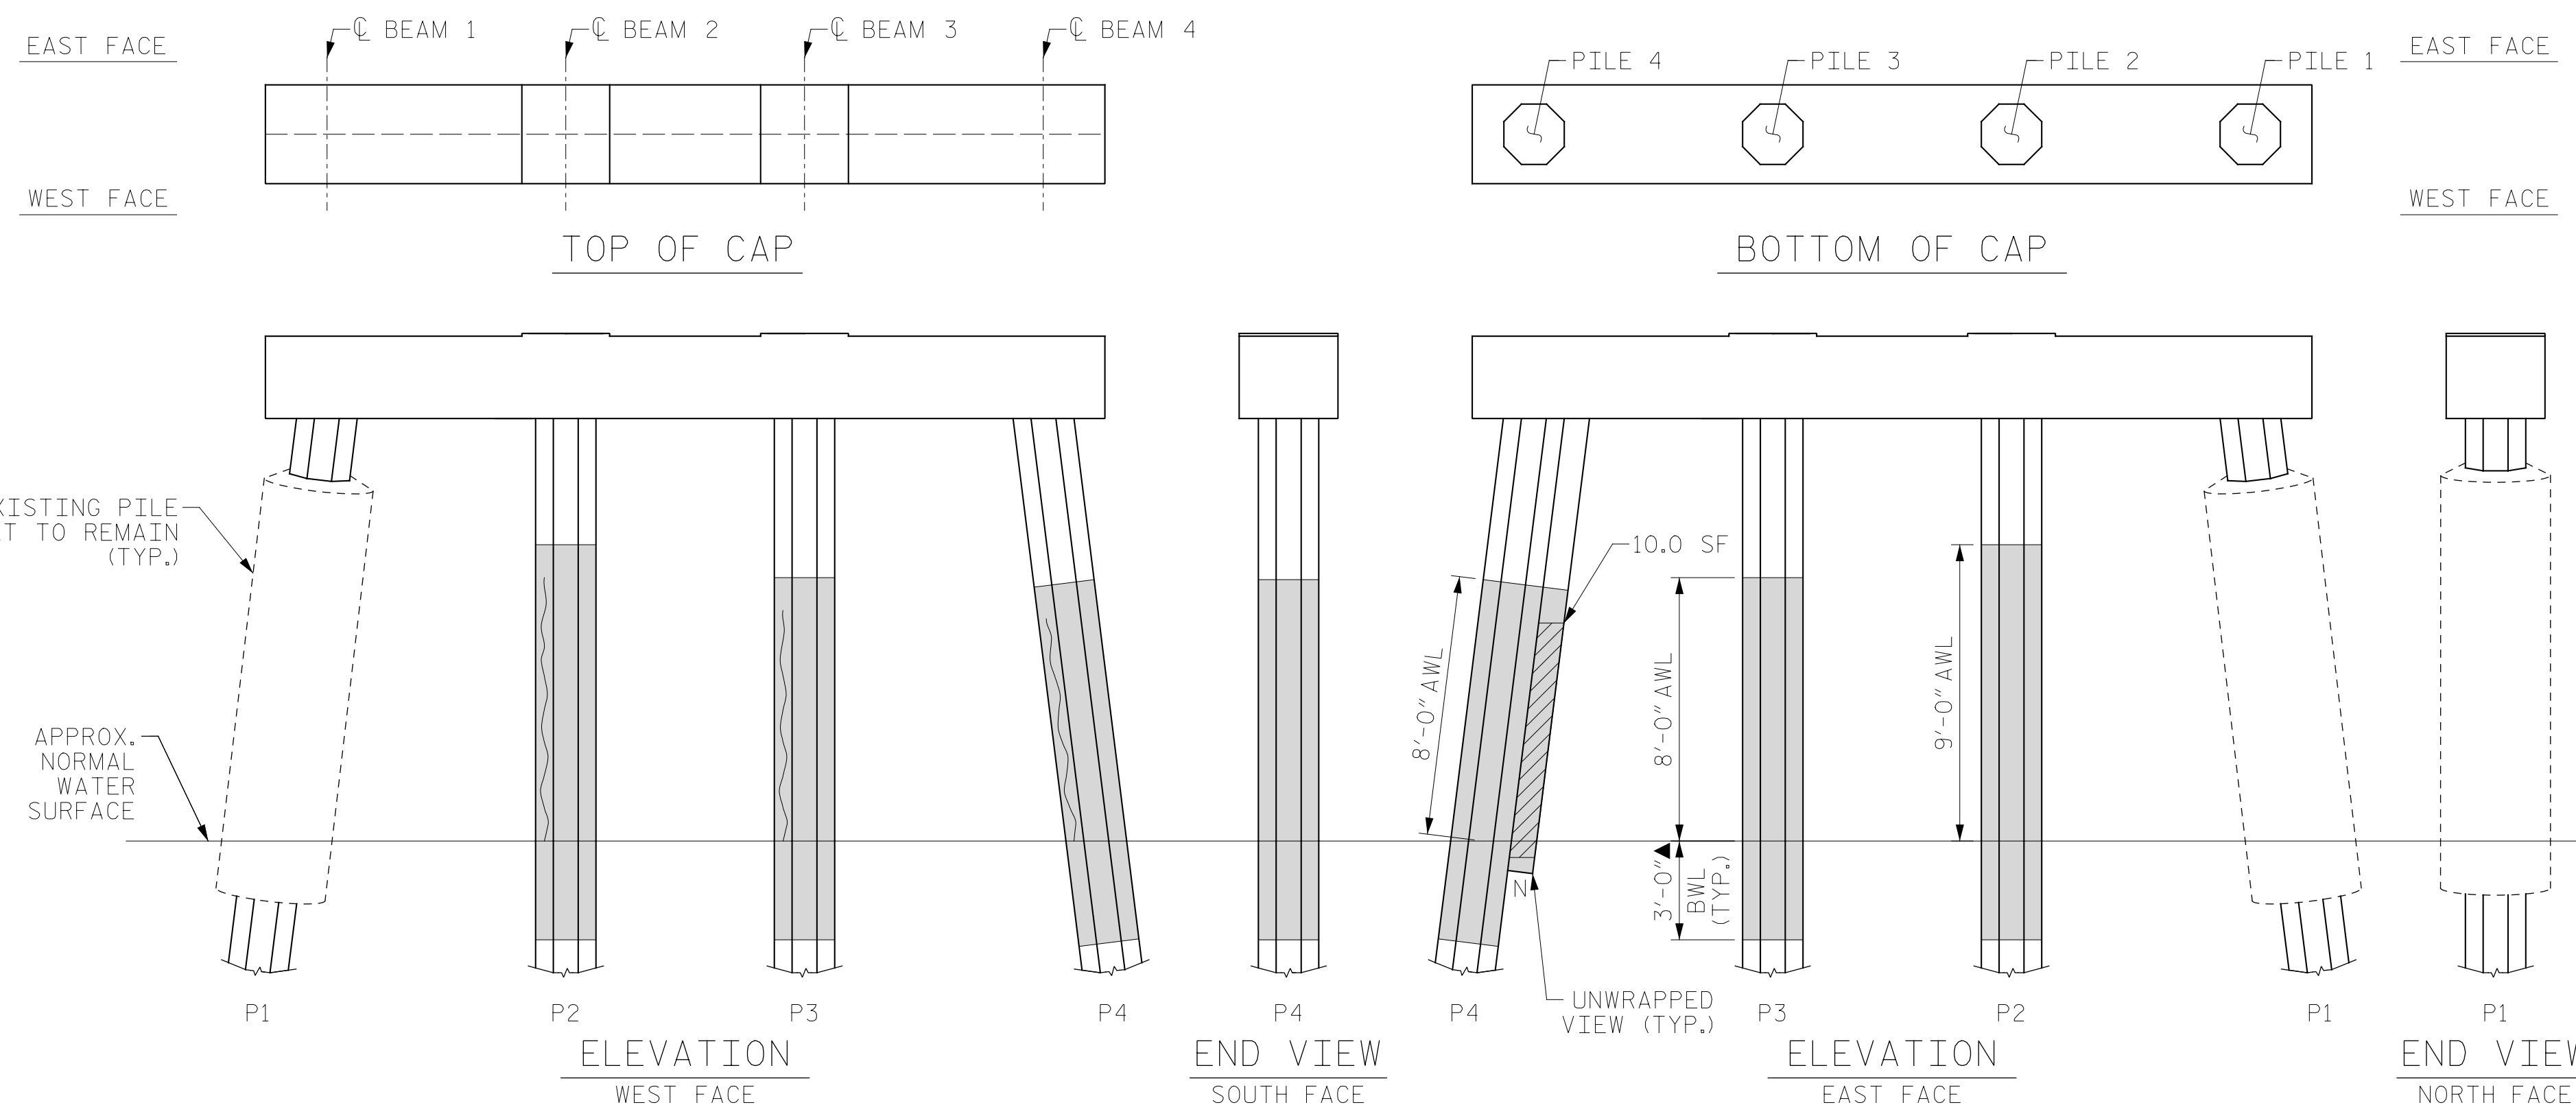
BENT 264

CAP REPAIRS		ESTIMATE			
SHOTCRETE REPAIRS	5.2 SF	2.6 CF	SF	CF	
EPOXY RESIN INJECTION	- LF				LF
PILE REPAIRS		ESTIMATE			
PILE CONCRETE RESTORATION	8.1 SF	3.7 CF	SF	CF	
FRP PROTECTIVE SYSTEM AWL	143.0 SF				
FRP PROTECTIVE SYSTEM BWL	49.5 SF
