AS-BUILT REPAIR QUANTITY TABLE

PROJECT NO. HB-0017  
DARE COUNTY  
 BRIDGE NO. 270009

STATE OF NORTH CAROLINA  
 DEPARTMENT OF TRANSPORTATION  
 RALEIGH

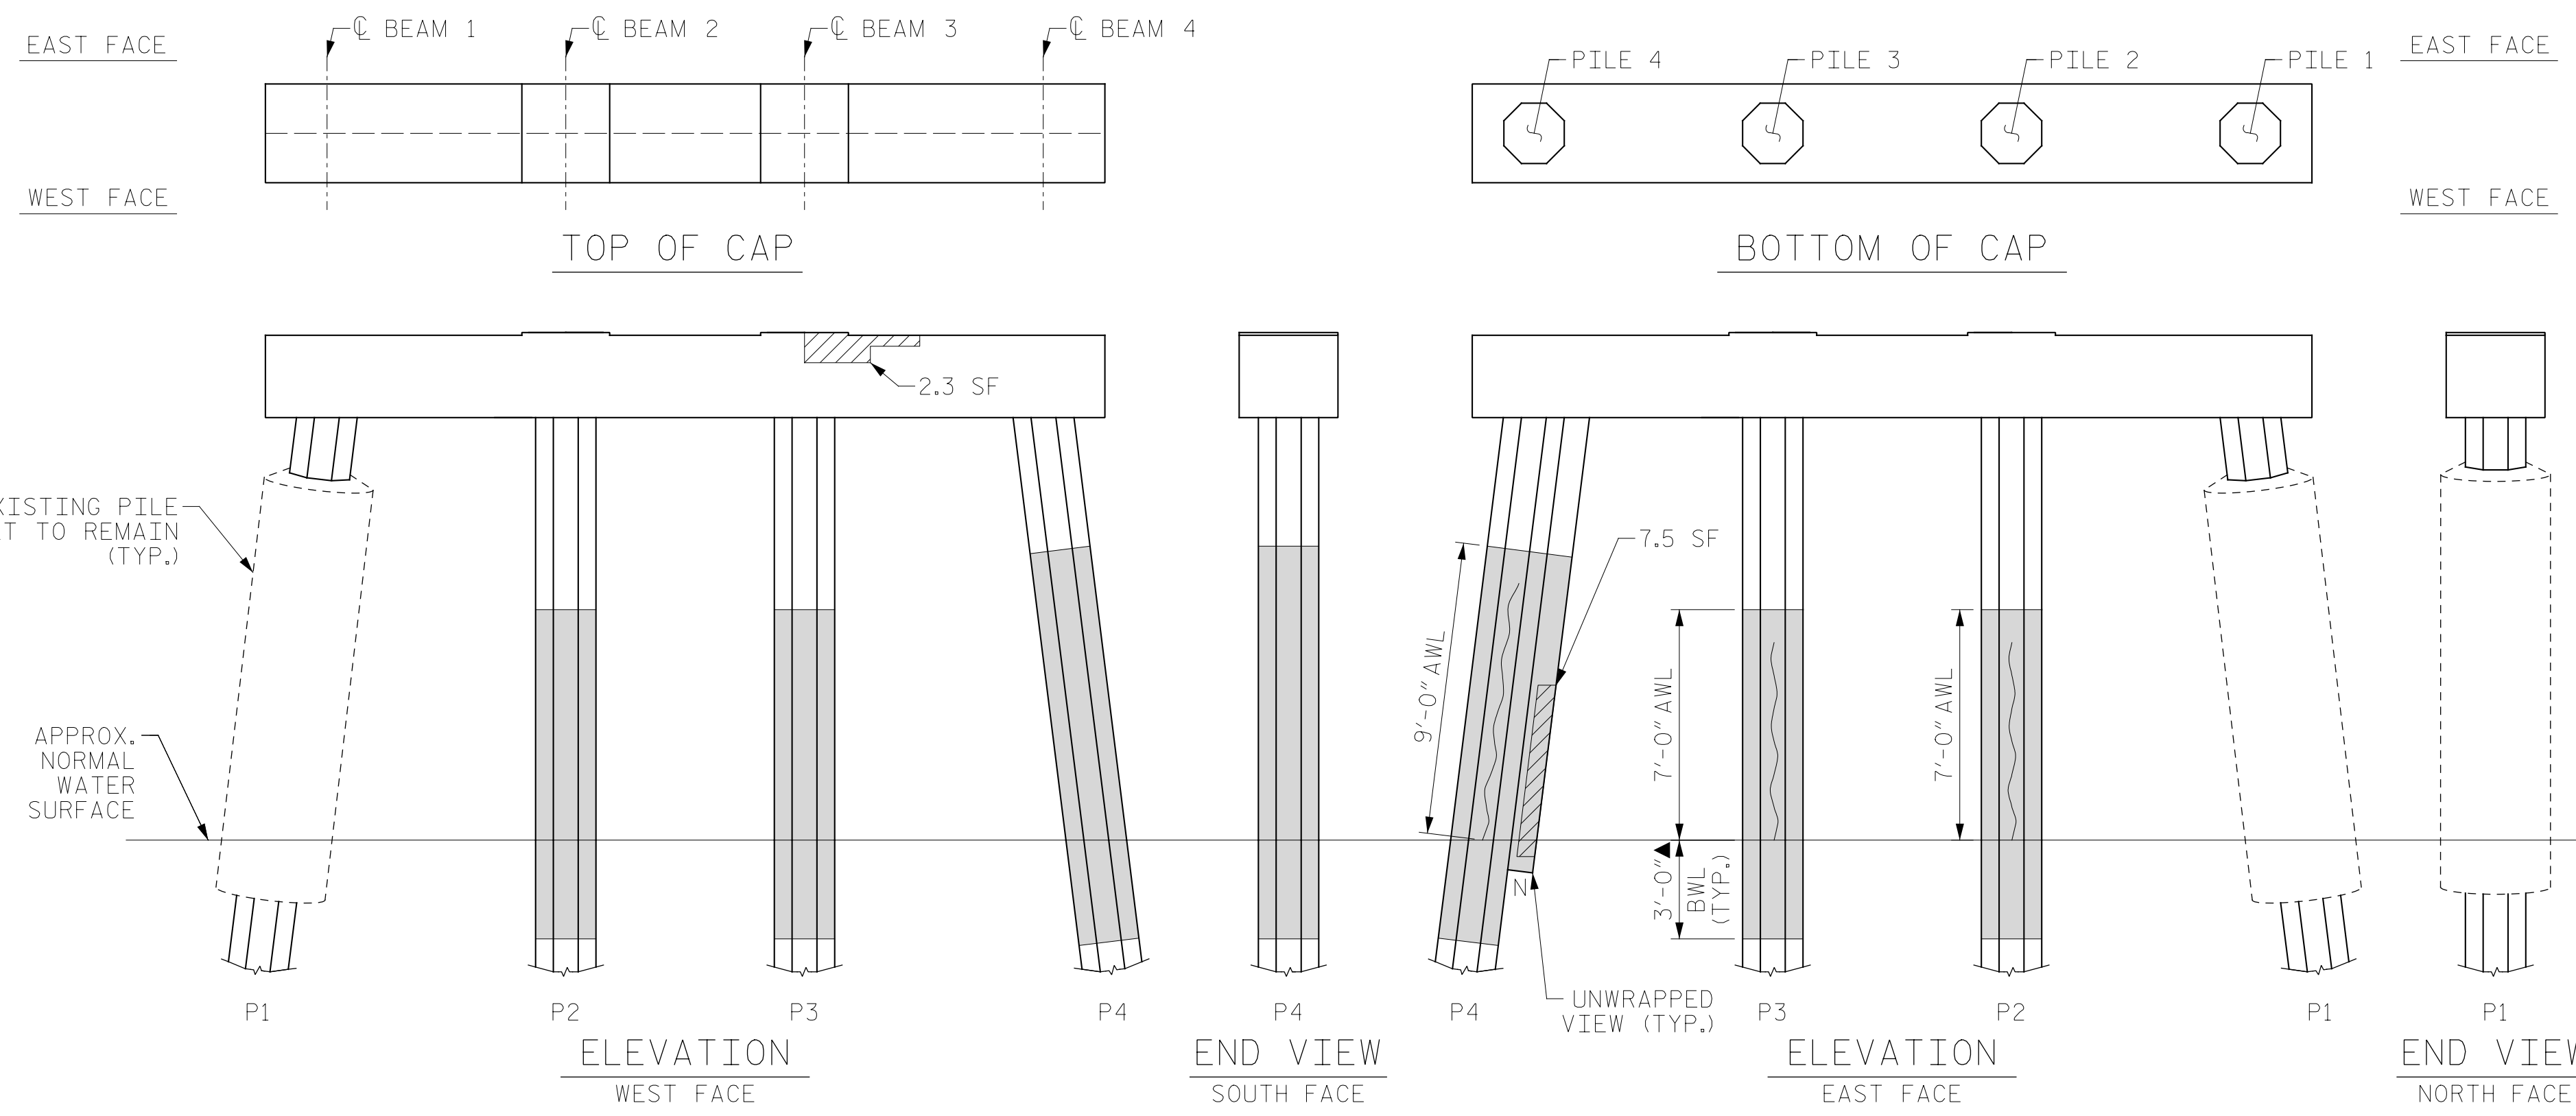
BENT 265

CAP REPAIRS		ESTIMATE			
SHOTCRETE REPAIRS	- SF	- CF	SF	CF	
EPOXY RESIN INJECTION		- LF			LF
PILE REPAIRS		ESTIMATE			
PILE CONCRETE RESTORATION	7.3 SF	3.2 CF	SF	CF	
FRP PROTECTIVE SYSTEM AWL	224.6 SF				
FRP PROTECTIVE SYSTEM BWL	66.0 SF

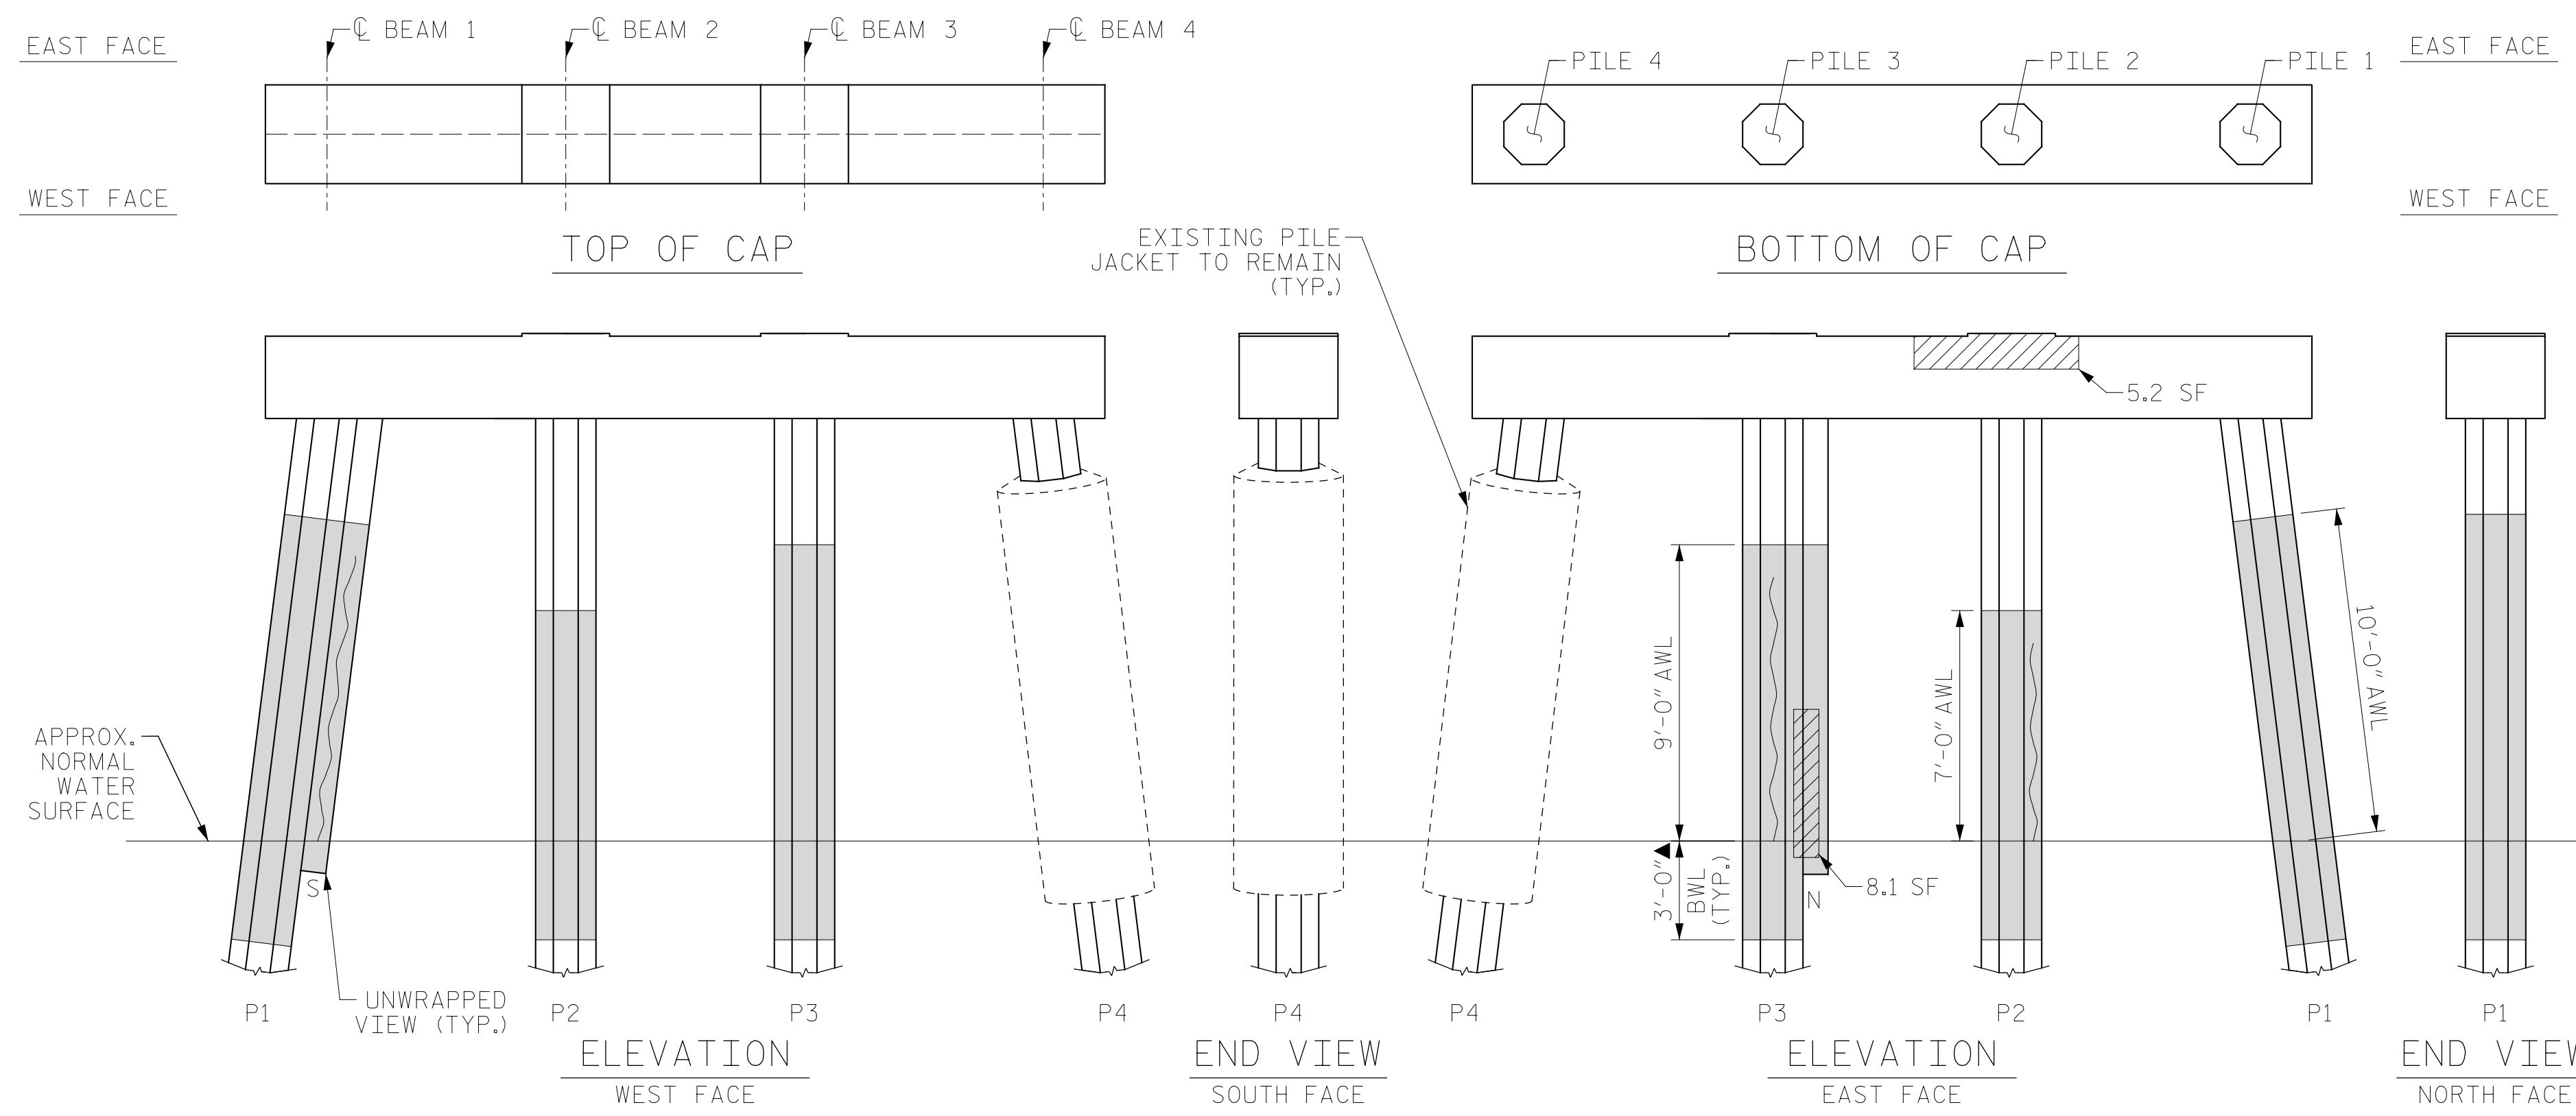
BENT 266

CAP REPAIRS		ESTIMATE			
SHOTCRETE REPAIRS	- SF	- CF	SF	CF	
EPOXY RESIN INJECTION		- LF			LF
PILE REPAIRS		ESTIMATE			
PILE CONCRETE RESTORATION	134.9 SF	52.3 CF	SF	CF	
FRP PROTECTIVE SYSTEM AWL	324.5 SF				
FRP PROTECTIVE SYSTEM BWL	99.0 SF

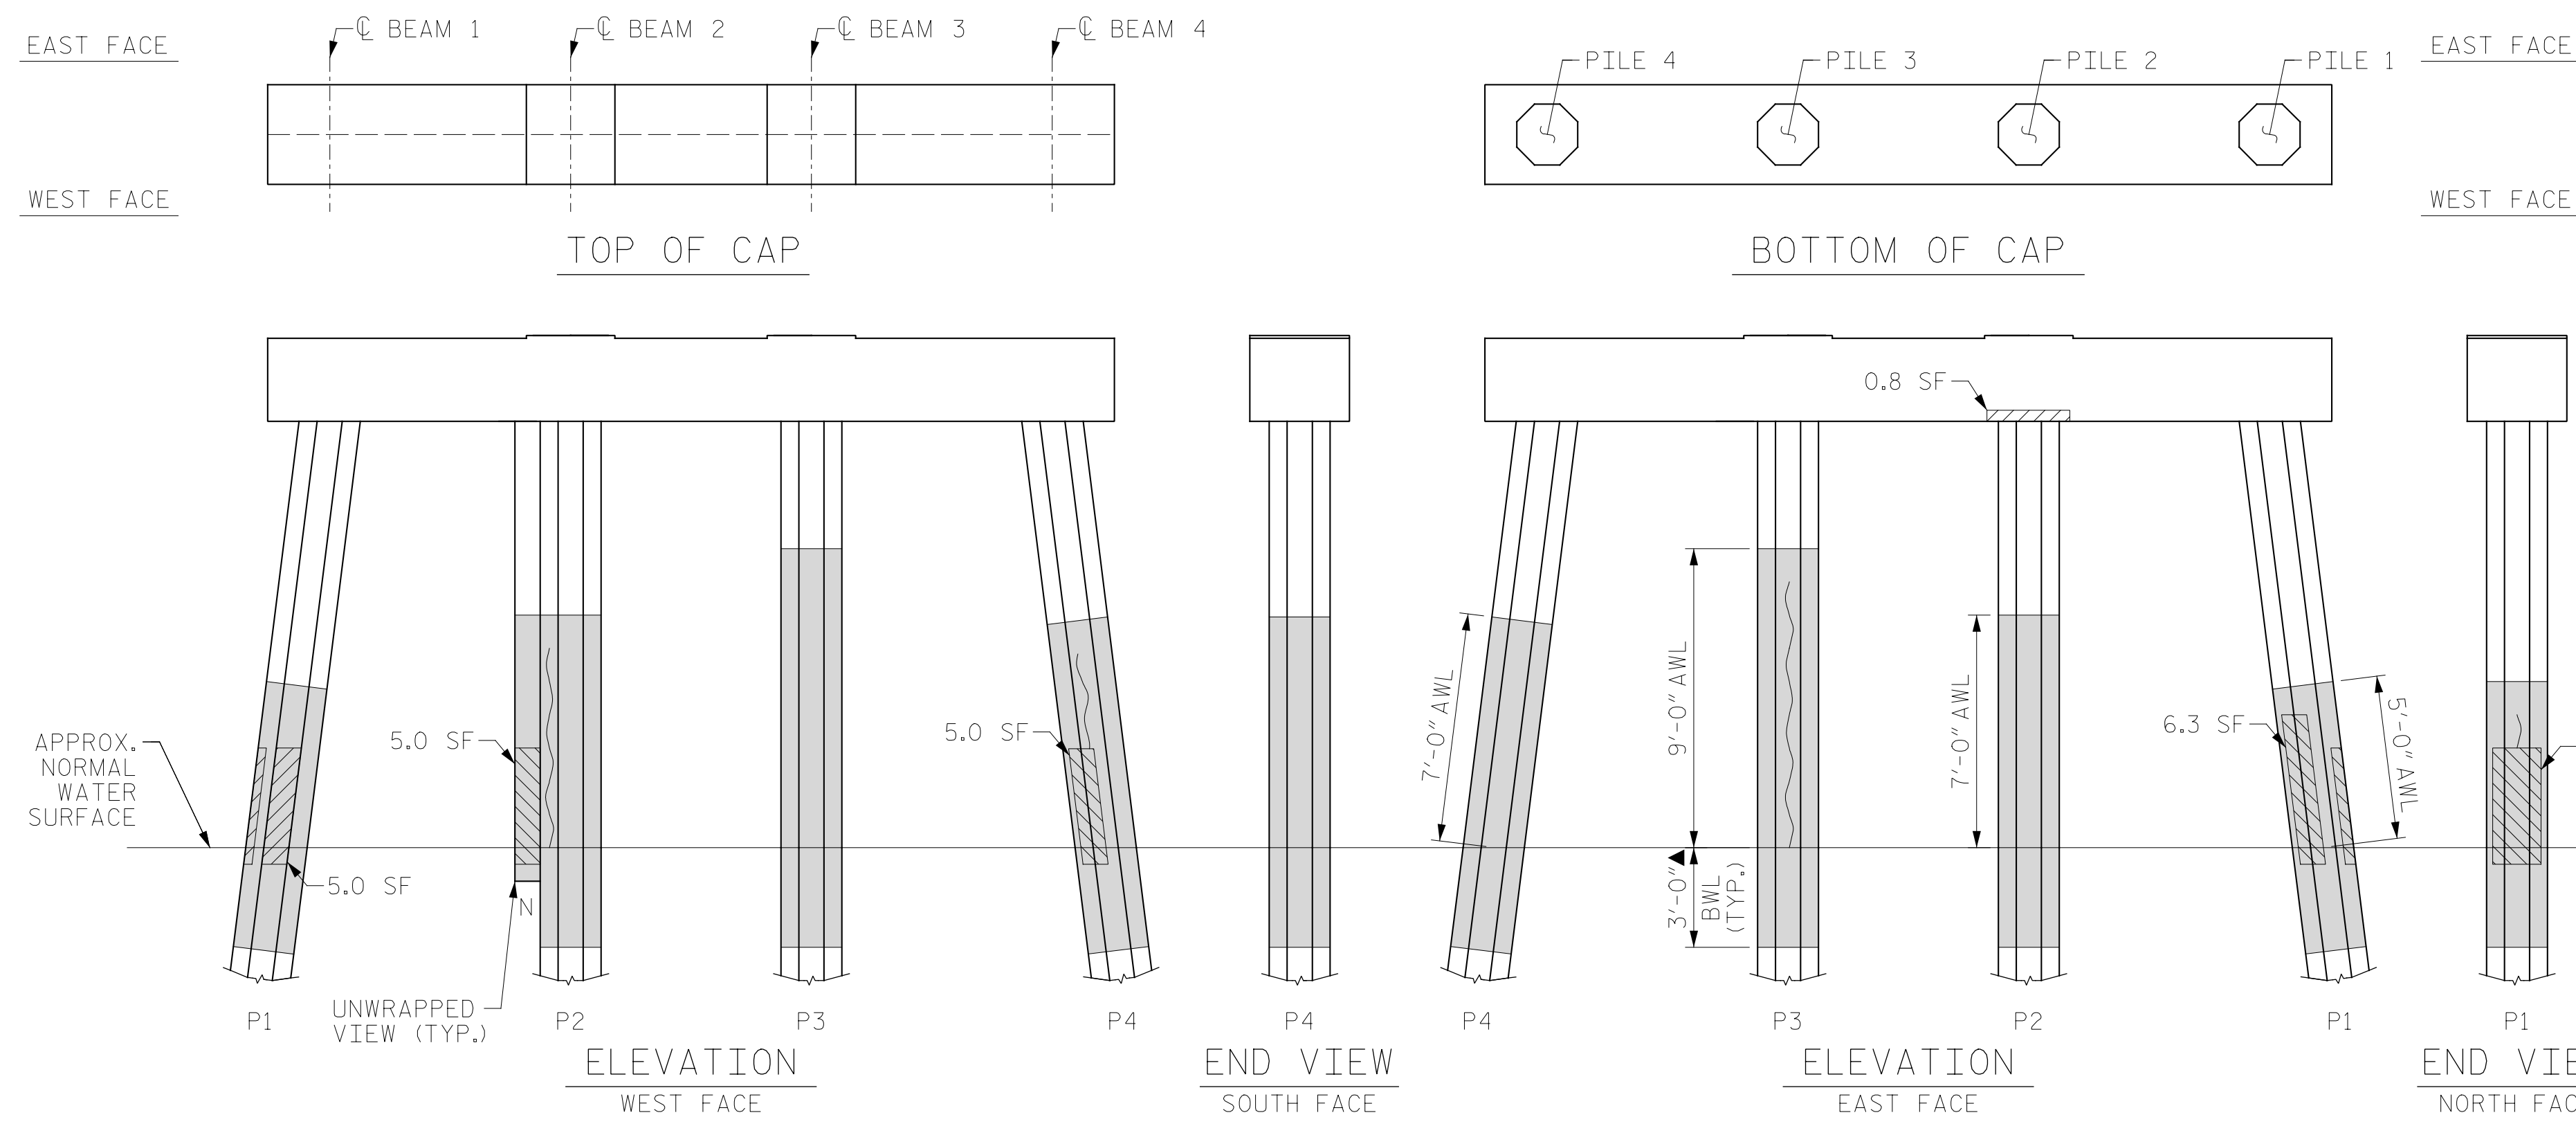
BENT 269

CAP REPAIRS				
SHOTCRETE REPAIRS	15.4 SF	7.7 CF	SF	CF
EPOXY RESIN INJECTION	- LF			LF
PILE REPAIRS				
PILE CONCRETE RESTORATION	- SF	- CF	SF	CF
FRP PROTECTIVE SYSTEM AWL	33.0 SF			
FRP PROTECTIVE SYSTEM BWL	16.5 SF

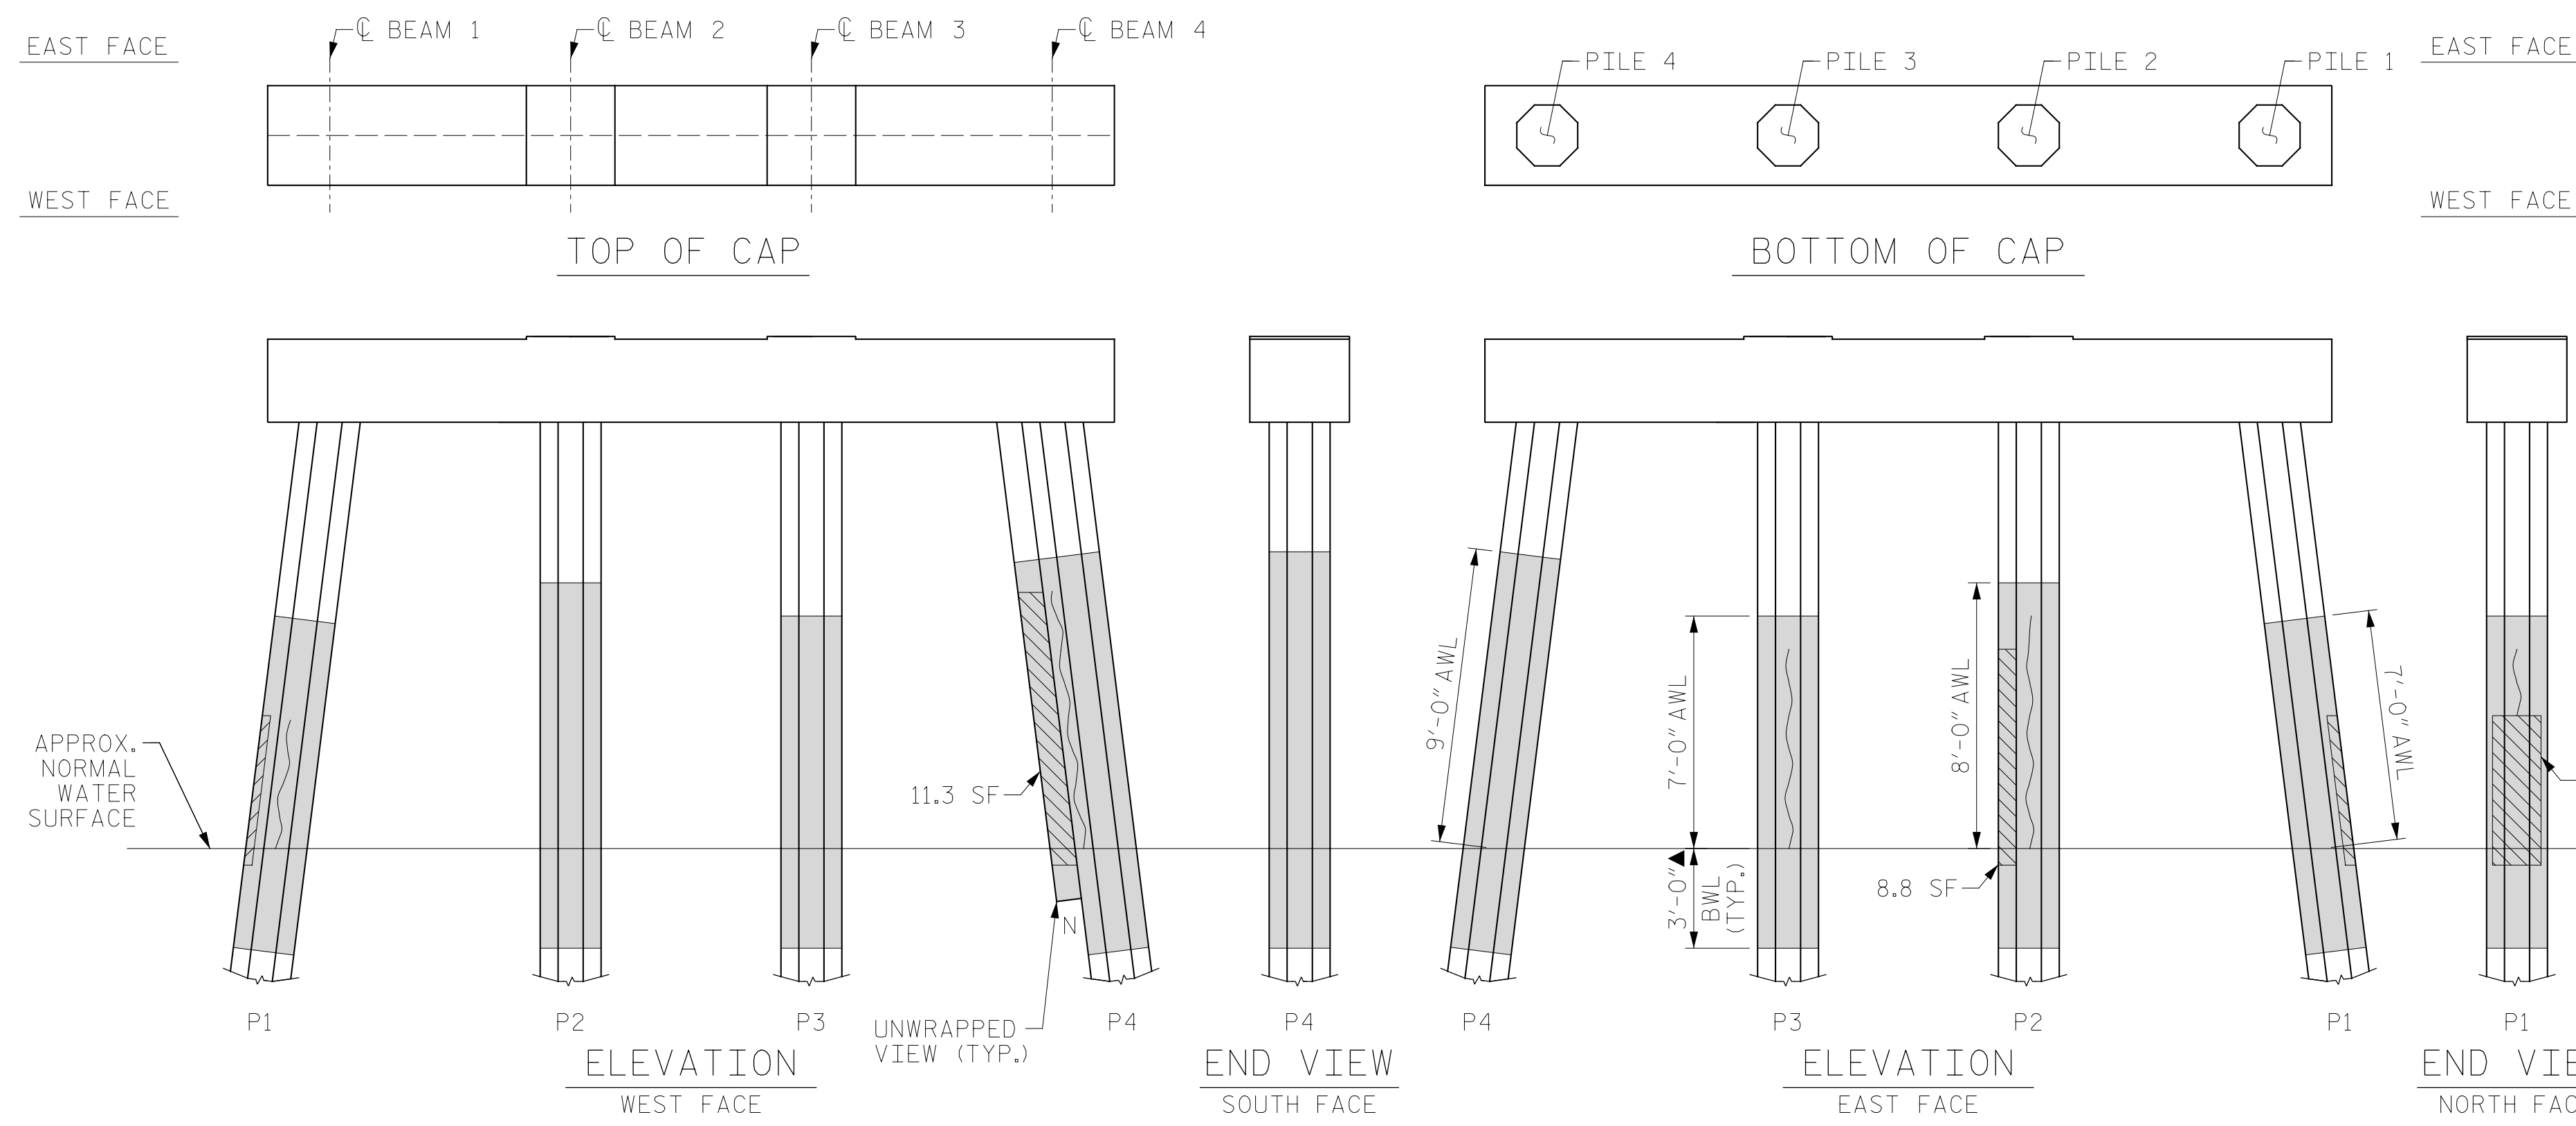
BENT 270

CAP REPAIRS				
SHOTCRETE REPAIRS	- SF	- CF	SF	CF
EPOXY RESIN INJECTION	- LF			LF
PILE REPAIRS				
PILE CONCRETE RESTORATION	- SF	- CF	SF	CF
FRP PROTECTIVE SYSTEM AWL	180.6 SF			
FRP PROTECTIVE SYSTEM BWL	66.0 SF

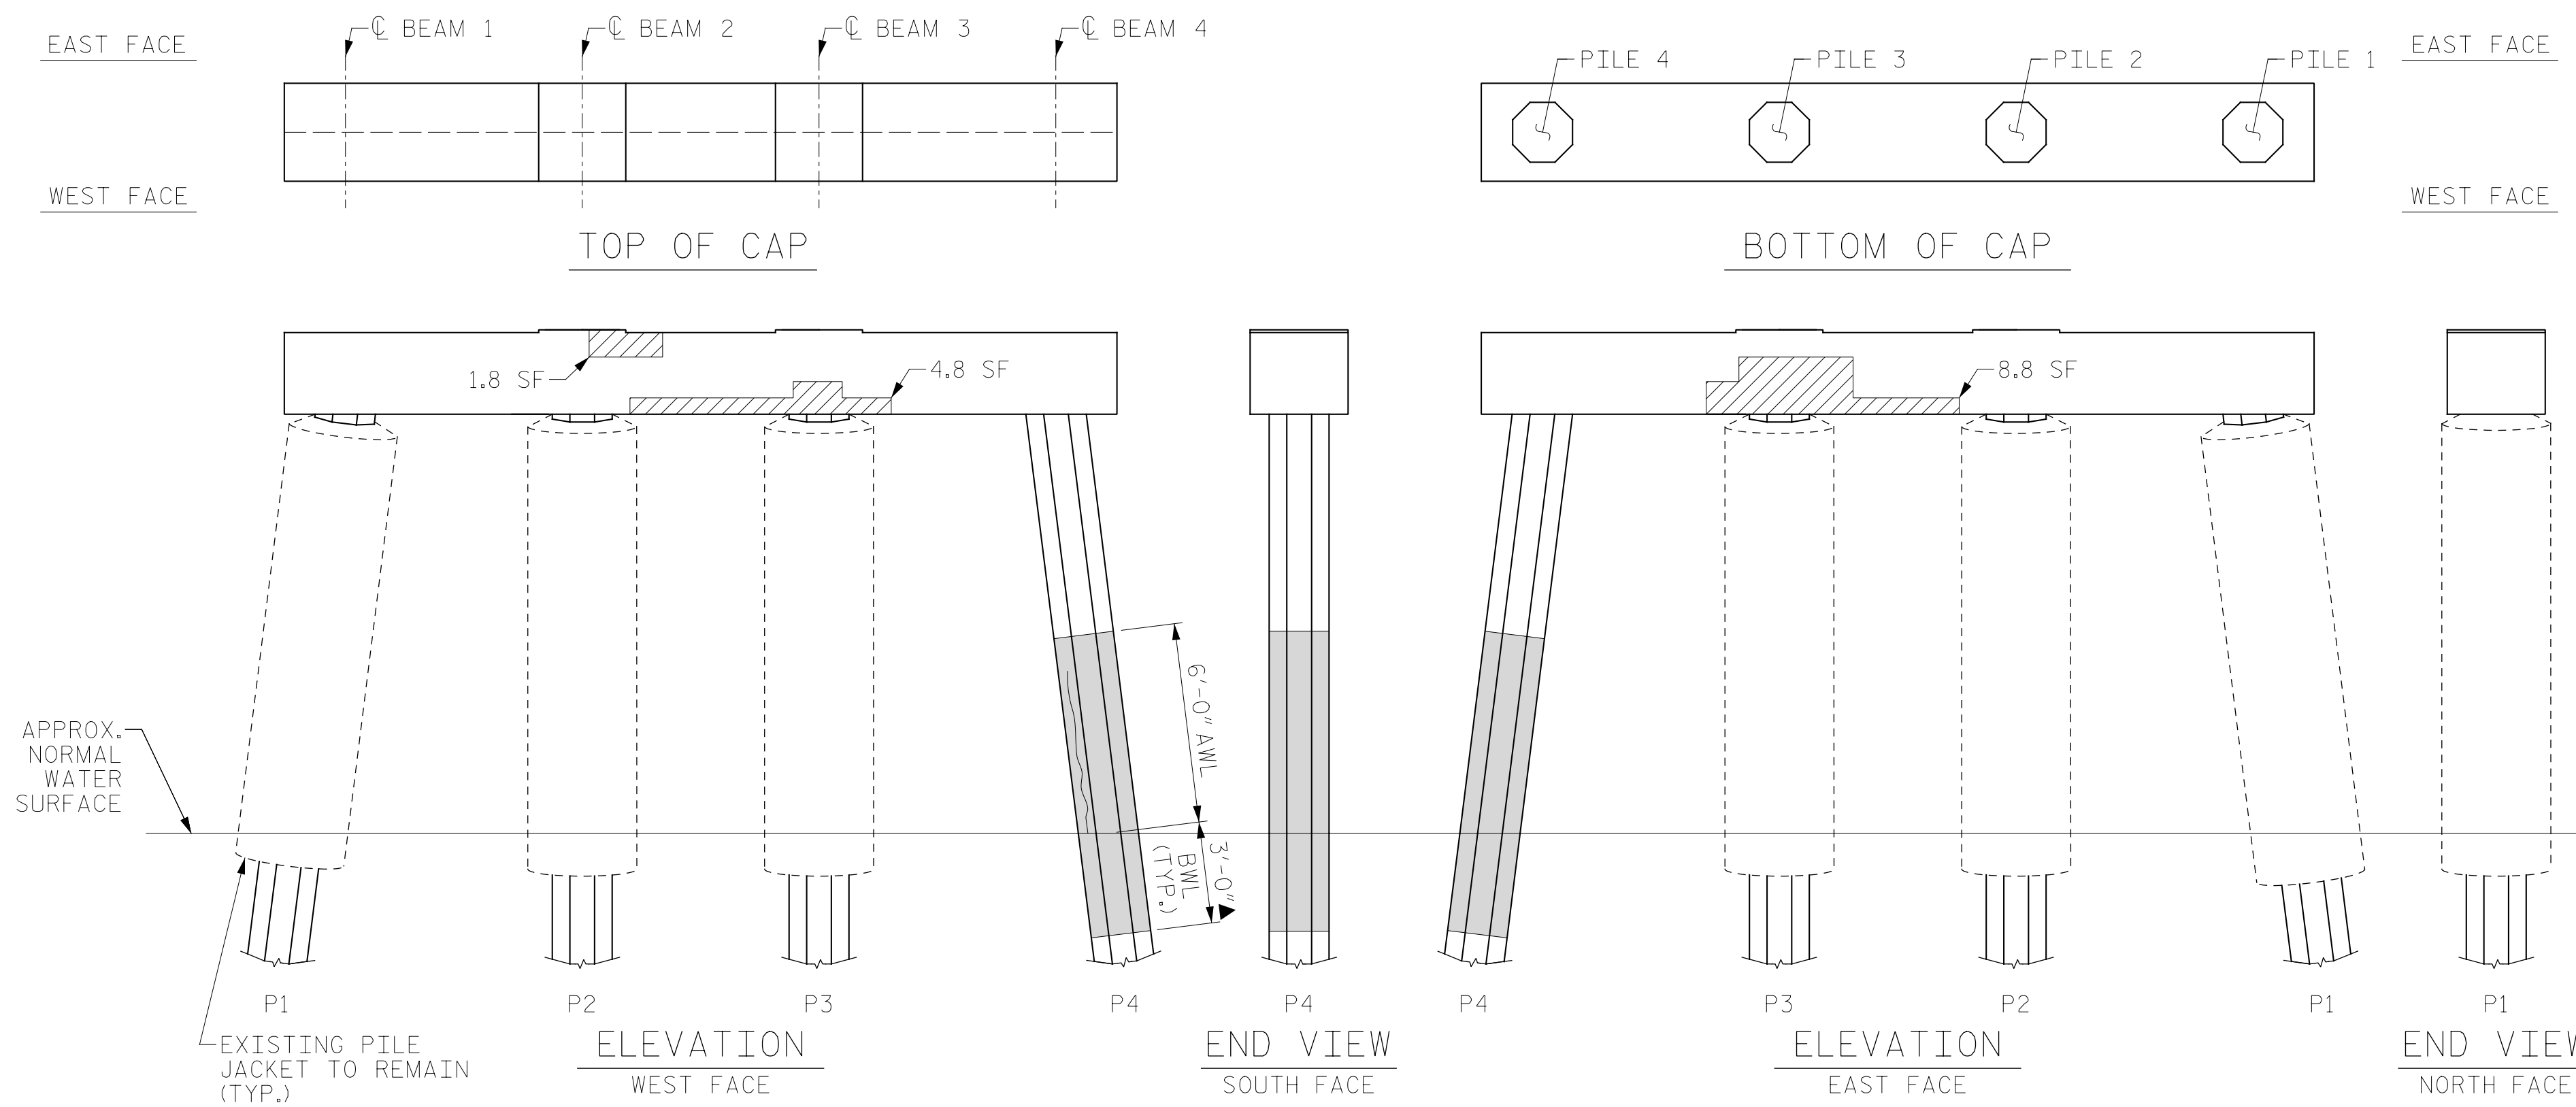
BENT 271

CAP REPAIRS			
SHOTCRETE REPAIRS	11.6 SF	5.8 CF	
EPOXY RESIN INJECTION	- LF		
PILE REPAIRS			
PILE CONCRETE RESTORATION	25.3 SF	10.3 CF	
FRP PROTECTIVE SYSTEM AWL	192.5 SF		
FRP PROTECTIVE SYSTEM BWL	66.0 SF

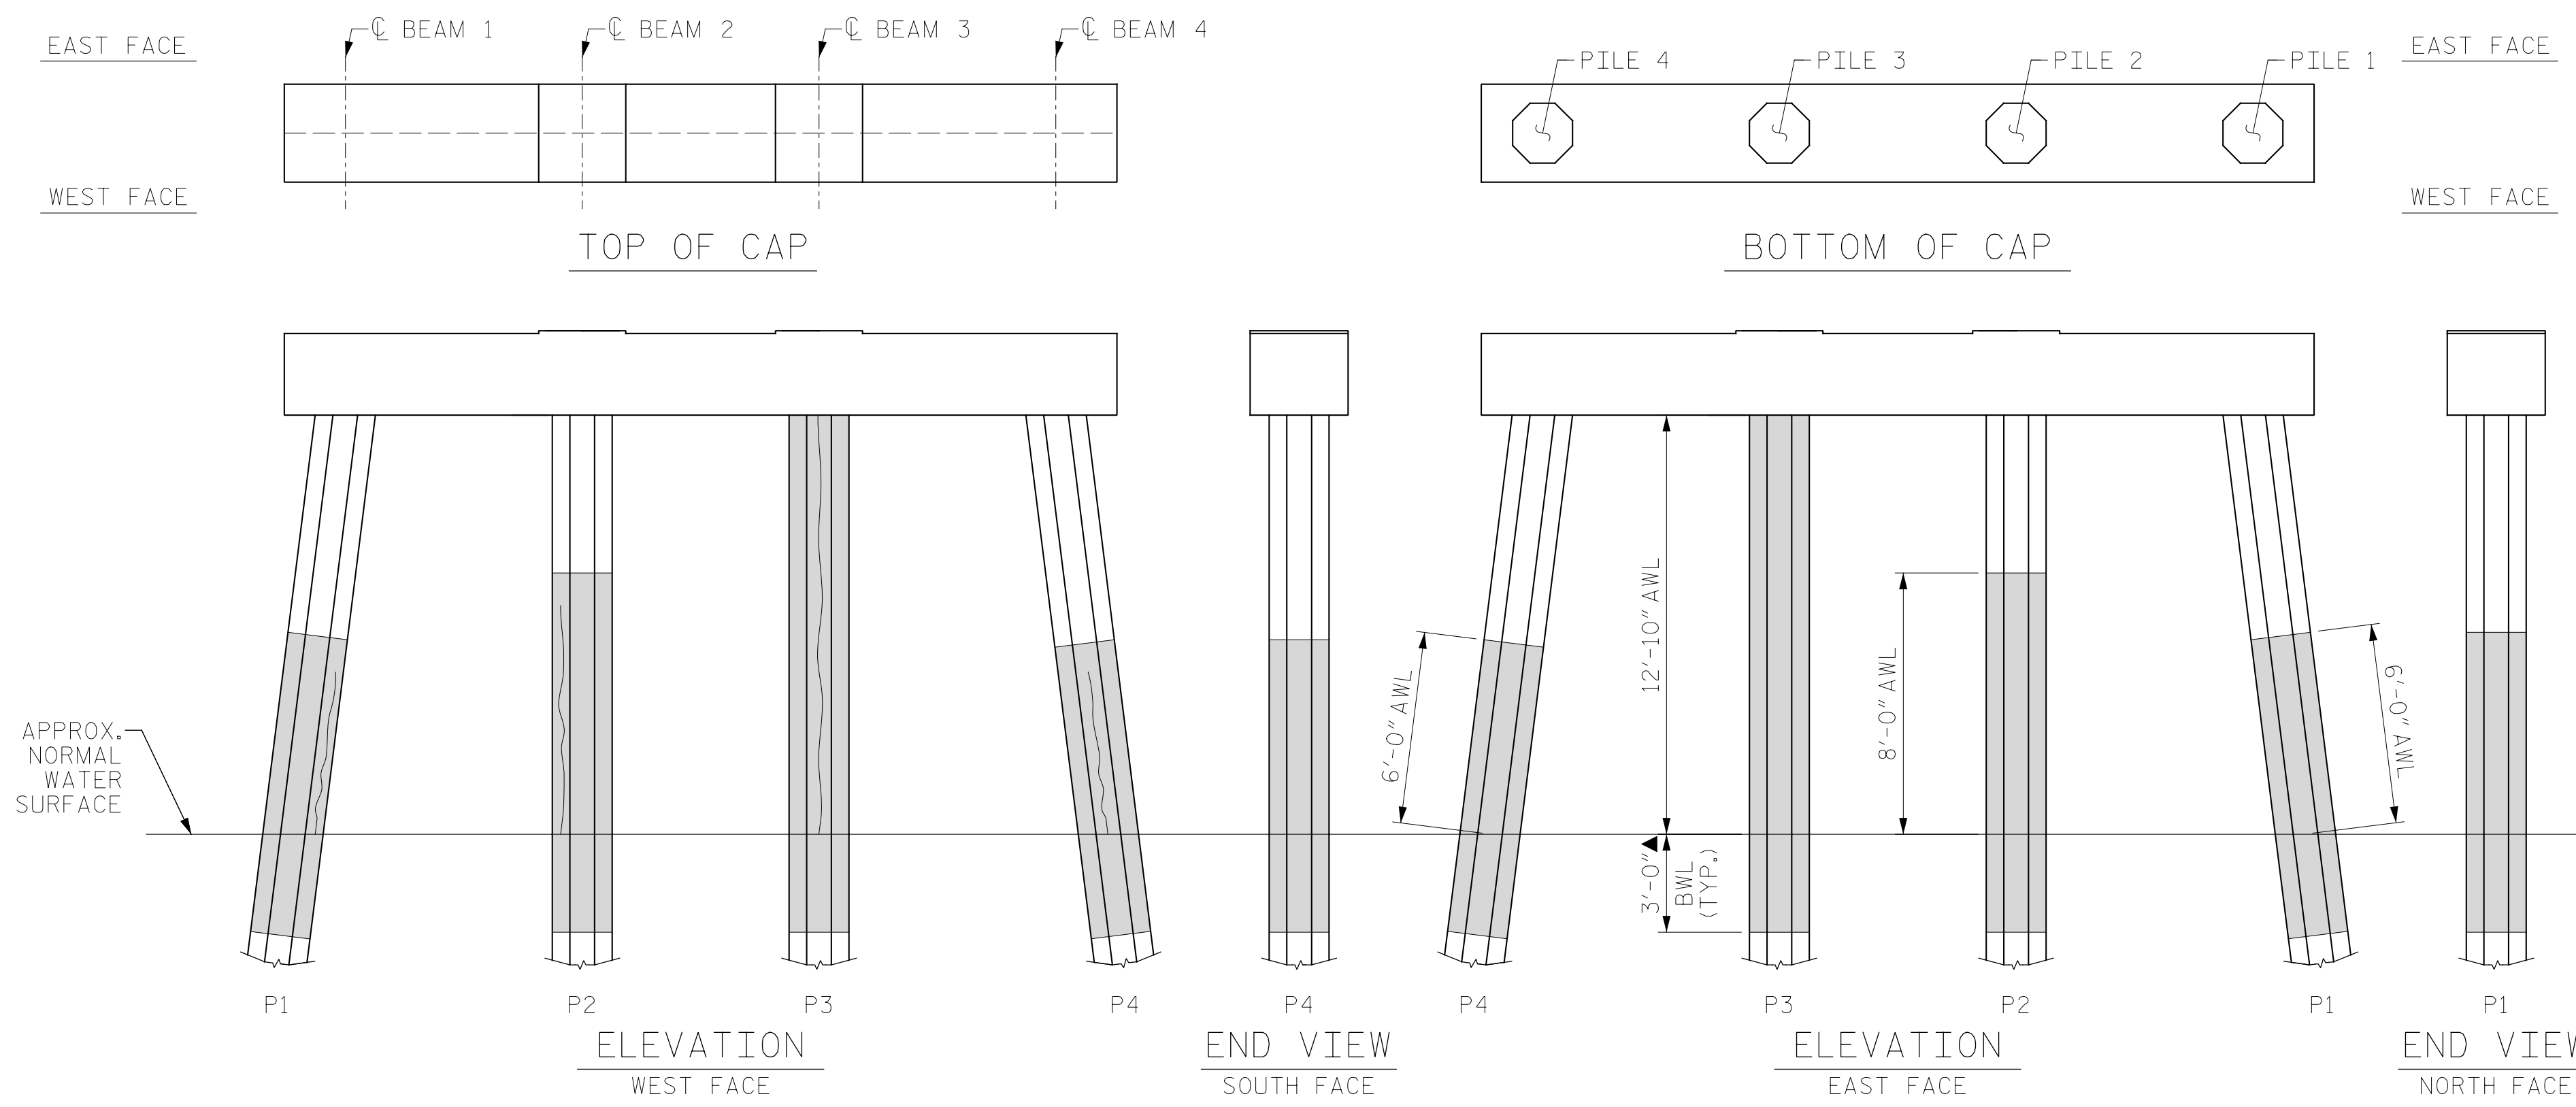
BENT 272

CAP REPAIRS			
SHOTCRETE REPAIRS	1.4 SF	0.7 CF	
EPOXY RESIN INJECTION	- LF		
PILE REPAIRS			
PILE CONCRETE RESTORATION	36.4 SF	14.6 CF	
FRP PROTECTIVE SYSTEM AWL	191.6 SF		
FRP PROTECTIVE SYSTEM BWL	66.0 SF

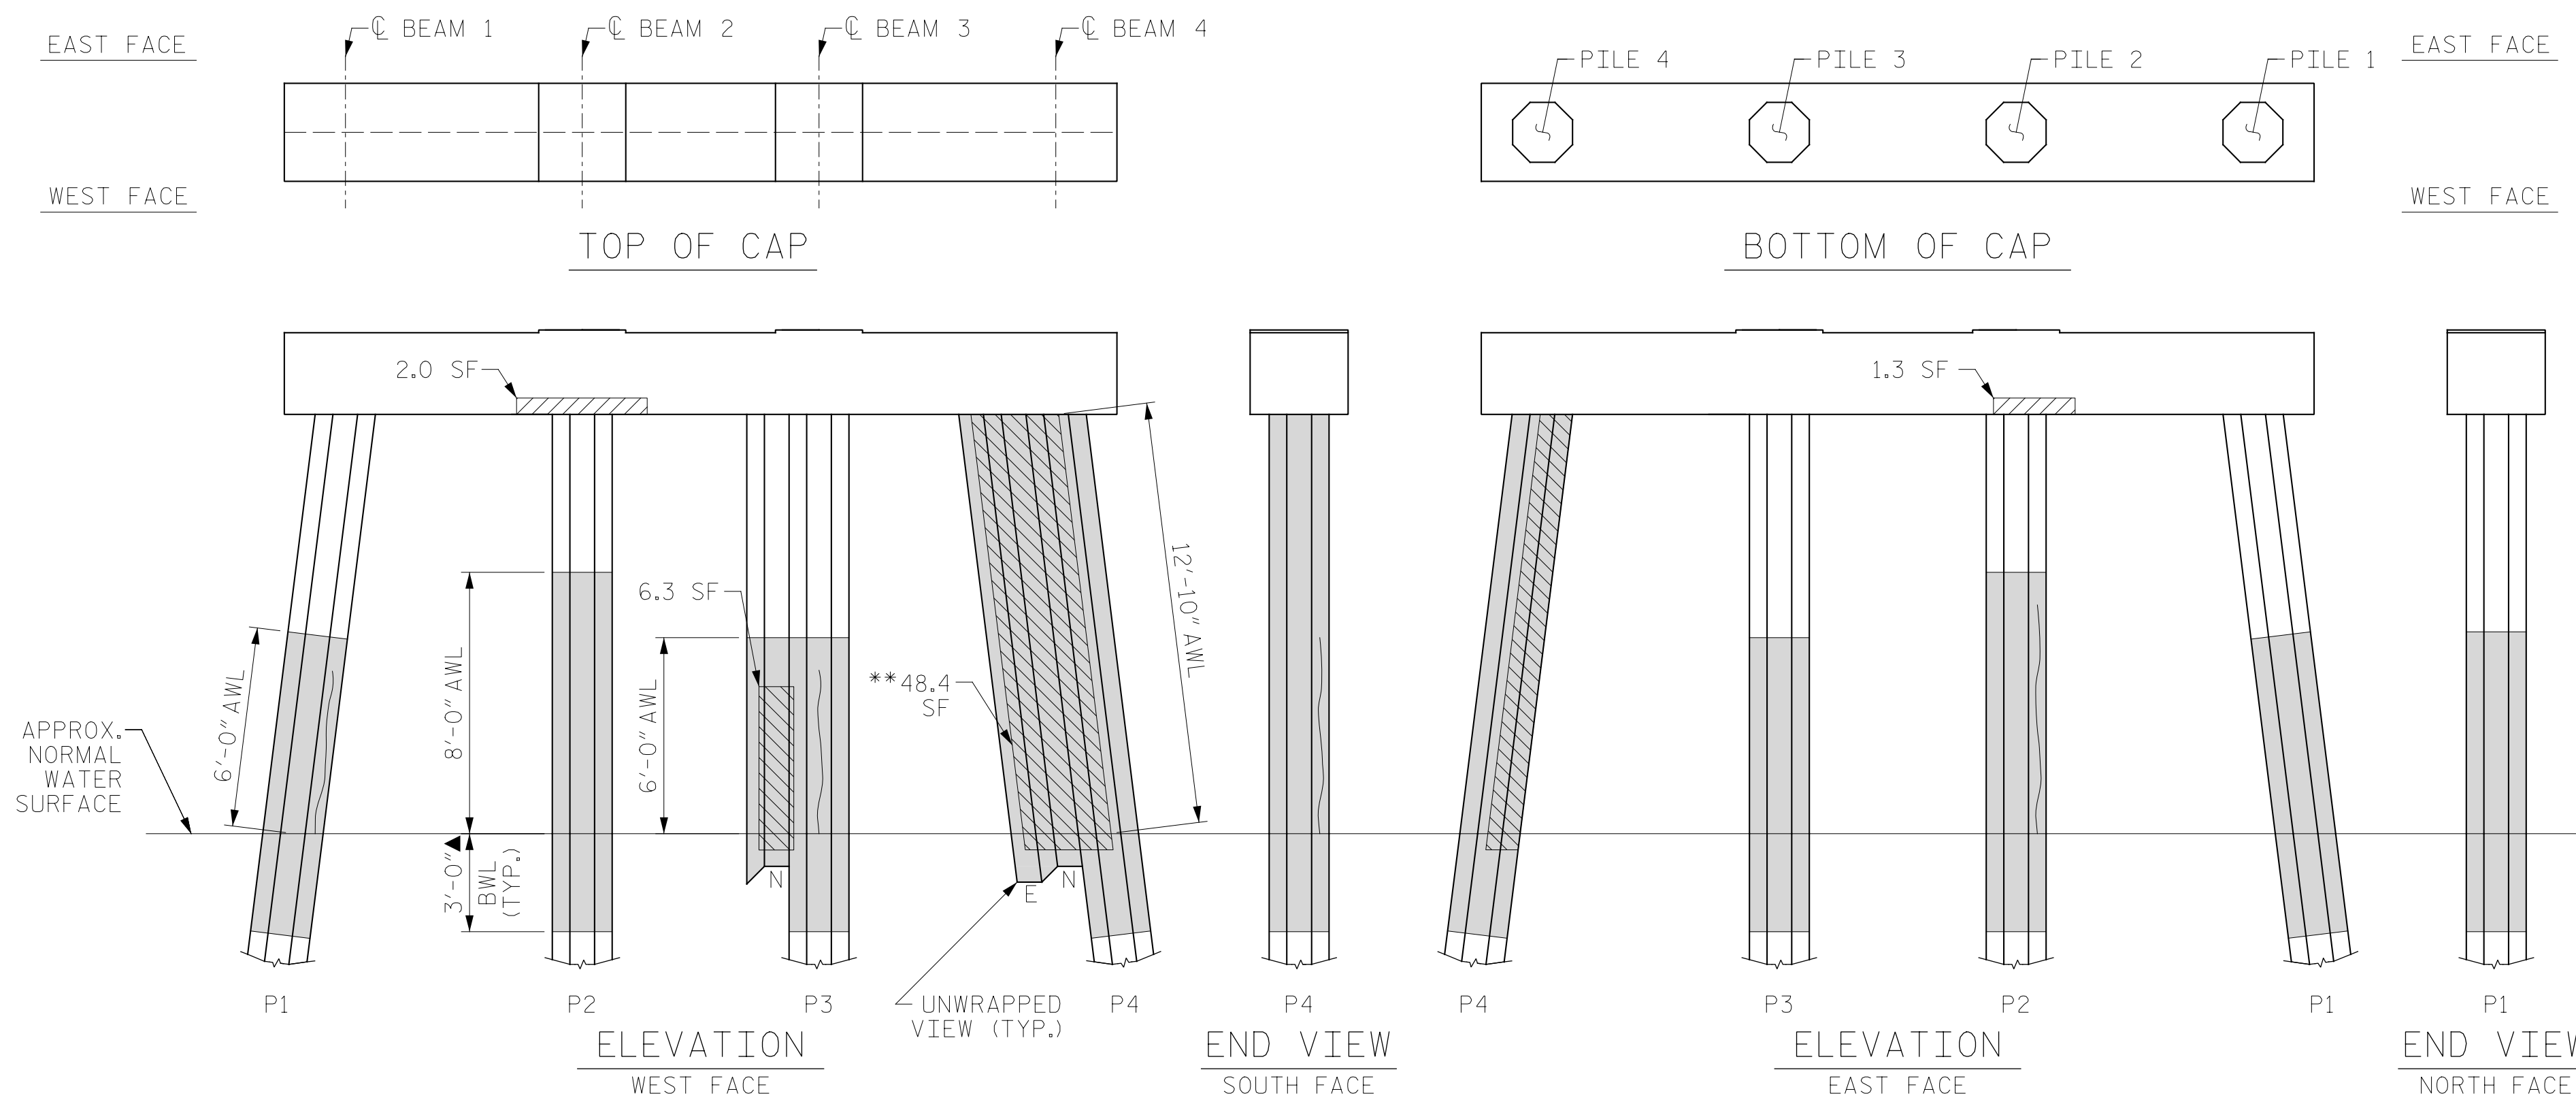
BENT 277

CAP REPAIRS			
SHOTCRETE REPAIRS	3.3 SF	1.7 CF	SF CF
EPOXY RESIN INJECTION	- LF		LF
PILE REPAIRS			
PILE CONCRETE RESTORATION	54.7 SF	20.5 CF	SF CF
FRP PROTECTIVE SYSTEM AWL	180.6 SF		
FRP PROTECTIVE SYSTEM BWL	66.0 SF
