AS-BUILT REPAIR QUANTITY TABLE

PROJECT NO. HB-0017  
DARE COUNTY  
 BRIDGE NO. 270009

STATE OF NORTH CAROLINA  
 DEPARTMENT OF TRANSPORTATION  
 RALEIGH

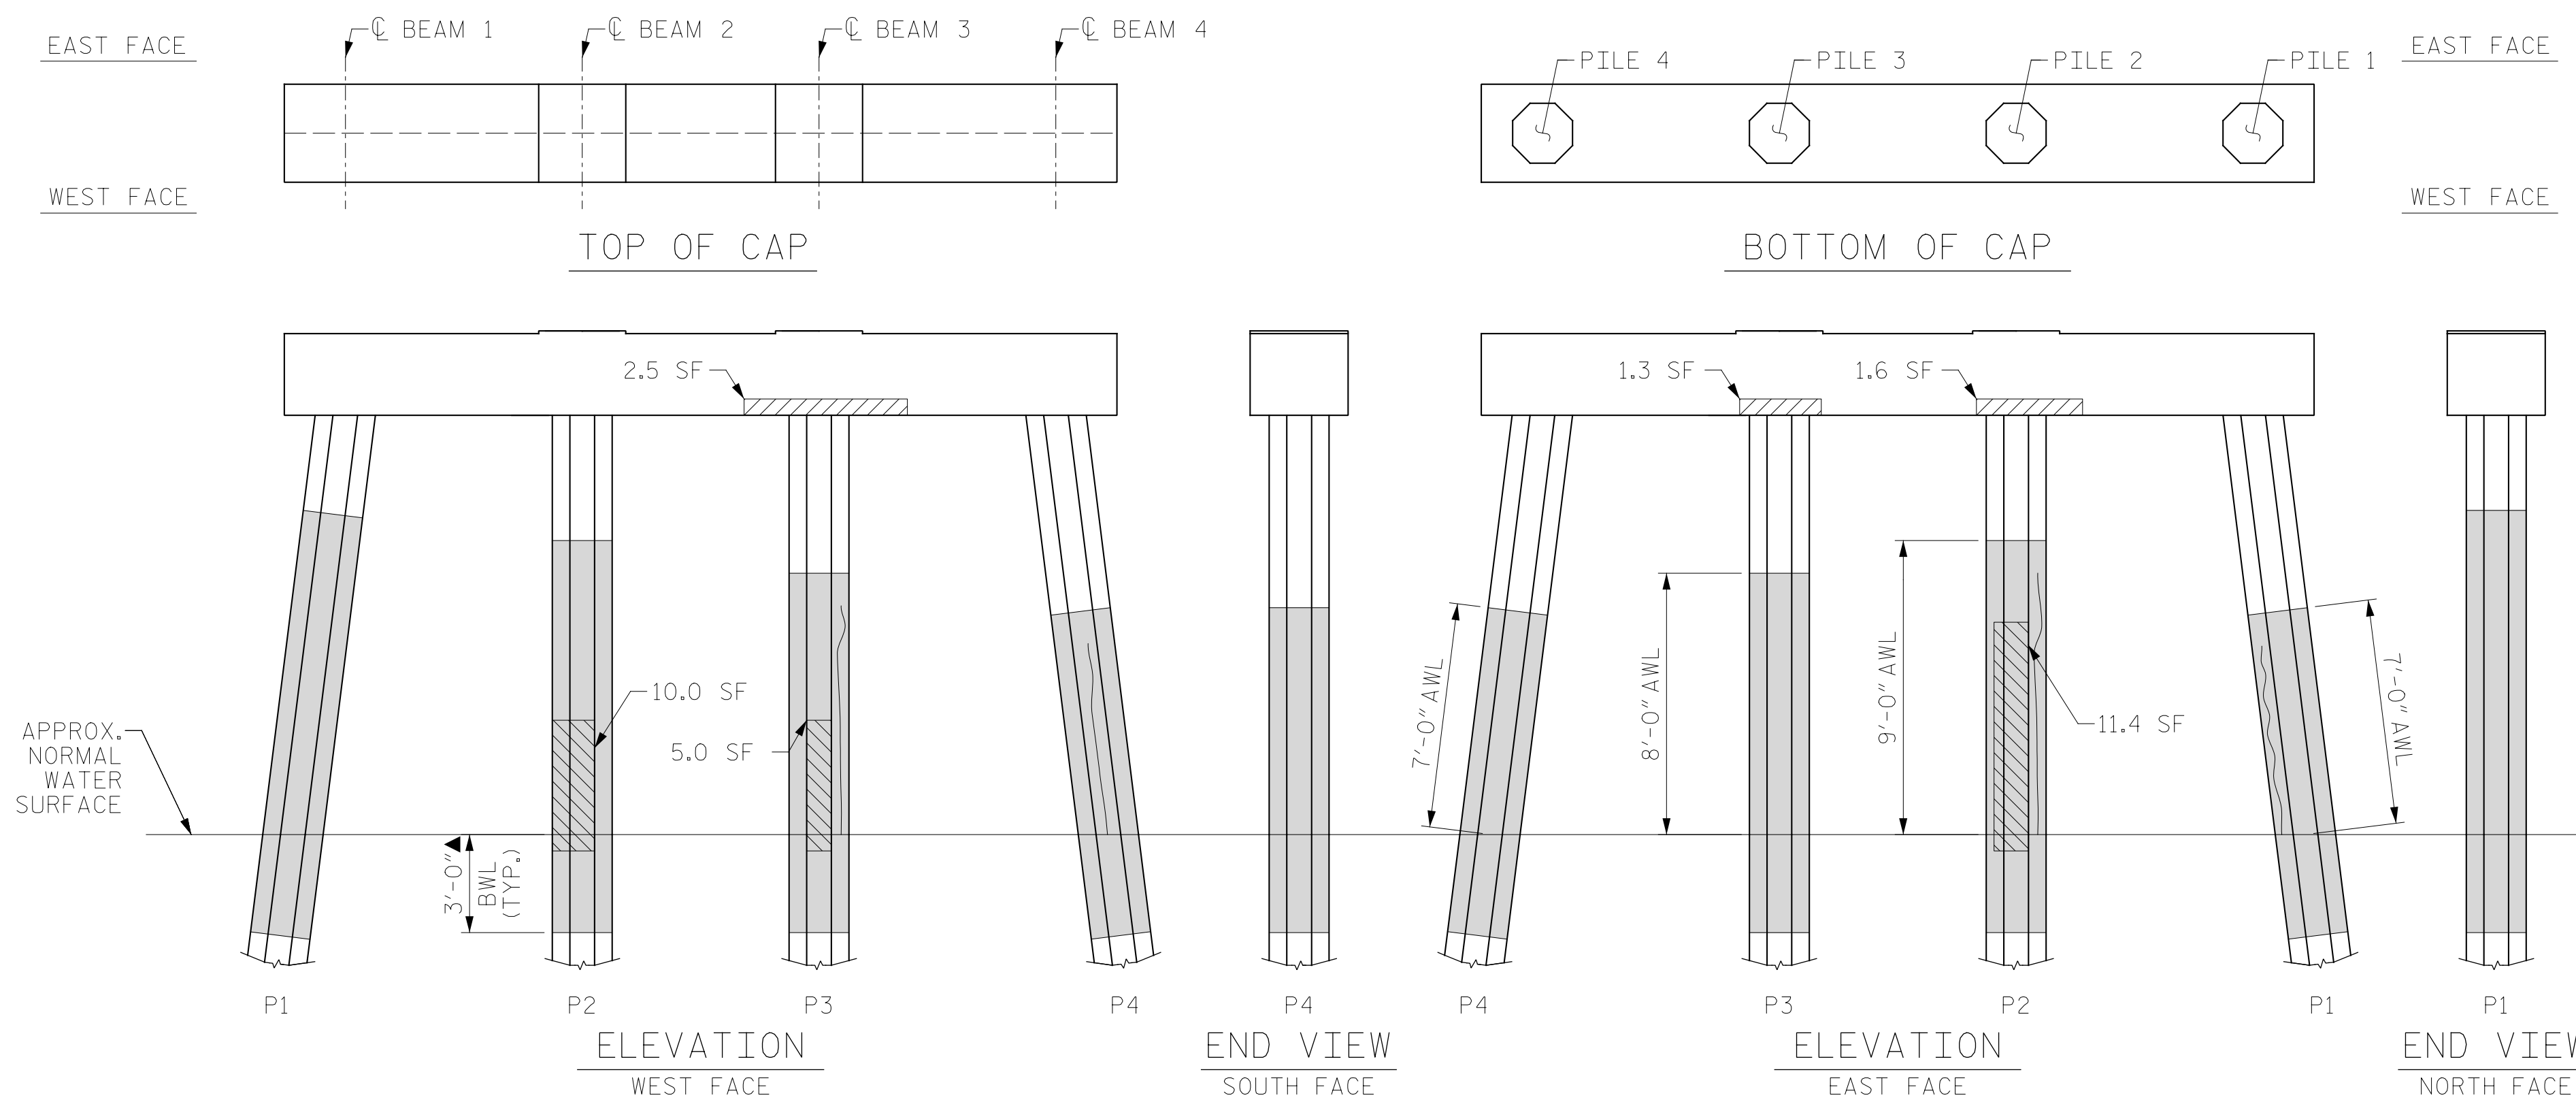
BENT 278

CAP REPAIRS			
SHOTCRETE REPAIRS	5.4 SF	2.7 CF	SF CF
EPOXY RESIN INJECTION	- LF		LF
PILE REPAIRS			
PILE CONCRETE RESTORATION	26.4 SF	11.2 CF	SF CF
FRP PROTECTIVE SYSTEM AWL	170.5 SF		
FRP PROTECTIVE SYSTEM BWL	66.0 SF
