December 9, 2020

Mr. Christopher Tripp
On-Scene Coordinator
U.S. Environmental Protection Agency, Region 4
61 Forsyth Street, SW
Atlanta, Georgia 30303

**Subject: Removal Site Evaluation Report
Davidson Community Asbestos
Davidson, Mecklenburg County, North Carolina
EPA Contract No.: 68HE0519D0006
Task Order / Task Order Line Item No.: 68HE0419F0097 / 97-005**

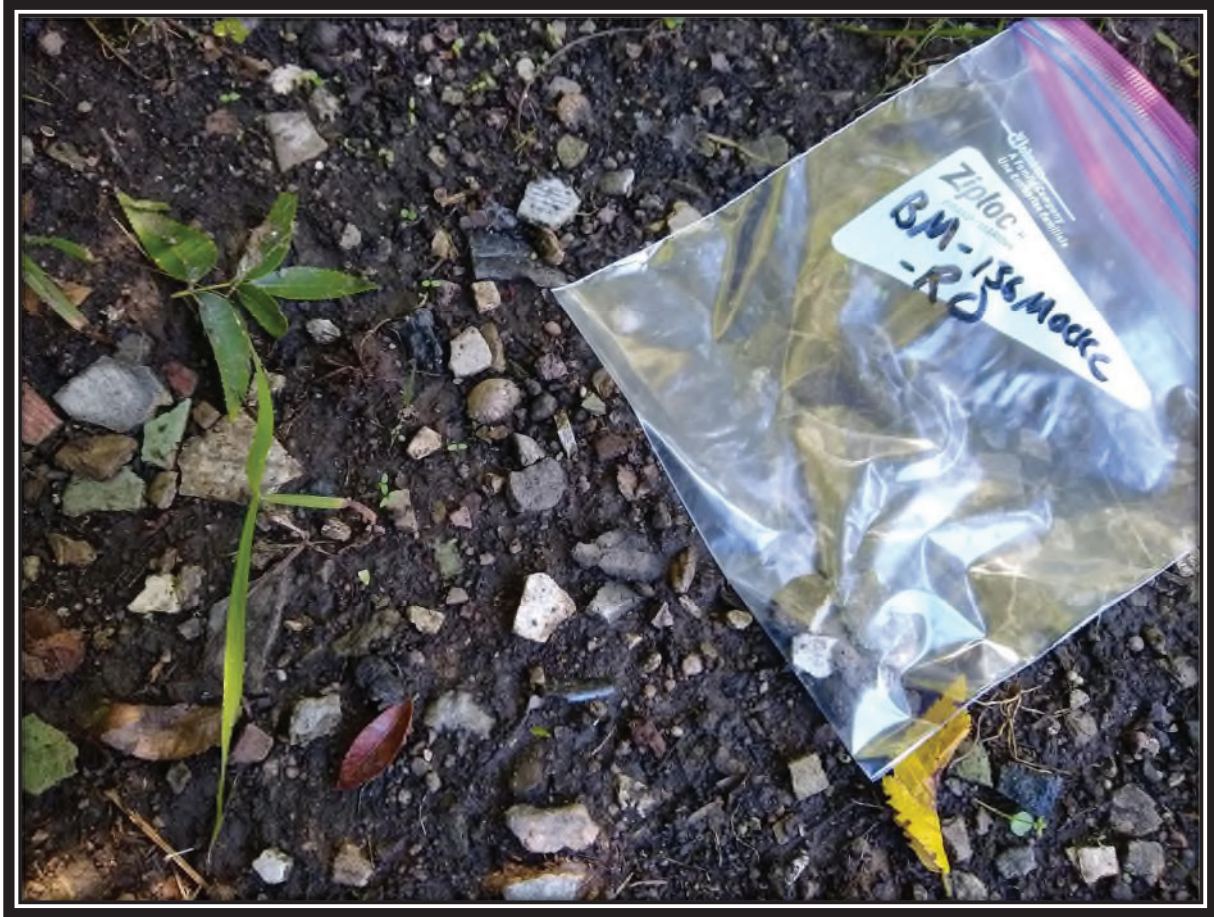
Subject: Members of the START sampling team collected soil samples from residences along Westside Terrace in Davidson, North Carolina.
