Structure Safety Report

4 Year Underwater Element Inspection

COUNTY: JOHNSTON STRUCTURE NUMBER: 500050 FREQUENCY: 48 MONTHS

FEATURE INTERSECTED: MIDDLE CREEK

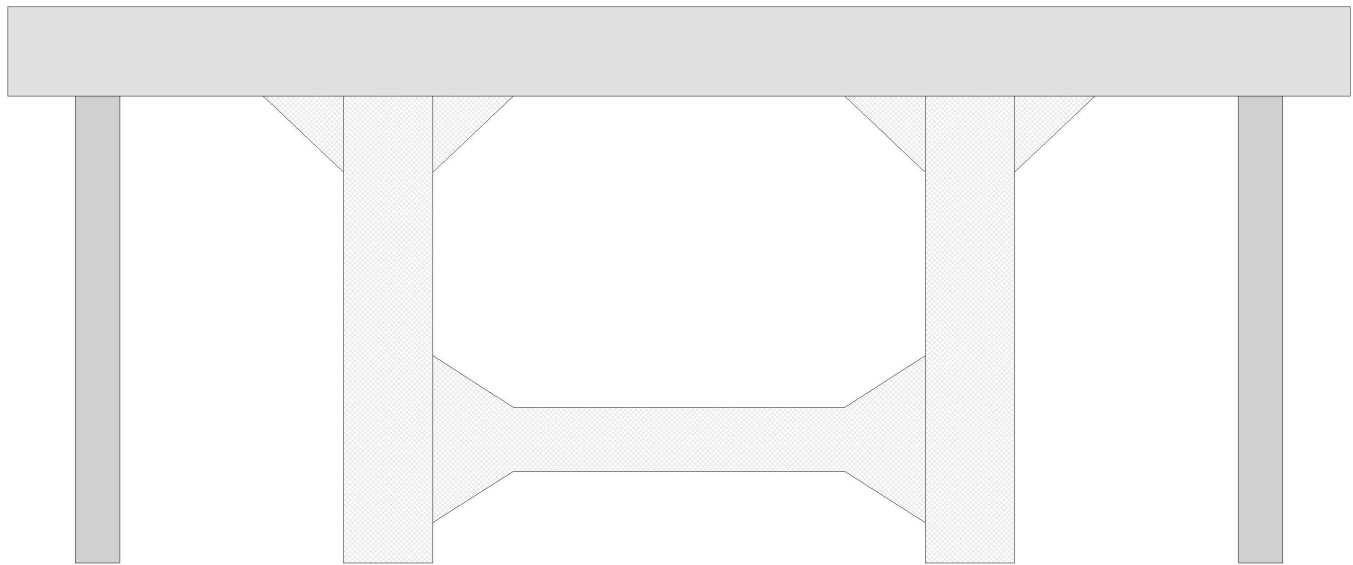
Title SUBSTRUCTURE				Description BENT DIAGRAM			
Bridge No: 500050	Drawn By: WTW			Date: 10/22/2013	File Name: S0018014562

Bent 1	Row 1	Piles and Columns	1							
Element: 226	Name	Prestressed Concrete Pile	Qty: 1	Lvl 2: 1	Lvl 3: 0	Lvl 4: 0	Maint. Qty: 0	5		
Defect Description:										
Underwater inspection:										
5' of Abrasion/Wear (PSC): Abrasion or wearing has exposed coarse aggregate but the aggregate remains secure in the concrete.

Bent 1	Row 1	Piles and Columns	2							
Element: 205	Name	Reinforced Concrete Column	Qty: 1	Lvl 2: 1	Lvl 3: 0	Lvl 4: 0	Maint. Qty: 0	5		
Defect Description:										
Underwater inspection:										
5 Feet of Abrasion/Wear (RC): Abrasion or wearing has exposed coarse aggregate but the aggregate remains secure in the concrete. 1/16" cracks on f-2 and f-4 from m/l to w/l.

Bent 1	Row 1	Piles and Columns	3							
Element: 205	Name	Reinforced Concrete Column	Qty: 1	Lvl 2: 1	Lvl 3: 0	Lvl 4: 0	Maint. Qty: 0	5		
Defect Description:										
Underwater inspection:										
5 Feet of Abrasion/Wear (RC): Abrasion or wearing has exposed coarse aggregate but the aggregate remains secure in the concrete. 1/16" cracks on f-2 and from m/l to w/l.

Bent 1	Row 1	Piles and Columns	4							
Element: 226	Name	Prestressed Concrete Pile	Qty: 1	Lvl 2: 1	Lvl 3: 0	Lvl 4: 0	Maint. Qty: 0	5		
Defect Description:										
Underwater inspection:										
5' of Abrasion/Wear (PSC): Abrasion or wearing has exposed coarse aggregate but the aggregate remains secure in the concrete.

Cap Information			Material Cast-in-Place Concrete							
Length	Width	Height	Left Overhang	Right Overhang	Left Beam to End of Cap.	Right Beam to End of Cap.				
30.000 ft.	2.500 ft.	2.000 ft.	2.000 ft.	2.000 ft.	1.000 ft.	1.000 ft.				
Subcap Information			Material							
Length	Width	Height	Left Overhang	Right Overhang	Left Pile to Splice.					
Sill Information			Material							
Length	Width	Height								
Pile #	Material	Spacing	Width/Dia.	Height	Length	Orientation	Driven?	Replacement?	Removed?	Collar?
1	Concrete	6.5 ft.	1.0 ft.			Vertical	Yes	No	No	No
2	Concrete	13.0 ft.	2.0 ft.			Vertical	No	No	No	No
3	Concrete	6.5 ft.	2.0 ft.			Vertical	No	No	No	No
4	Concrete		1.0 ft.			Vertical	Yes	No	No	No
Bent/Abutment #: 1			Similar Bents: BENTS 2 & 3
