**Phase II Site Assessment Report  
December 1, 2021  
WBS Element: 45786.1.1  
State Project: B-5833  
Yadkin County**

**Parcel #: 011  
Add-On Venture Properties, LLC Property  
5652 and 5704 US Hwy 21; Jonesville, NC, 28642  
PIN #: 4869563147, 4869562417, 4869563091  
Facility ID No.: 00-0-0000023364  
Groundwater Incident #: 37795**

**Mr. Gordon Box  
NCDOT, Geotechnical Engineering Unit  
GeoEnvironmental Section  
1589 Mail Service Center  
Raleigh, NC 27699-1589**

**Seramur & Associates, PC  
165 Knoll Drive  
Boone, NC 28607**

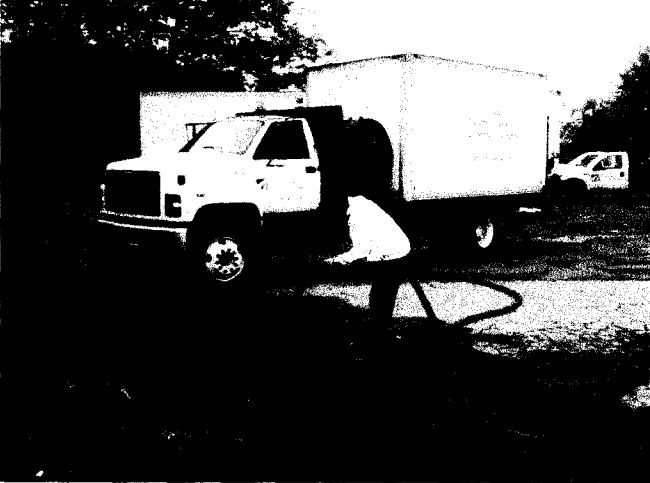
Spreading oil dry over parking lot

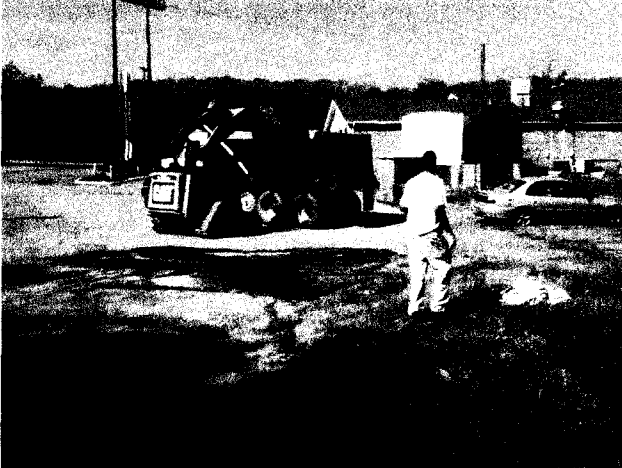
Sweeping oil dry off the pavement.
