NC DEPARTMENT OF TRANSPORTATION  
DIVISION OF HIGHWAYS  
BRIDGE MANAGEMENT UNIT

# BRIDGE INSPECTION REPORT

COUNTY WILKES BRIDGE NUMBER 960144 INSPECTION CYCLE 0 YRS

ROUTE SR1737 ACROSS E.PRONG ROARING RIVER M.P. 0

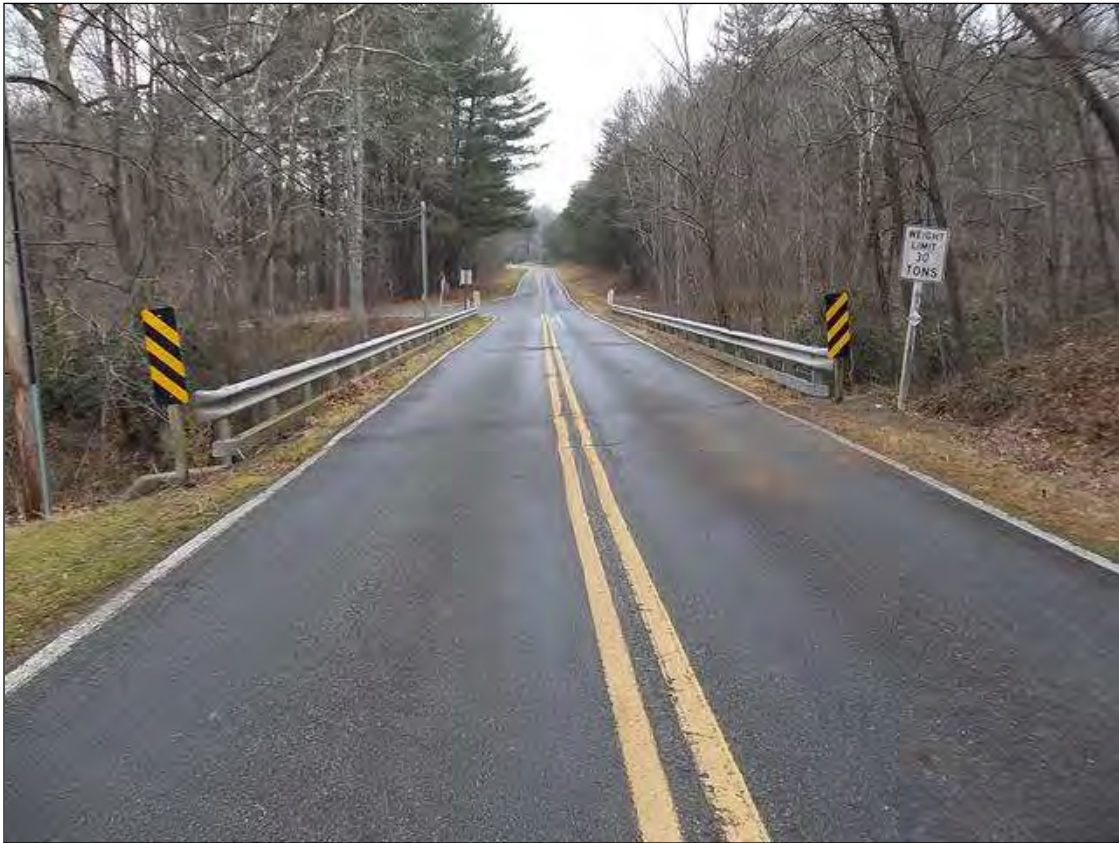
EAST APPROACH, LOOKING WEST

FULL WIDTH TRANSVERSE CRACK UP TO 1" IN ASPHALT WEARING SURFACE, EAST APPROACH APPROX. 7' FROM ABUTMENT 2.

| MMS Code | Description of Function | Unit | Quantity | Remarks | Est. Cost |
|---|---|---|---|---|---|
| 2816 | Asphalt Surface Repair or Replacement | SY | 100 | FULL WIDTH TRANSVERSE CRACK UP TO 1" IN ASPHALT WEARING SURFACE EAST APPROACH APPROXIMATLY 7' FROM ABUTMENT 2 | |

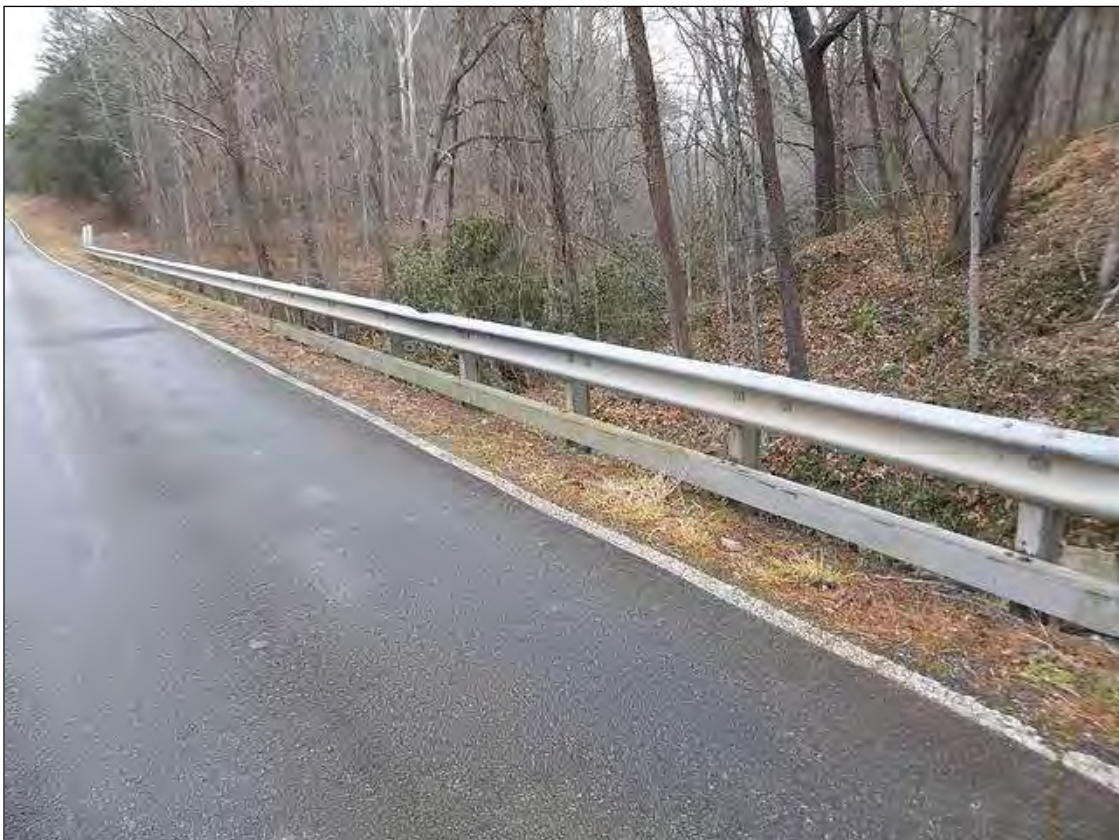
NORTH BRIDGE RAIL

IMPACT DAMAGE ON TOP OF NORTH BRIDGE RAIL, MID-SPAN 3.

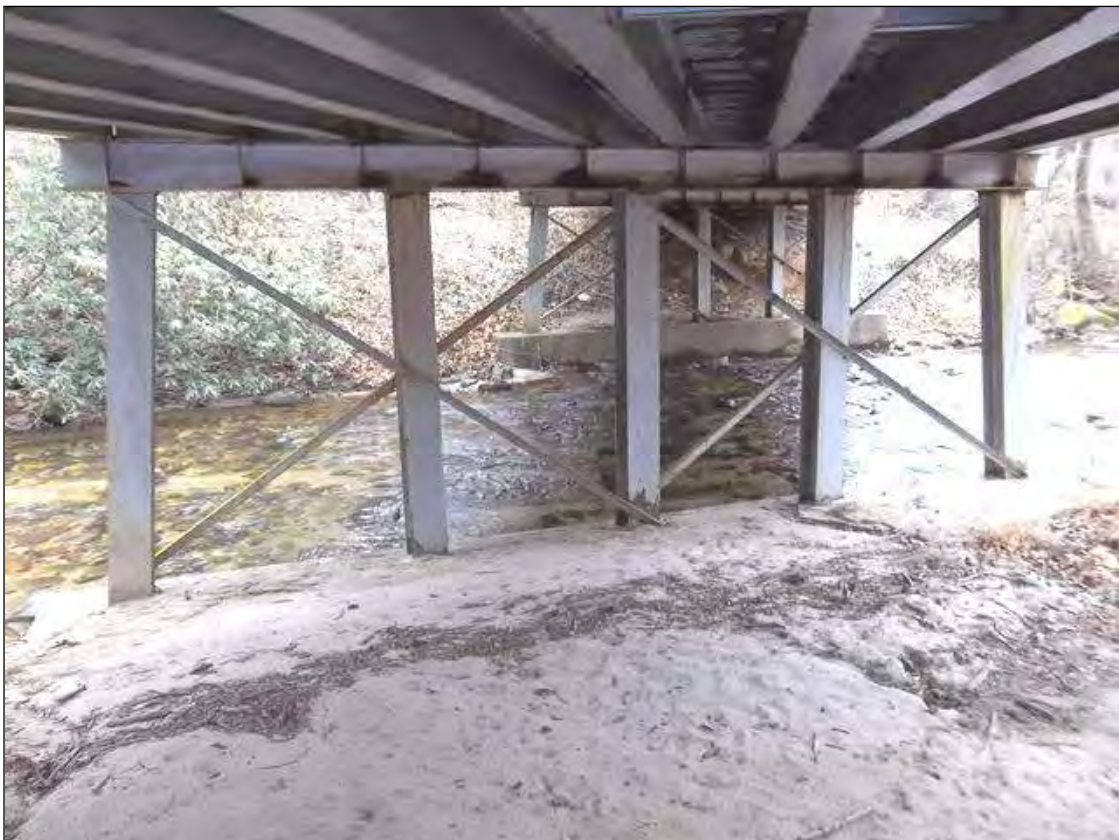
BENT 1 ELEVATION, LOOKING EAST

| Bridge I&A Form 1(82)H<br>State of North Carolina<br>Dept. of Transportation<br>Division of Highways | | <h1 style="text-align: center;">FIELD INSPECTION REPORT</h1> <p style="text-align: center;"><u>Bridge Inspection &amp; Analysis</u></p> | |
|---|---|---|--|
| 37b | F | HEAVY RUST SCALE AROUND TOP PLATES OF BENT 1 H-PILES.<br>PAINT PEELING AND FLAKING AT BOTTOM OF BENT 1 H-PILES. (BENT 2 SIMILAR) | |

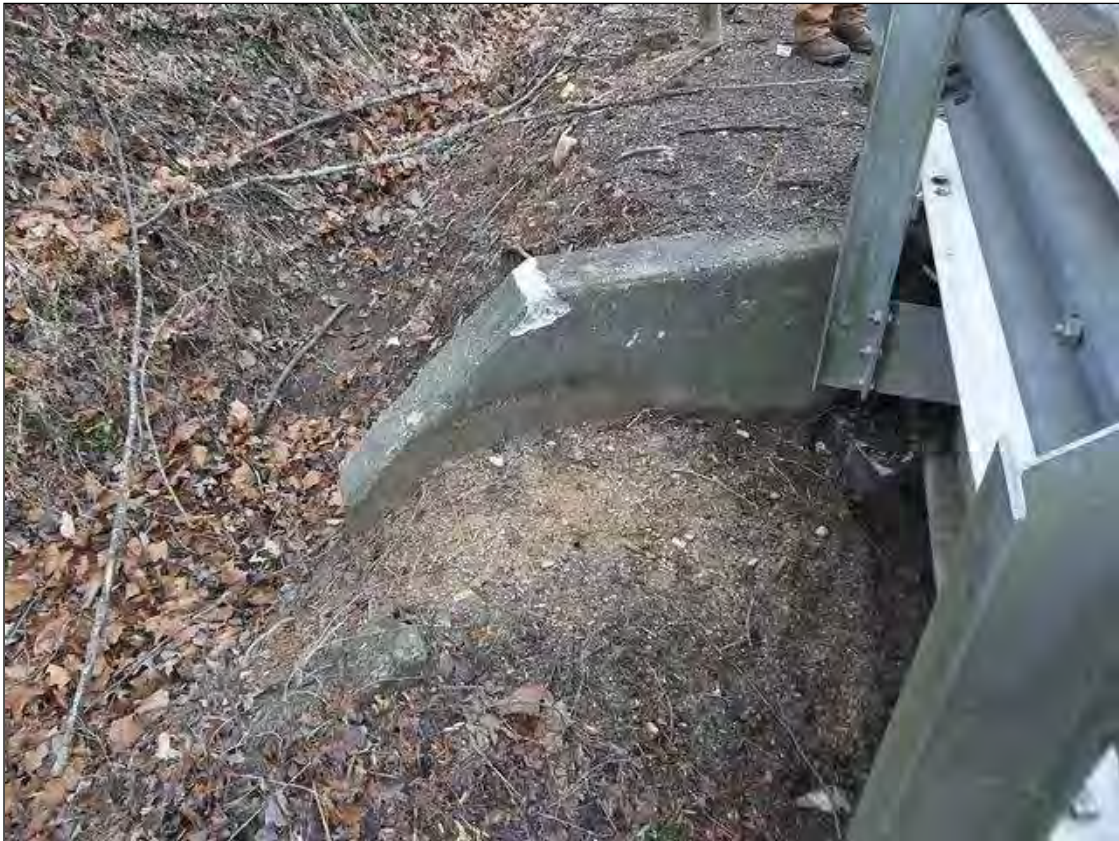
NORTHEAST WINGWALL

| Bridge I&A Form 1(82)H<br>State of North Carolina<br>Dept. of Transportation<br>Division of Highways | | <h1 style="text-align: center;">FIELD INSPECTION REPORT</h1> <p style="text-align: center;"><u>Bridge Inspection &amp; Analysis</u></p> | |
|---|---|---|--|
| 36d | G | 7" X 4" SPALL ON TOP OF NORTHEAST WINGWALL. | |

7" X 4" SPALL ON TOP OF NORTHEAST WINGWALL.
