NC DEPARTMENT OF TRANSPORTATION  
DIVISION OF HIGHWAYS  
BRIDGE MANAGEMENT UNIT

# BRIDGE INSPECTION REPORT

INSPECTION TYPE: Routine Inspection - Contract

COUNTY WILKES BRIDGE NUMBER 960187 INSPECTION CYCLE 0 YRS  
ROUTE SR2340 ACROSS FISHING CREEK M.P. 0

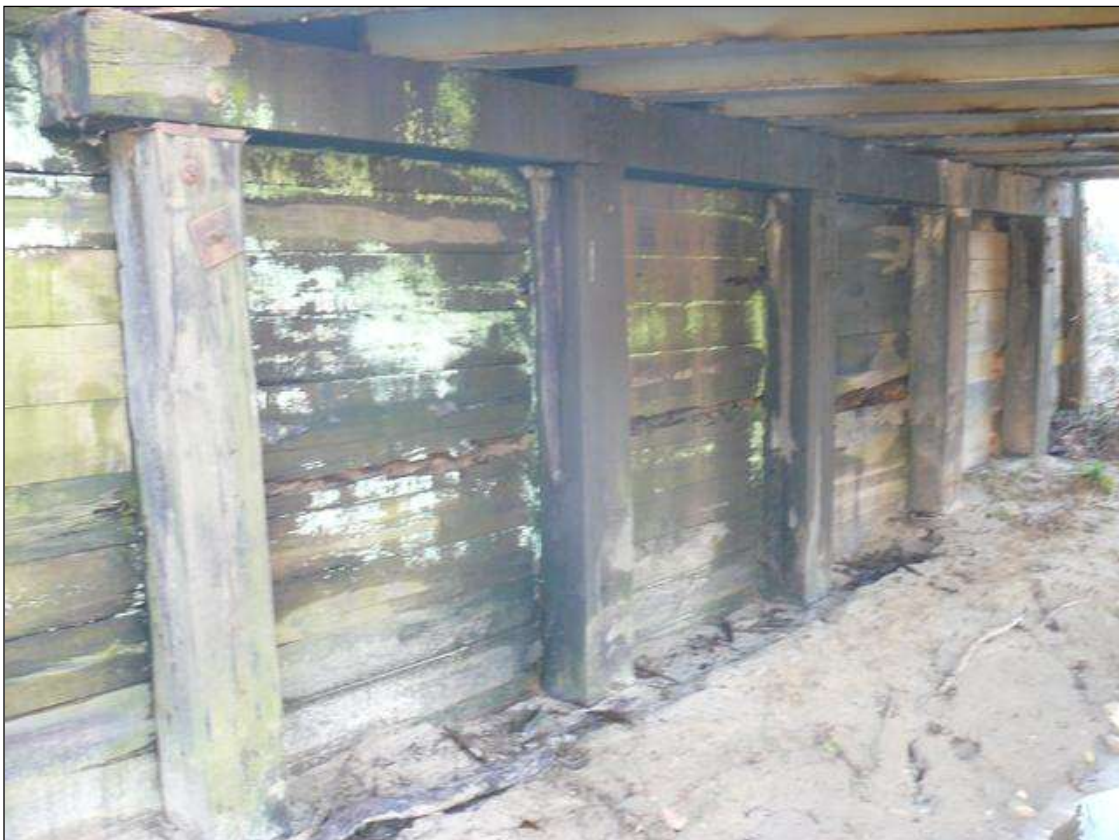
| Bridge I&A Form 1(82)H<br>State of North Carolina<br>Dept. of Transportation<br>Division of Highways | | <h1 style="text-align: center;">FIELD INSPECTION REPORT</h1> <h2 style="text-align: center;"><u>Bridge Inspeccion &amp; Analysis</u></h2> | |
|---|---|---|--|
| 35a | F | END BENT 1 CAP IS DECAYED ON THE LT END 3" X 3" X 20" DEEP ALONG BACK EDGE NEXT TO BULKHEAD.<br>END BENT 2 RT END OF THE CAP IS DECAYED FROM BULKHEAD OUT 5 1/2" X 3 1/2" TOP DOWN AND 14" DEEP. | |
| 35b | P | CRACKING AND SOFT. SOFT ON ENDS. SPLIT & SPOT DECAY ON LEFT END BOTH CAPS. DECAY IN TOP 2 IN. ON RIGHT END CAP 2 ALMOST TO EXTERIOR BEARING.<br>END BENT 1 PILE 1 IS DECAYED INSIDE A SHELL 6" WIDE X 6" DEEP X 4' HIGH FROM BOTTOM CAP DOWN. PM ISSUED<br>END BENT 2 PILE 1 IS DECAYED 6" DEEP AREA X 7" WIDE X FROM TOP DOWN 4. PM ISSUED.<br>END BENT 2 PILE 5 IS DECAYED FROM THE TOP DOWN 5' X 6 1/2" W X 8" DEEP. PM ISSUED | |
| 35c | P | END BENT 1 THE RT WINGWALL IS DECAYED AND POST AND BOARDS ARE DECAYED.<br>END BENT 1 BULKHEAD BOARDS ARE DECAYED BETWEEN MOST ALL PILES . | |

| MMS Code | Description of Function | Unit | Quantity | Remarks | Est. Cost |
|---|---|---|---|---|---|
| 3344 | Repair / Replace Timber Substructure Components | LF | 5 | END BENT 1 PILE 1 IS DECAYED HAS A 1" INSIDE SHELL WITH AREA BEING 6" W X 6" D X 4' HIGH FROM TOP OF CAP DOWN. END BENT 1 PILE 1 IS DECAYED INSIDE A SHELL 6" WIDE X 6" DEEP X 4' HIGH FROM BOTTOM CAP DOWN. PM ISSUED | |
| 3344 | Repair / Replace Timber Substructure Components | LF | 4 | END BT 1 CAP DECAYED ALONG LT END IN AREA AT BULKHEAD, END BT 2 CAP RT END IS DECAYED ALONG BACK OF BULKHEAD. | |
| 3346 | Repair / Maintain Timber Wings & Blkhs | SF | 200 | BULKHEAD BOARDS AT END BT 1 AND END BT 2 HAVE SCATTERED AREAS OF DECAY THROUGH OUT AND WING PILES DECAYED | |

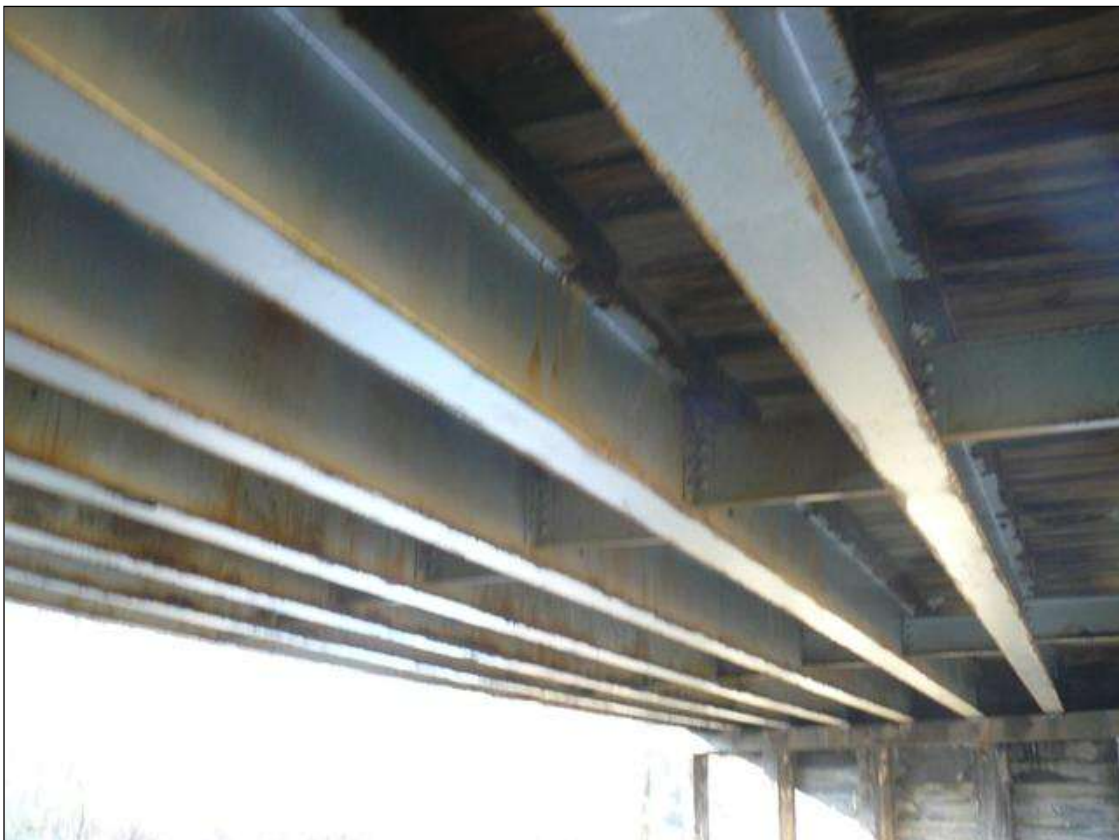
SUPERSTRUCTURE

| Bridge I&A Form 1(82)H<br>State of North Carolina<br>Dept. of Transportation<br>Division of Highways | | <h1 style="text-align: center;">FIELD INSPECTION REPORT</h1> <h2 style="text-align: center;"><u>Bridge Inspeccion &amp; Analysis</u></h2> | |
|---|---|---|--|
| 10 | F | STEEL BEAMS ARE RUSTY AND SCALING ALONG THE TOP AND BOTTOM FLANGES WITH UP TO 1/8" SECTION LOSS.<br>THE STEEL BEAMS HAVE RUST AND SCALING ALONG TOP FLANGES NEAR MIDSPAN ON MOST BEAMS WITH UP TO 3/16" LOSS IN SPOTS. | |
| 52 | F | AREAS OF RUST ALONG THE TOP AND BOTTOM FLANGES OF THE BEAMS AND ON THE BEARING AREAS. | |

| MMS Code | Description of Function | Unit | Quantity | Remarks | Est. Cost |
|---|---|---|---|---|---|
| 3342 | Clean and Paint Structural Steel | SF | 300 | BEAMS HAVE RUST AND FLAKING ALONG THE TOP AND BOTTOM FLANGES AND IN THE BEARING AREAS. | |
