# BRIDGE INSPECTION REPORT

INSPECTION TYPE: Routine Inspection

COUNTY HAYWOOD BRIDGE NUMBER 430102 INSPECTION CYCLE 2 YRS  
ROUTE SR1173 ACROSS PLOTT CREEK M.P. 0

INSPECTION DATE 02/11/2013

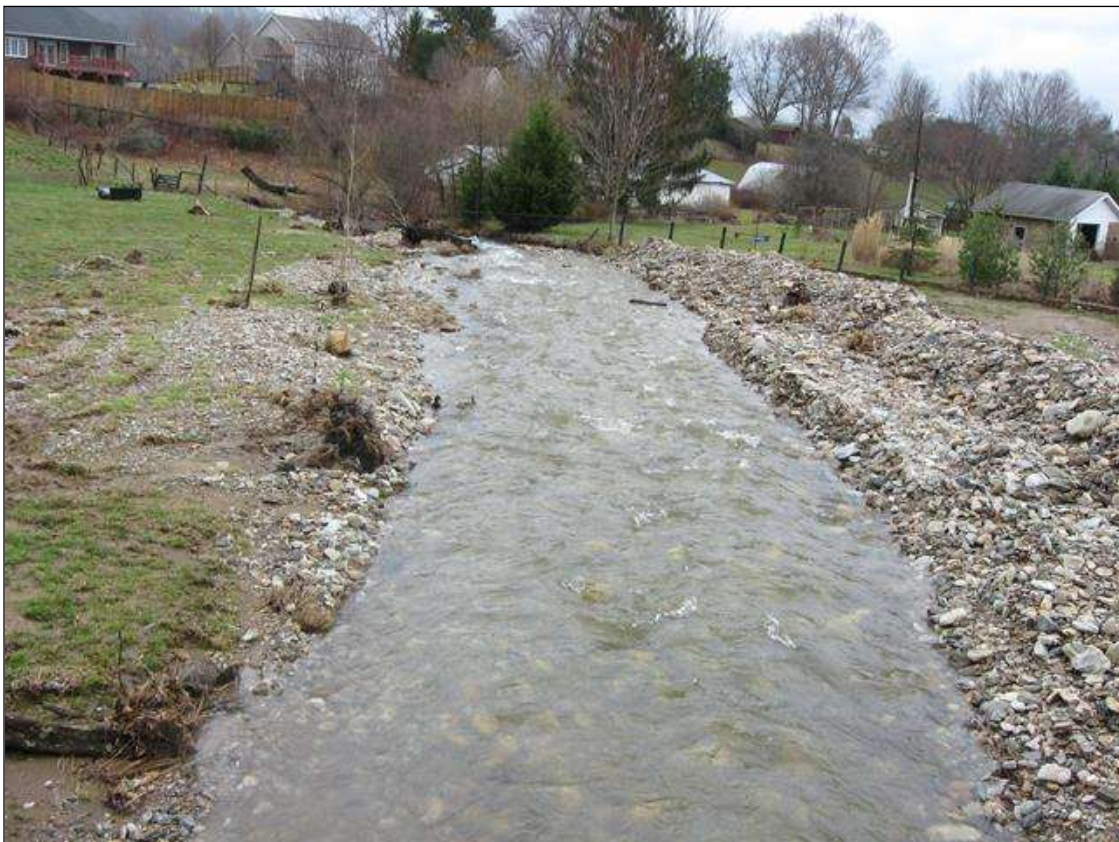
LOOKING DOWNSTREAM FROM TOP OF BRIDGE.

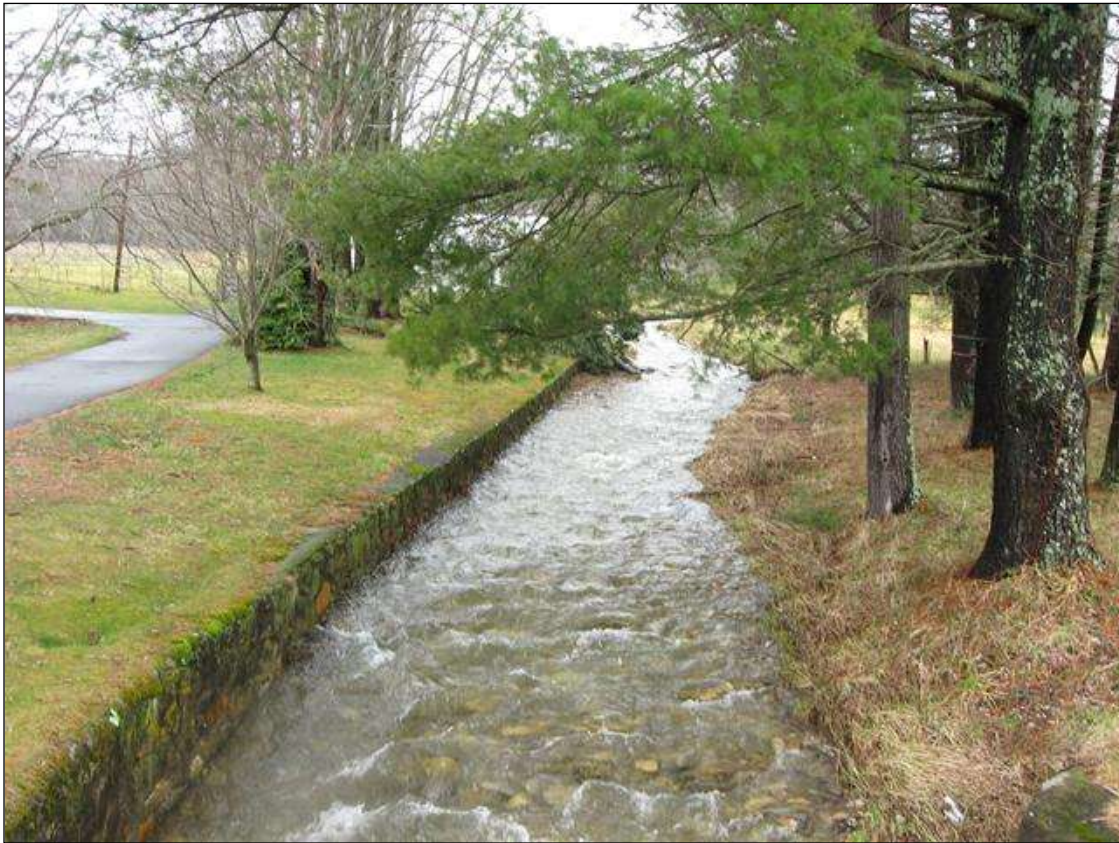
LOOKING UPSTREAM FROM TOP OF BRIDGE.

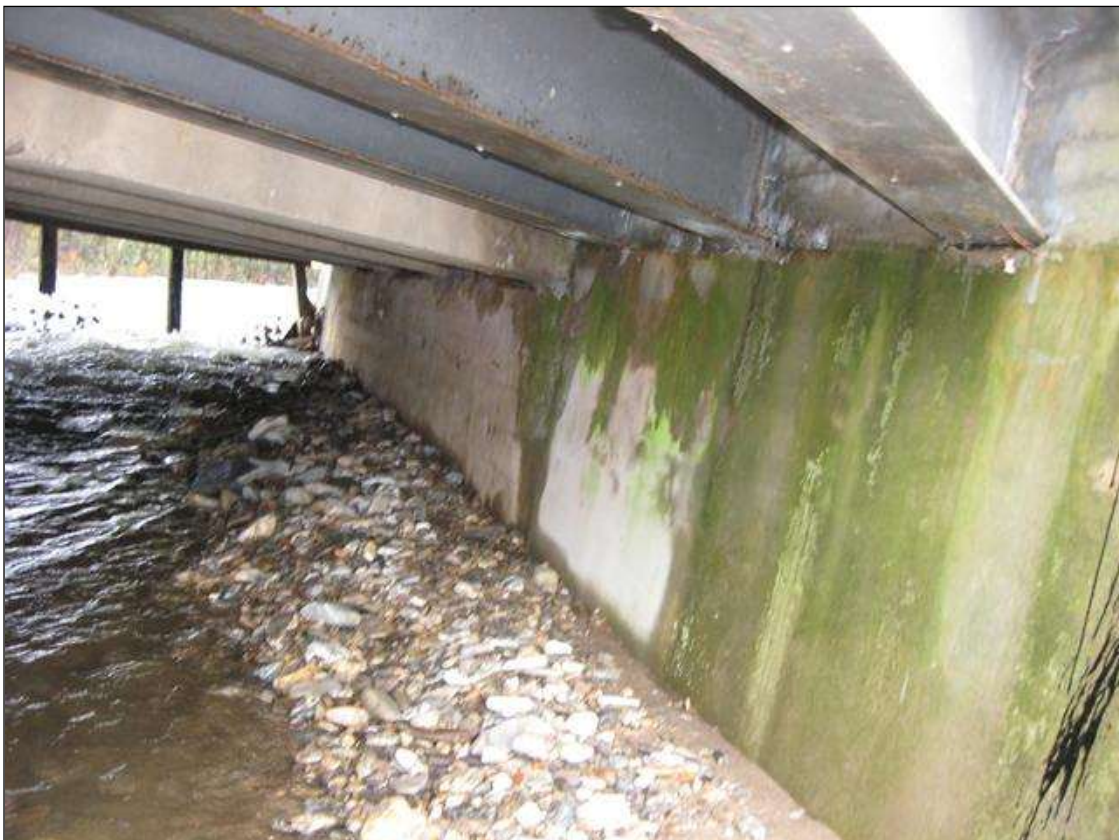
| Bridge I&A Form 1(82)H<br>State of North Carolina<br>Dept. of Transportation<br>Division of Highways | | <h1>FIELD INSPECTION REPORT</h1> <h2><u>Bridge Inspection &amp; Analysis</u></h2> | |
|---|---|---|--|
| 36a | F | CAPS,BREASTWALLS AND FOOTINGS; 1/8" TO 1/4" DIAG. TYPE CRACKS BEGINS IN VISIBLE PORTION OF FOOTING AND EXTENDS ENTIRE HT. OF ABUTMENT 2. [SEE PHOTO].<br>CRACK IS JUST DOWNSTREAM OF BEAM 1 AT CAP.<br>FOOTINGS ARE LIGHT TO MOD. DETER. UP TO 1" DEEP WHERE VISIBLE.<br>NO CHANGE IN PAST SEVERAL INSPS. | |

REP. OF ABUTMENTS 1 AND 2. PHOTO WAS TAKEN OF ABUTMENT 2.

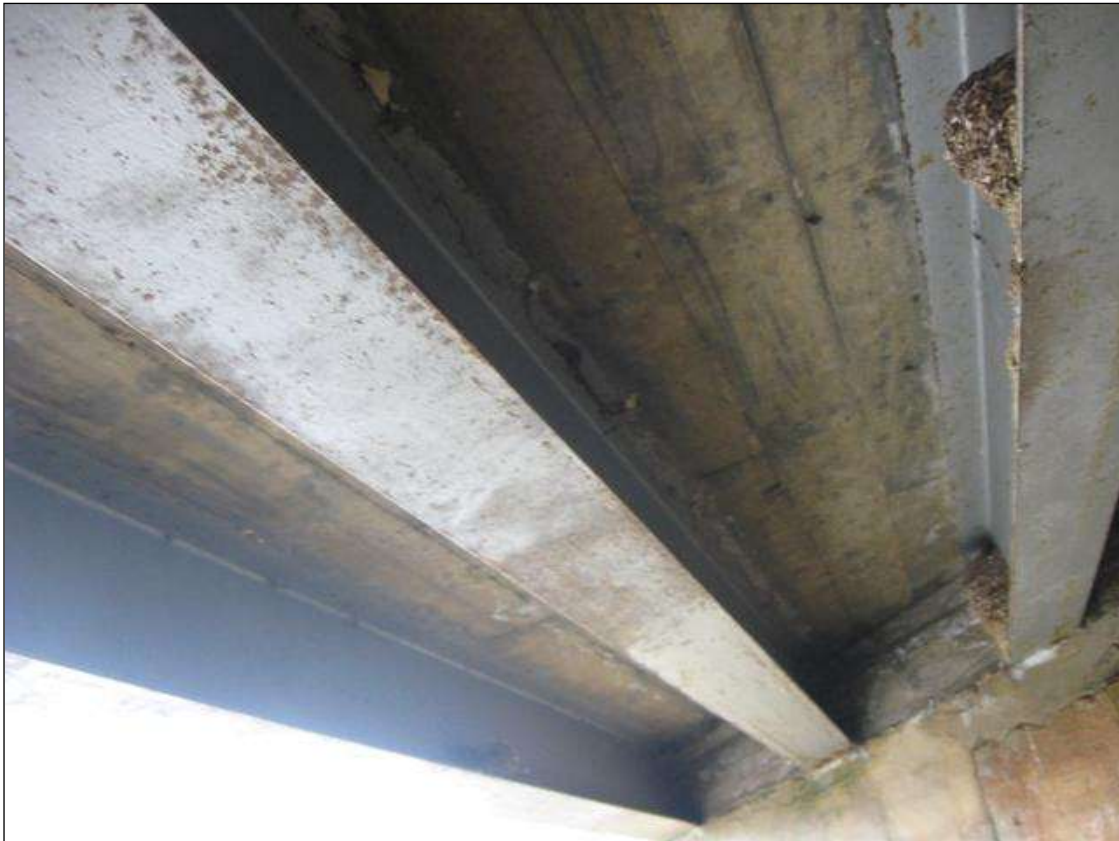
| Bridge I&A Form 1(82)H<br>State of North Carolina<br>Dept. of Transportation<br>Division of Highways | | <h1>FIELD INSPECTION REPORT</h1> <h2><u>Bridge Inspection &amp; Analysis</u></h2> | |
|---|---|---|--|
| 2a | G | CONCRETE FLOOR; TOPSIDE - COVERED WITH ASPHALT WEARING SURFACE - NO VISIBLE PROBLEMS.<br>UNDERSIDE - A FEW 1/8" WIDE DIAG. AND LONG. TYPE CRACKS WHERE FORM BOARDS HAVE BEEN REMOVED.<br>VERY LITTLE CHANGE IN PAST SEVERAL INSPS. | |

REP. OF UNDERSIDE WITH BEAMS.

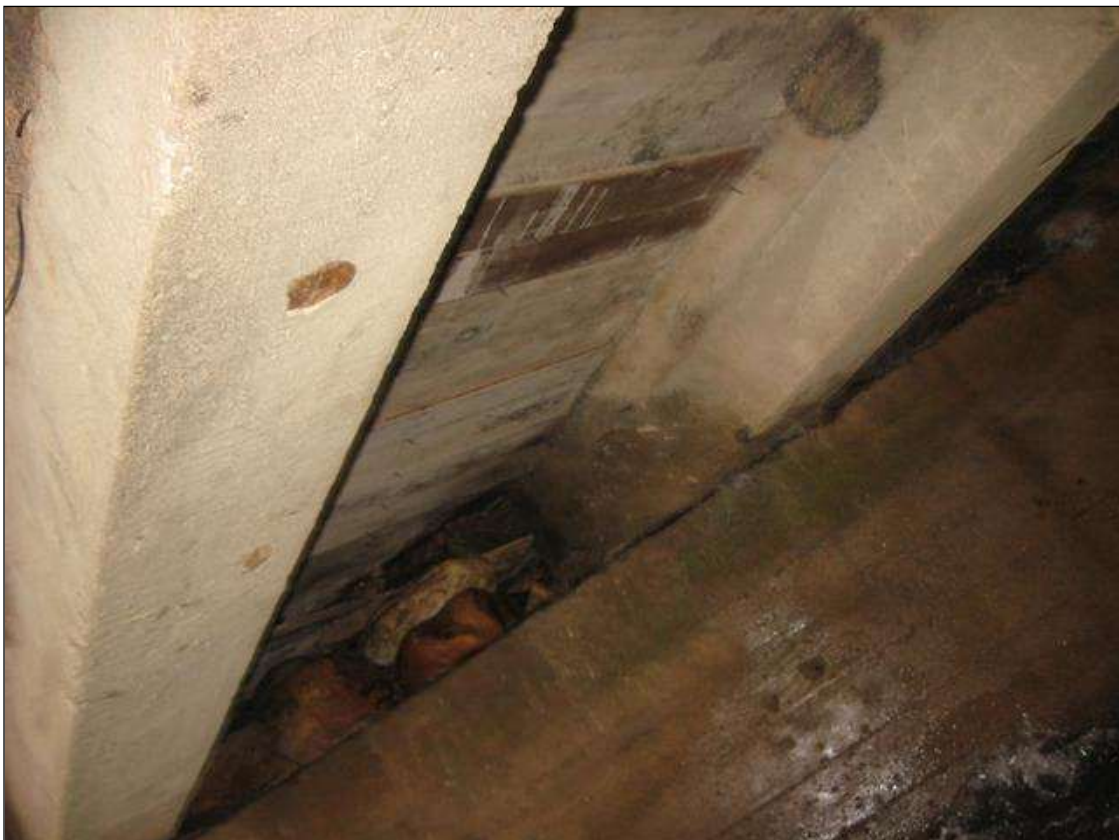
| Bridge I&A Form 1(82)H<br>State of North Carolina<br>Dept. of Transportation<br>Division of Highways | | <h1>FIELD INSPECTION REPORT</h1> <h2><u>Bridge Inspection &amp; Analysis</u></h2> | |
|---|---|---|--|
| 10 | F | GIRDERS; HEAVY AREAS OF 1" DEEP HONEY-COMB SCATTERED THROUGHOUT WITH REINF. EXPOSED.<br>A COUPLE OF 1/2" TO 1 1/2" DEEP X 6" LONG X 2" HIGH SPALLS AND/OR DETER. AREAS.<br>NO PROBLEMS DUE TO CONDITIONS AS YET. | |

REP. OF UNDERSIDE WITH GIRDERS.
