NC DEPARTMENT OF TRANSPORTATION  
DIVISION OF HIGHWAYS  
BRIDGE MANAGEMENT UNIT

# BRIDGE INSPECTION REPORT

COUNTY HAYWOOD BRIDGE NUMBER 430314 INSPECTION CYCLE 2 YRS  
ROUTE SR1355 ACROSS CREEK M.P. 0

INSPECTION DATE 05/15/2013 PRESENT CONDITION POOR

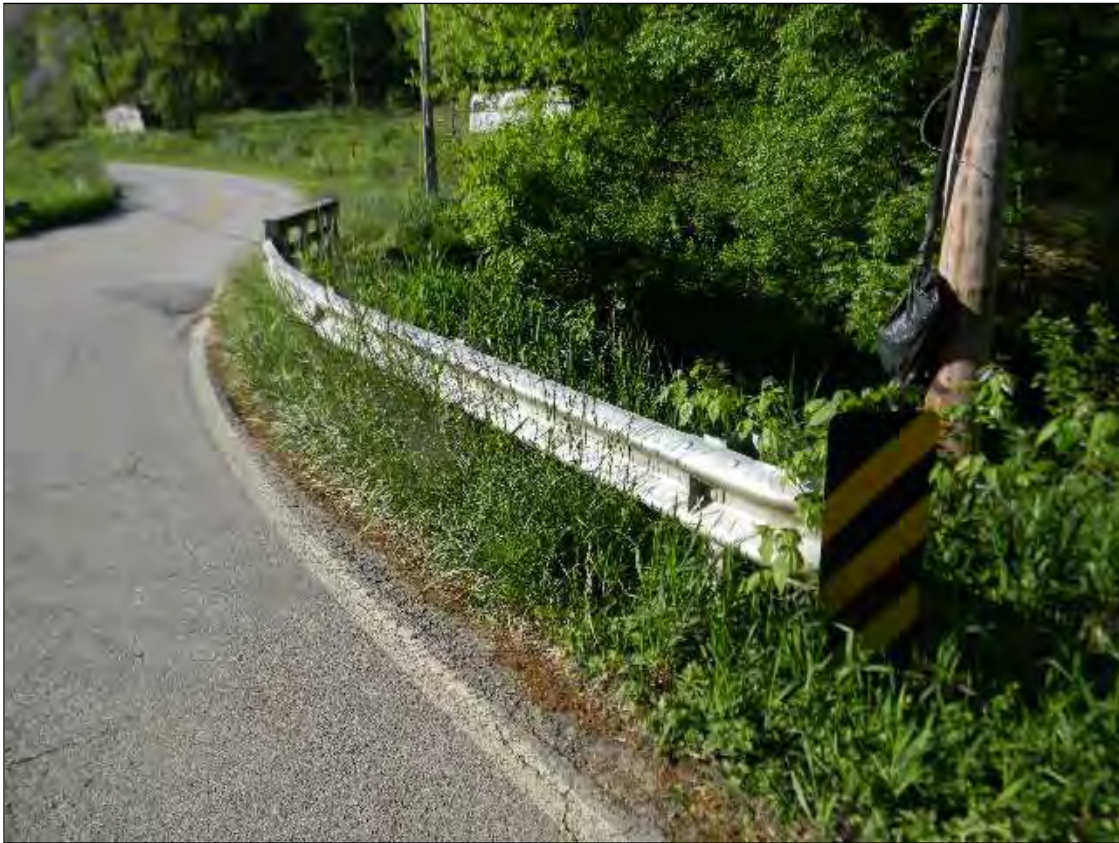
GUARDRAIL AT THE NW CORNER. SE GUARDRAIL IS SIMILAR.

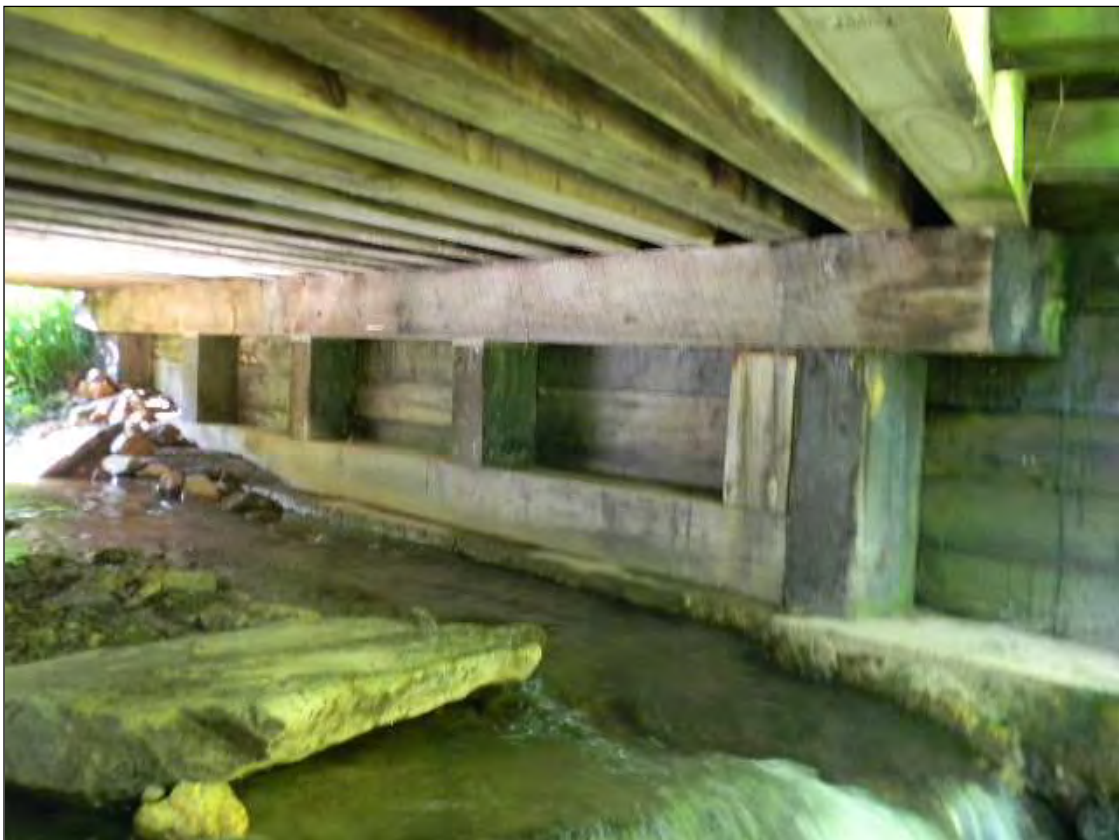
| 36e | F | DETERIORATION AT DOWNSTREAM END ABUTMENT 1 FOOTING. | |

| MMS Code | Description of Function | Unit | Quantity | Remarks | Est. Cost |
|---|---|---|---|---|---|
| 3344 | Repair / Replace Timber Substructure Components | LF | 8 | RIGHT END OF ABUTMENT 1 CAP HAS 95% LOSS UNDER THE 2 EXTERIOR JOISTS. DECAY EXTENDS 5' INTO THE CAP UNDER THE 5 EXTERIOR JOISTS. A PRIORITY MAINTENANCE IS BEING ISSUED FOR THIS CAP. | |
| 3346 | Repair / Maintain Timber Wings & Blkhds | SF | 40 | ABUTMENT 1 BULKHEAD AT THE SE CORNER HAS COMPLETE DECAY EXPOSING THE FILL. THIS AREA IS INCLUDED IN THE PRIORITY MAINTENANCE ISSUED FOR THE BULKHEADS. | |

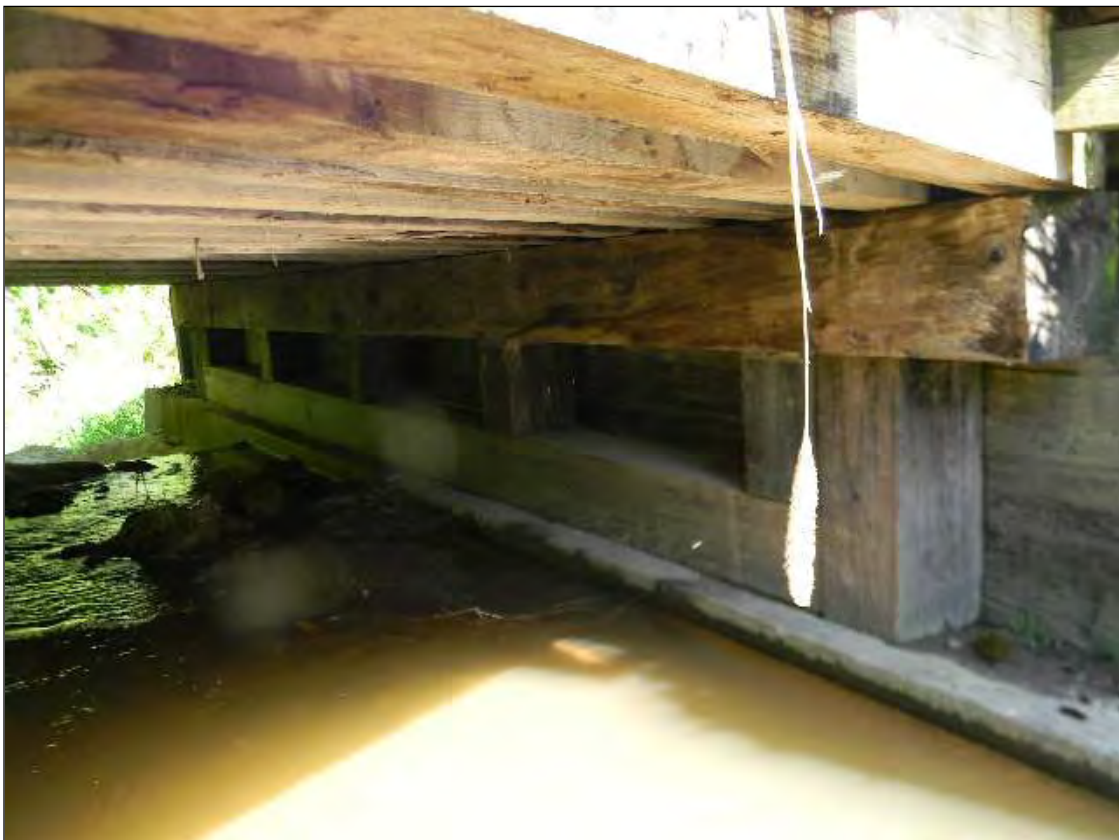
| MMS Code | Description of Function | Unit | Quantity | Remarks | Est. Cost |
|---|---|---|---|---|---|
| 3344 | Repair / Replace Timber Substructure Components | LF | 2 | 6" WIDE X 11" HIGH X 10" DEEP DECAY IN THE LEFT END OF ABUTMENT 2 CAP EXTENDS UNDER THE 2 EXTERIOR JOISTS. A PRIORITY MAINTENANCE IS BEING RE-ISSUED FOR THIS CAP. | |
| 3346 | Repair / Maintain Timber Wings & Blkhds | SF | 300 | ABUTMENT 2 BULKHEAD BOARDS AT THE NE CORNER HAVE COMPLETE DECAY EXPOSING THE BACKFILL. THE STREAM FLOWS TOWARD THIS AREA. A PRIORITY MAINTENANCE IS BEING ISSUED FOR BOTH BULKHEADS AND ALL TIMBER WINGS. | |
