NC DEPARTMENT OF TRANSPORTATION  
DIVISION OF HIGHWAYS  
BRIDGE MANAGEMENT UNIT

# BRIDGE INSPECTION REPORT

INSPECTION TYPE: Routine Inspection

COUNTY COLUMBUS BRIDGE NUMBER 230118 INSPECTION CYCLE 2 YRS  
ROUTE SR1317 ACROSS GUM SWAMP M.P. 0

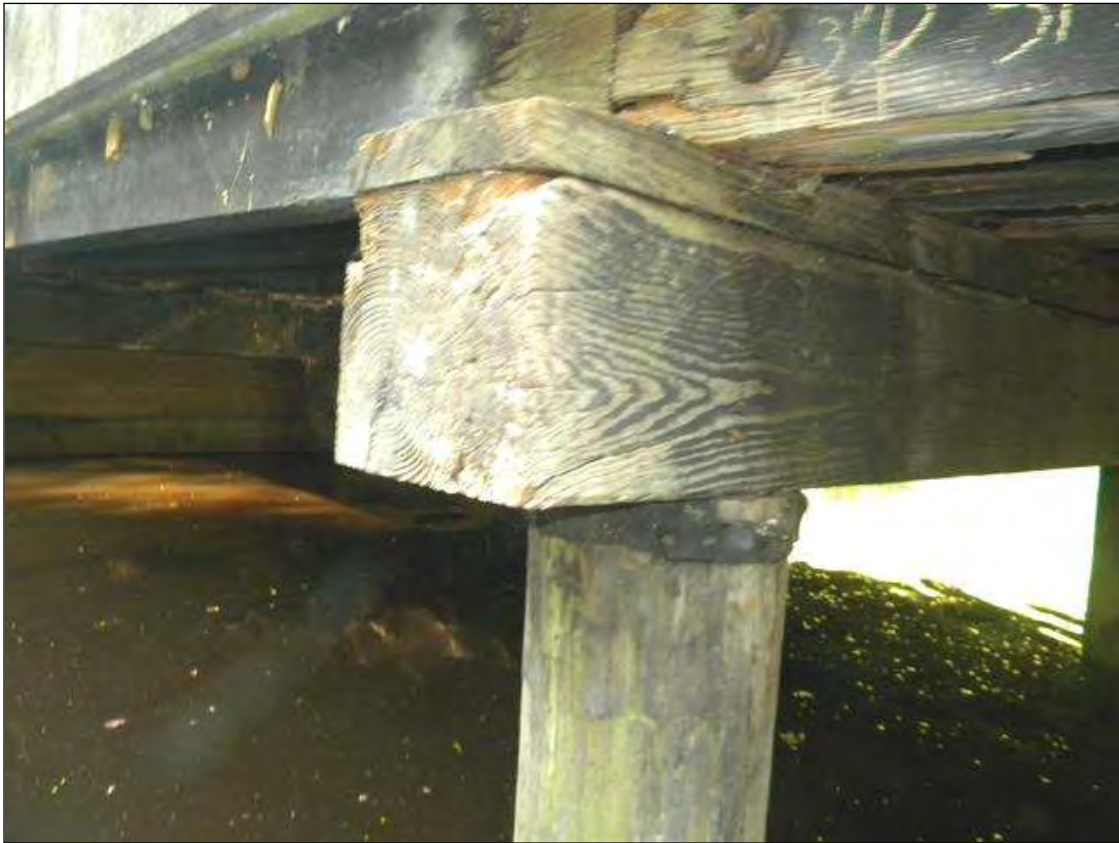
EAST END OF BENT 1 CAP

| <b>35b</b> | <b>G</b> | THE BENT 1 CAP AT EAST END IS SURFACE DECAYED. (PHOTO)<br>( TIMBER PILES ) PILE 2 AT END BENT 1 IS ENCASED IN CONCRETE. (PHOTO)<br><br>PILE 1 AT BENT 1 IS ENCASED IN CONCRETE. (PHOTO)<br><br>PILE 3 AT END BENT 1 IS SURFACE DECAYED. (PHOTO)<br><br>THERE IS NO CROSSBRACING AT BENT 1.<br><br>SEE DIVERS UNDERWATER INSPECTION REPORT DATED 3/29/2011. | |
