NC DEPARTMENT OF TRANSPORTATION  
DIVISION OF HIGHWAYS  
BRIDGE MANAGEMENT UNIT

# BRIDGE INSPECTION REPORT

COUNTY COLUMBUS BRIDGE NUMBER 230167 INSPECTION CYCLE 2 YRS  
ROUTE SR1379 ACROSS GAPWAY SWAMP M.P. 0

INSPECTION DATE 07/22/2013

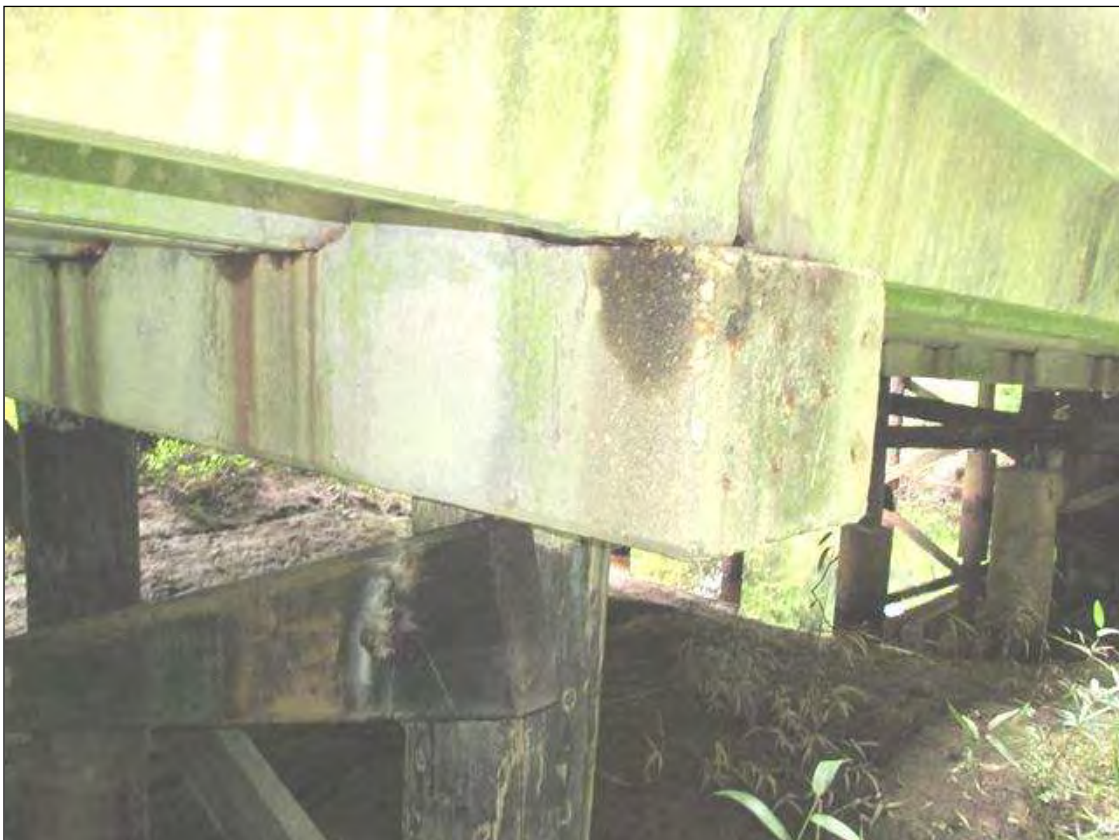
SOUTH END OF BENT 1 CAP

| Bridge I&A Form 1(82)H<br>State of North Carolina<br>Dept. of Transportation<br>Division of Highways | | <h2 style="text-align: center;">FIELD INSPECTION REPORT</h2> <p style="text-align: center;"><u>Bridge Inspeccion &amp; Analysis</u></p> | |
|---|---|---|--|
| 36a | F | ( PPC CAPS ) THERE ARE EXPOSED CABLE ENDS AT SOUTH END OF BENT 1. ALL CAP ENDS ARE SIMILAR. (PHOTO)<br><br>THERE ARE STAINS ON CAPS DUE TO JOINT LEAKAGE. | |
