NC DEPARTMENT OF TRANSPORTATION  
DIVISION OF HIGHWAYS  
BRIDGE MANAGEMENT UNIT

# BRIDGE INSPECTION REPORT

INSPECTION TYPE: Routine Inspection

COUNTY COLUMBUS BRIDGE NUMBER 230171 INSPECTION CYCLE 2 YRS  
ROUTE SR1414 ACROSS DUNN SWAMP M.P. 0

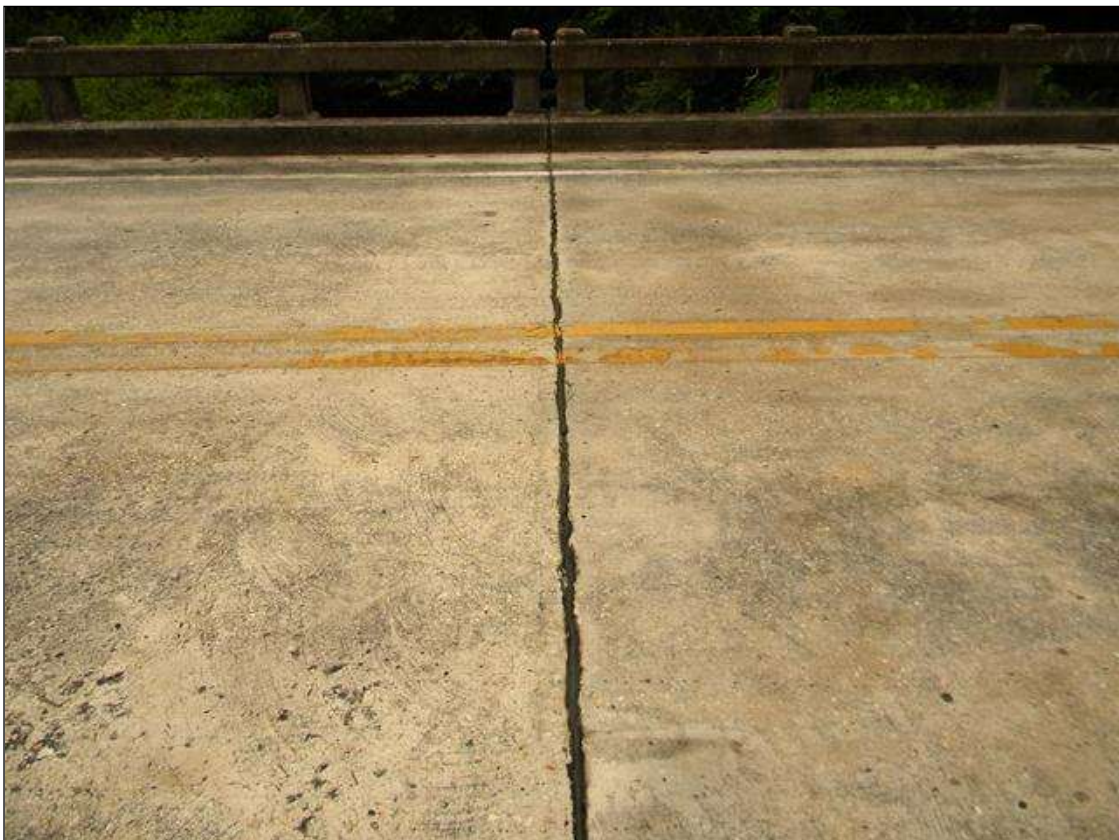
| Bridge I&A Form 1(82)H<br>State of North Carolina<br>Dept. of Transportation<br>Division of Highways | | <h1 style="text-align: center;">FIELD INSPECTION REPORT</h1> <h2 style="text-align: center;"><u>Bridge Inspection &amp; Analysis</u></h2> | |
|---|---|---|--|
| 6d | P | ( STANDARD JOINTS ) THERE ARE A FEW LOCATIONS ON THE UNDERSIDE THAT HAVE SIGNS OF LEAKAGE.<br><br>THE TOP SEAL IS DETERIORATED, CRACKED, SETTLED, AND LEAKING AT ALL STANDARD JOINTS. (PHOTOS) | |

BENT 1 STANDARD JOINT, ALL JOINTS ARE SIMILAR

| MMS Code | Description of Function | Unit | Quantity | Remarks | Est. Cost |
|---|---|---|---|---|---|
| 3310 | Maintenance/Repair/Replacement of Standard Bridge Expansion Joints | LF | 72 | BENT 1 STANDARD JOINT MATERIAL DETERIORATED, CRACKED, AND LEAKING ALL JOINTS ARE SIMILAR | |

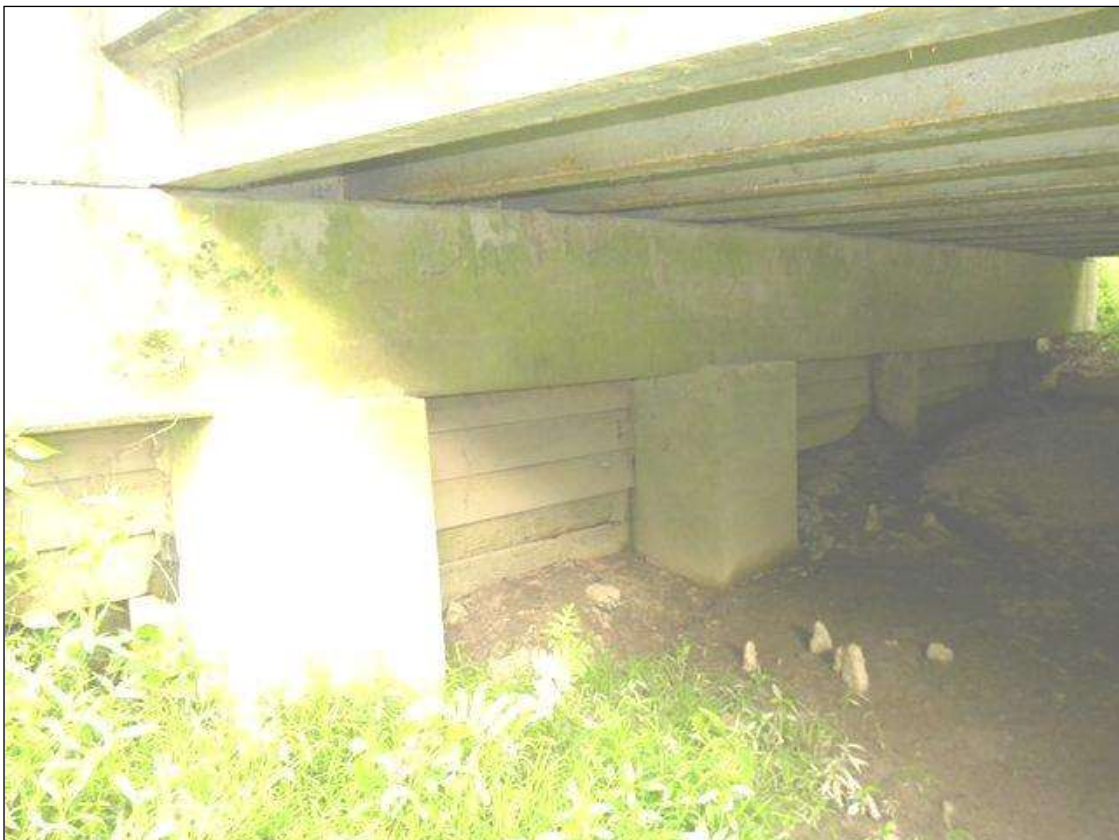
| Bridge I&A Form 1(82)H<br>State of North Carolina<br>Dept. of Transportation<br>Division of Highways | | <h1 style="text-align: center;">FIELD INSPECTION REPORT</h1> <h2 style="text-align: center;"><u>Bridge Inspection &amp; Analysis</u></h2> | |
|---|---|---|--|
| 13 | G | ( END DIAPHRAGMS ) THERE IS A HAIRLINE VERTICAL CRACK IN THE END DIAPHRAGM AT END BENT 1 IN BAY 5. (PHOTO) | |

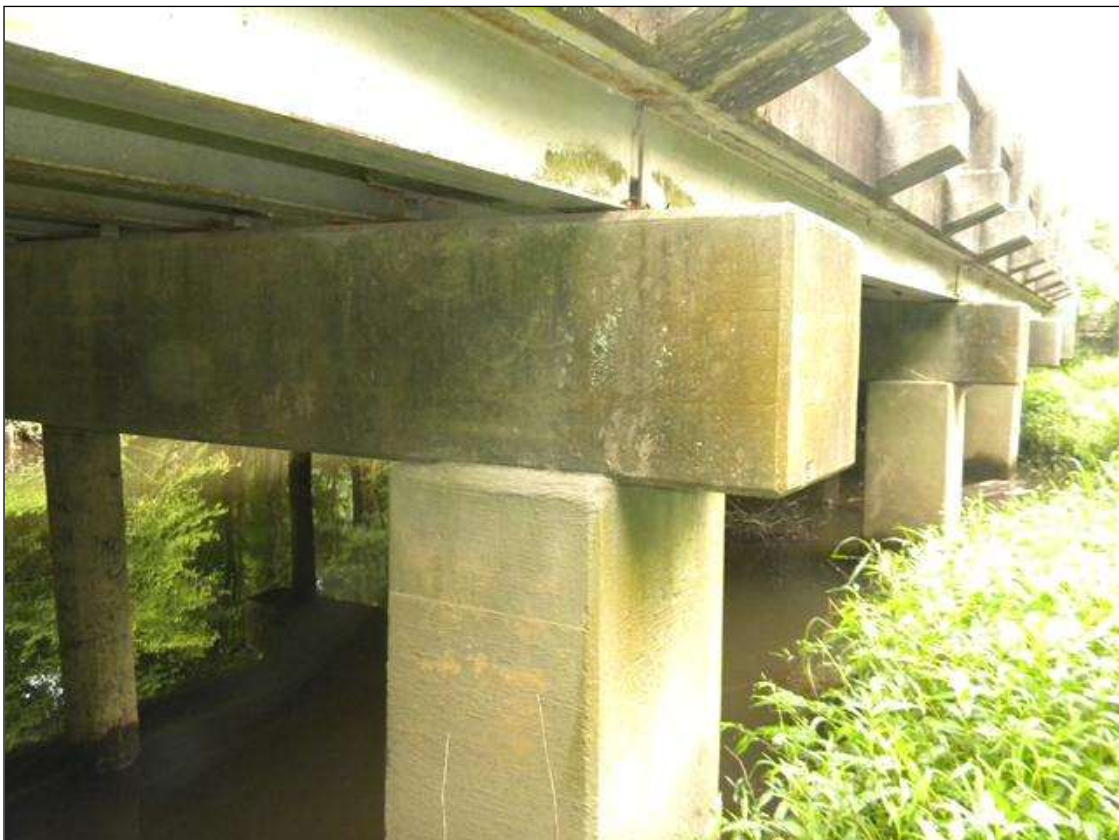
| <b>39</b> | <b>F</b> | THERE IS A SURFACE SPALL ON EAST END OF BENT 1 CAP. (PHOTO)<br>( SLOPE PROTECTION )    RIP RAP PLACED AT END BENT 2. | |

EAST END OF BENT 1 CAP

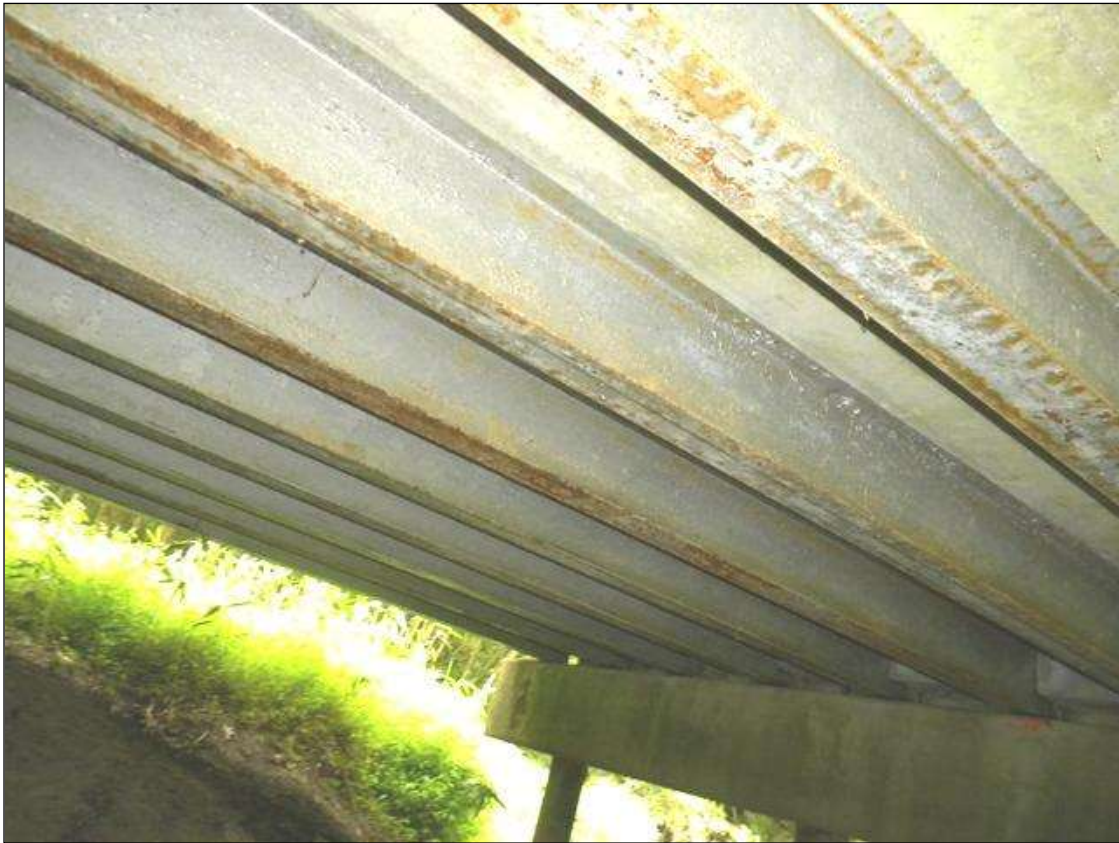
| Bridge I&A Form 1(82)H<br>State of North Carolina<br>Dept. of Transportation<br>Division of Highways | | <h1 style="text-align: center;">FIELD INSPECTION REPORT</h1> <h2 style="text-align: center;"><u>Bridge Inspection &amp; Analysis</u></h2> | |
|---|---|---|--|
| 52 | F | ( PAINT SYSTEM ) MOST BEAMS HAVE AREAS OF PEELING, SURFACE RUST AND SHALLOW PITTING AT THE BEARING AREAS. (PHOTOS) | |

SPAN 1 UNDERSIDE, ALL SPANS ARE SIMILAR

| MMS Code | Description of Function | Unit | Quantity | Remarks | Est. Cost |
|---|---|---|---|---|---|
| 3342 | Clean and Paint Structural Steel | SF | 1000 | SPAN 1 UNDERSIDE WITH PAINT PEELING AND SURFACE RUST, SIMILAR IN ALL SPANS | |

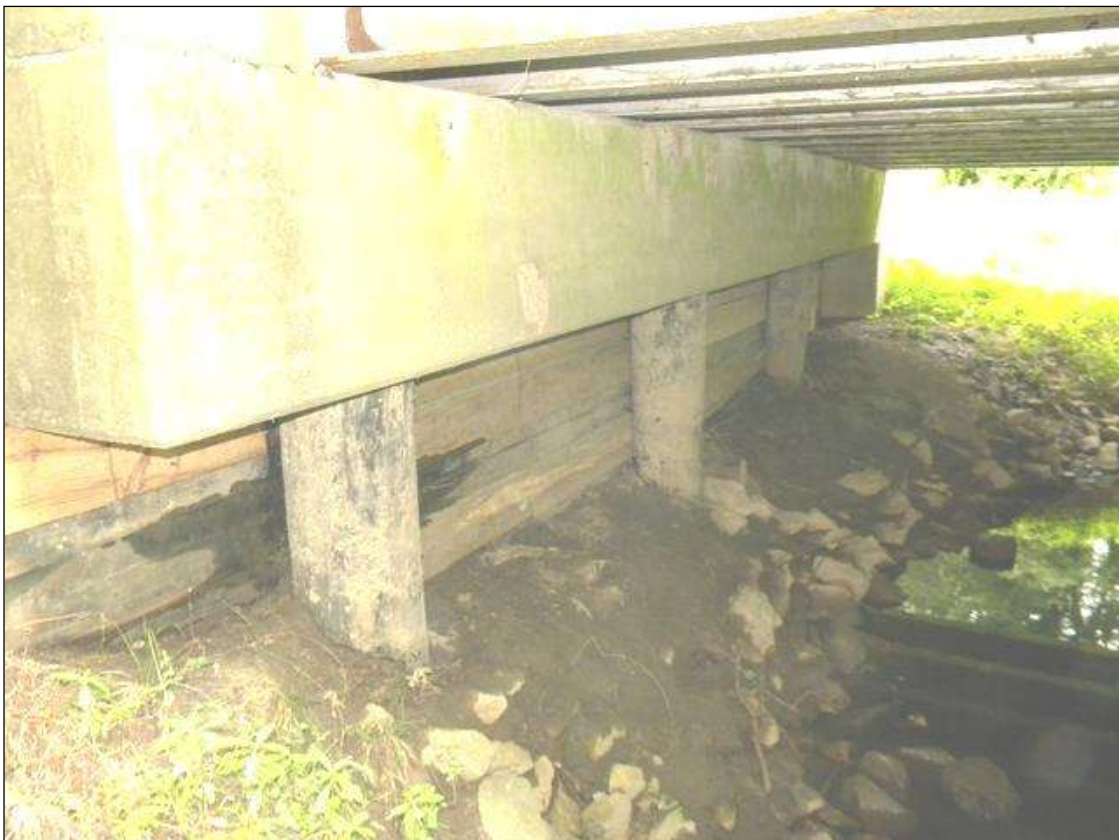
| <b>35c</b> | <b>F</b> | THERE ARE NO CROSSBRACING AT THE INTERIOR BENTS.<br>( TIMBER BULKHEADS AND WINGWALLS )        THERE IS FILL LEAKAGE ADJACENT TO PILE 2 AT END BENT 1. (PHOTO)<br><br>THE END BENT 2 BULKHEAD AT PILES 3 AND 4 HAS LEAKAGE OF FILL AND BOARDS ARE SOFT.<br><br>THE END BENT 2 BULKHEAD BETWEEN PILES 1 AND 2 HAVE AREAS THAT ARE SOFT AND DECAYED.<br><br>THERE IS A DECAYED EXTERIOR BULKHEAD BOARD AT THE SOUTHEAST CORNER. (PHOTO)<br><br>THERE IS A NEW TURNPILE AT SOUTHEAST CORNER. | |
